STABILITY PROBLEMS UNDER A CHAIRLIFT MIDWAY STATION IN CREEPING PERMAFROST TERRAIN, GRÄCHEN, SWISS ALPS

ABSTRACT: The mid-way station of a chairlift located in the ski resort Grächen (Swiss Alps) was originally built in 1997 at 2453 m ASL in alpine permafrost terrain. A few months after construction it became evident that the terrain at the mid-way station was unstable: settlement and creep occurred and cracks formed in the structure. Two 25 m boreholes were drilled near the foundations and equipped with inclinometer tubes and thermistors. The presence of permafrost with exceptionally large active layer depths and a 20 m thick talik containing water was confirmed. The deformation rates of the ground attained high values between 2002 and 2003. As a consequence, a specially developed new mid-way station had to be built in 2003. The excavation trench was lined with insulating material in order to avoid thermal disturbance of the underlying permafrost during the setting of the concrete. The new foundation consists of a concrete T-girder with three point bearings. Repositioning of the entire structure in response to creep is possible, due to the unique character of the structural beari

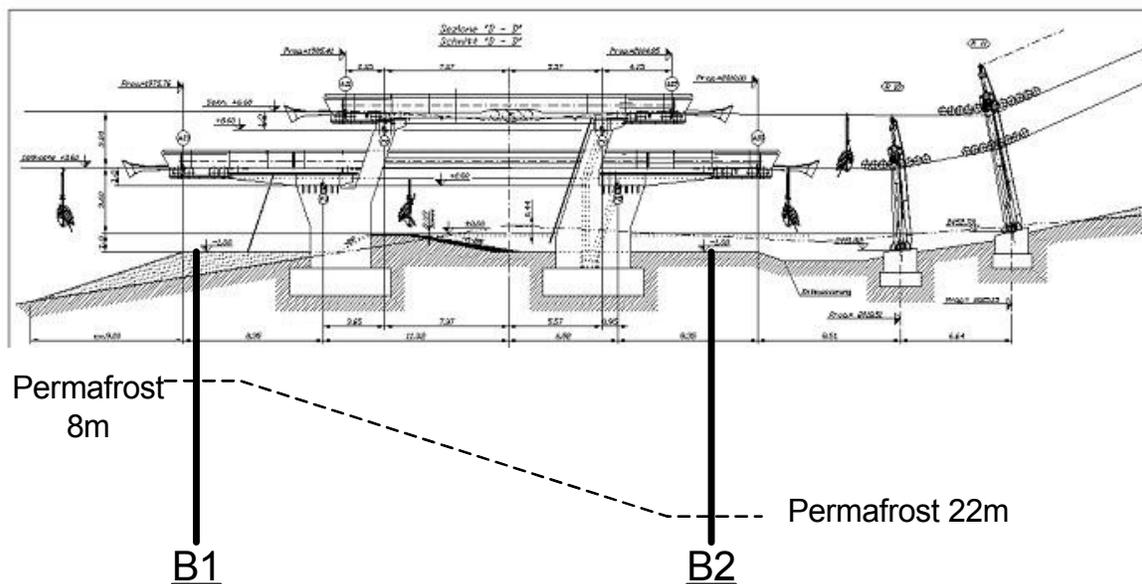
Fig. 1. Midway station of the Stafel-Seetalhorn chairlift, Grächen, Swiss Alps. The locations of boreholes B1 and B2 are shown, as well as the depth of permafrost.

Two 25 m boreholes (B1 and B2, Fig. 1) were drilled just above and below the midway station in October 2002. As the boreholes were drilled destructively and not cored, the volumetric ice content of the ground is not known. A layer of humid ground was observed during drilling at 15-17 m depth in both boreholes.

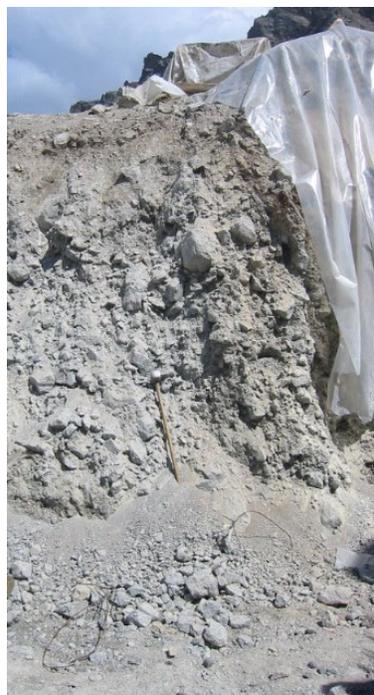
Fig. 2. Construction pit (August 2003), showing the foundation and earthy to blocky ground material in the sides of the trench (5 m deep).

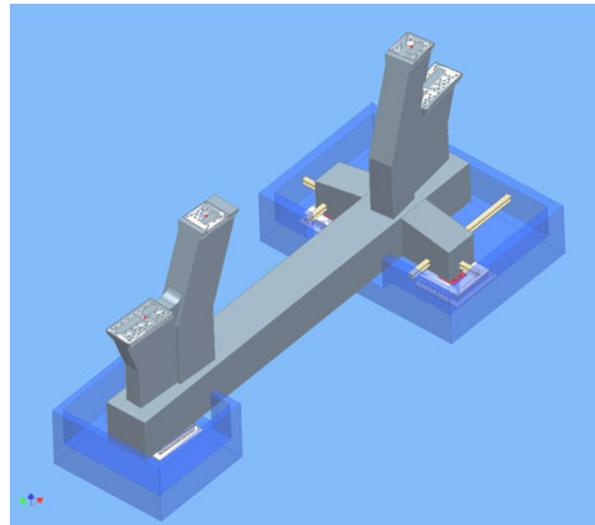
Fig. 3. Structure of the new midway station showing the two concrete supports (upslope support on the right), connected by the T-girder which rests on the 3 point bearings.

The new structure had to be supported and positioned in such a manner that terrain movements (up to about 3 m in any direction) can be taken into account without incurring damage. The new shifting device is located entirely underground. Transverse girders transfer the load of the new midway station to two concrete supports. The distance between the axes of the two supports is 15 m. The total loads (dead and live load) are 2323 kN and 2452 kN respectively, which corresponds to a mean foundation pressure of approximately 55 N mm^{-2} . The ground plates are 1 m thick. The two concrete supports are carried by a 20 m long T-shaped girder (see Fig. 3). The girder has three point bearings (two upslope and one downslope), which can slide horizontally in order to allow displacement of the entire midway station. The two upslope bearings are fixed whereas the downslope bearing can move freely. The T-girder can be displaced or uplifted hydraulically and steel plates can be inserted. The point bearings can therefore be relieved and repositioned.

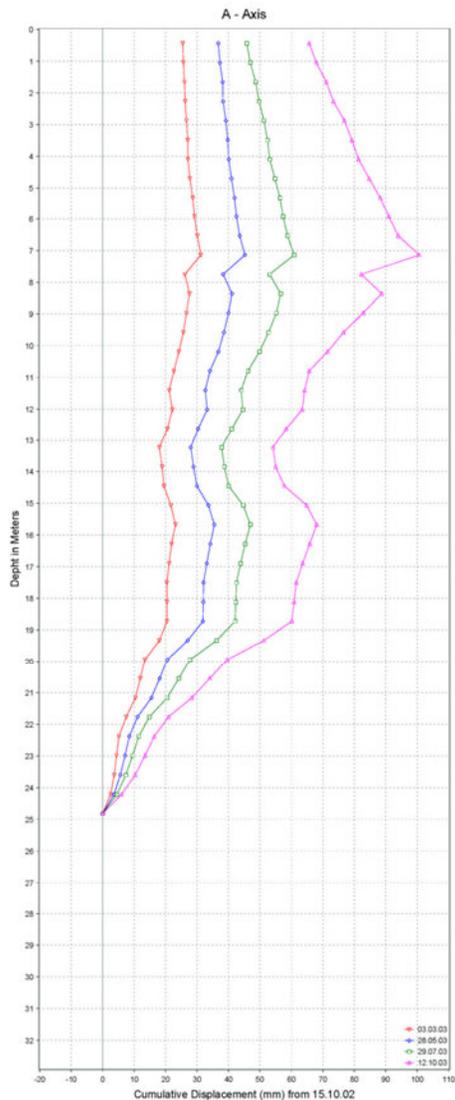
The deformation measurements in the boreholes were effected by Stump ForATec AG. The initial surveys were made in October 2002 and repeat surveys in March, May, July and December 2003. The results of the surveys in borehole B1 (located in the more unstable terrain downslope of the midway station) are shown in Fig. 4 (cumulative displacement). The displacement of the ground is very irregular. There is not one sharply defined sliding plane but complex translational and rotational movements, probably due to a combination of the local geology and the presence of frozen ground.

Fig. 4. Horizontal deformation (cumulative, in mm) in borehole B1 (3.3.2003, 28.5.2003, 29.7.2003, 12.10.2003, from left to right).

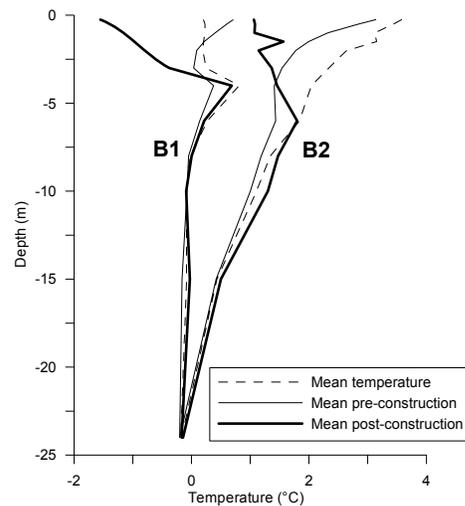
The temperature data indicate that the thermal regime of the ground is of a very particular nature: whereas the active layer in the lower borehole B1 is almost 8 m thick and the ground is permanently frozen to the base of the borehole, the upper borehole B2 has a 22 m unfrozen talik, below which the ground is frozen. Neither borehole reaches the base of the permafrost body (Fig. 5).

The effects of the thermal disturbance caused by construction work in 2003 can be seen in Fig. 5, where the overall mean temperature in both boreholes is shown (for 7.11.2002 to 16.8.2004) and the mean values for the period 7th November to 16th July in 2002-2003 (before construction) and 2003-2004 (after construction) respectively. In both boreholes the ground was warmer after construction, below about 4 m depth. In B1 the permafrost table was about 0.5 m and in B2 1.0 m lower than before. In addition, after construction the temperature curve comes very close to 0°C at 15 m depth in B1.

Fig. 5. Mean vertical temperature profiles in boreholes B1 and B2, and mean temperatures before and after construction of the new midway station for the period November 7th to July 16th in 2002-2003 and in 2003-2004 respectively.
