GONE LIKE A GHOST: THE GHOST GLACIER FAILURE AND SUBSEQUENT OUTBURST FLOOD,  
MT. EDITH CAVELL, JASPER NATIONAL PARK

**ABSTRACT:** During the evening of August 9th or early morning of the 10th 2012 the Ghost Glacier fell from the North Face of Mount Edith Cavell in Jasper National Park. Approximately 125,000 cubic meters of ice fell close to a vertical kilometer onto a lower glacier and then a tarn which was full to overflowing with recent precipitation and the winter's snowmelt runoff. The resulting wind blast and water displacement caused extensive damage to the park's infrastructure within an area that receives high numbers of park visitors. After an extensive search and rescue response it was determined that, due to the timing of the event, nobody was missing or injured. The glacial lake outburst flood is representative of the hazards within a rapidly changing post glacial environment and presents challenging questions to risk managers in high visitor use areas such as the Canadian National Parks.

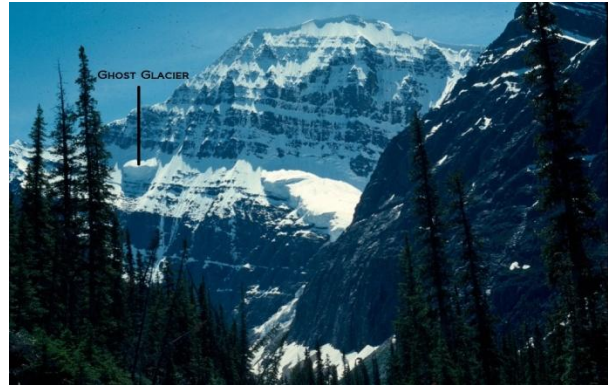
Fig. 2: The Ghost Glacier prior to August 10<sup>th</sup> 2012 (Parks Canada, Jasper Park archive)

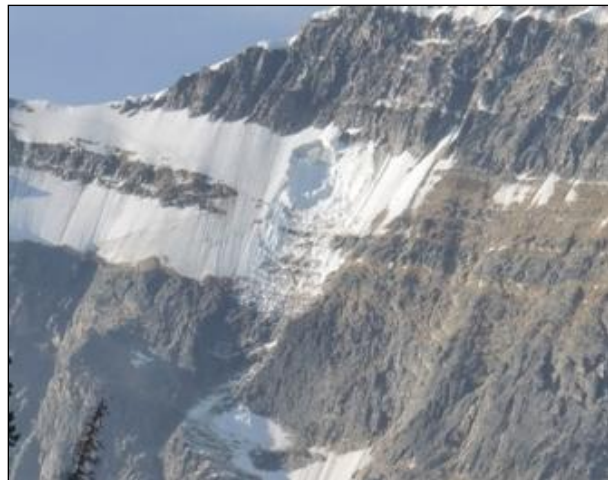
During the night of August 9th or the early morning of August 10th approximately 60% of the Ghost Glacier released from the north face of Mount Edith Cavell (Fig. 2 and 3). The displaced ice fell approximately 1,000 m onto the Cavell Glacier (Fig. 4) and into the Cavell tarn (elevation 1,775 m), located approximately 600 m from the base of the north face, producing a glacial lake outburst flood (GLOF). The estimated volume of the displaced ice ranges considerably from a maximum 200,000 cubic meters to a minimum of 100,000 cubic meters. It is likely the volume was close to 125,000 cubic meters. The estimated average ice thickness of the failed glacier material was 20 m. The ice entered the tarn from the southeasterly edge of the Cavell Glacier displacing a huge volume of water and ice blocks across 170-180 m of the downvalley shoreline .

Fig. 3: The Ghost Glacier after it fell on August 10<sup>th</sup> (Park Canada G.Lemke)

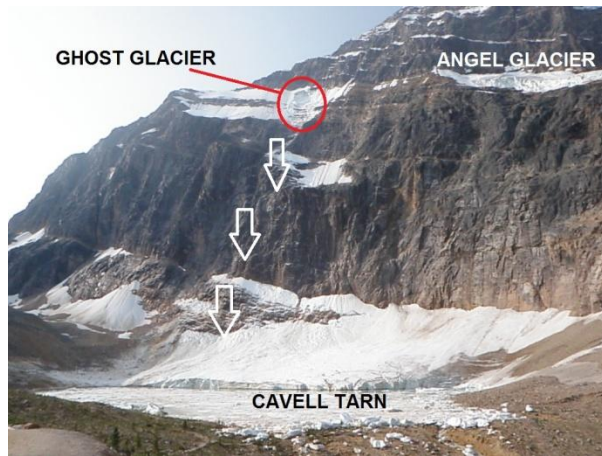
Fig. 4: The arrows show the trajectory of the ice-fall. (Parks Canada R.Wedgwood)

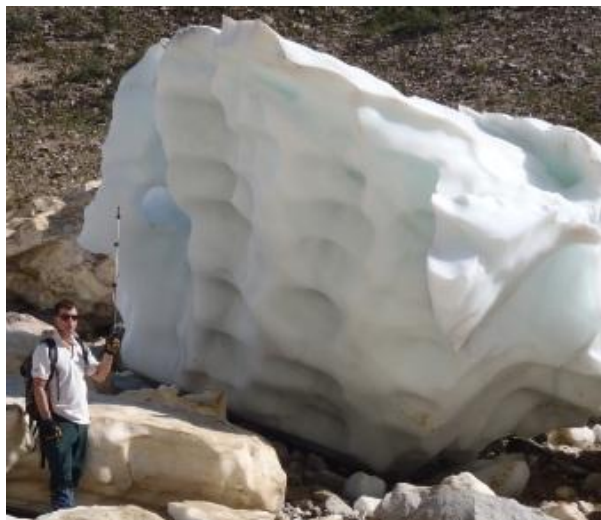
Ice blocks of up to four and a half meters high, weighing approximately 60-80 mt, were lifted out of the tarn by the surge (Fig. 5). Warning signs, positioned at the shoreline, were blasted out to the side by the surge wave and/or air blast. The waters ran downhill over the moraine plug at the tarn outflow carrying ice blocks with it. The overflow from the tarn was carried down the former, now considerably enlarged, stream channel from the tarn and a second, new channel with a slightly lower ingress, was cut across the moraine dam approximately 50 m west of the former channel.

Fig. 5: A large glacial ice blocks washed onto the moraine dam. (Parks Canada R.Wedgwood)

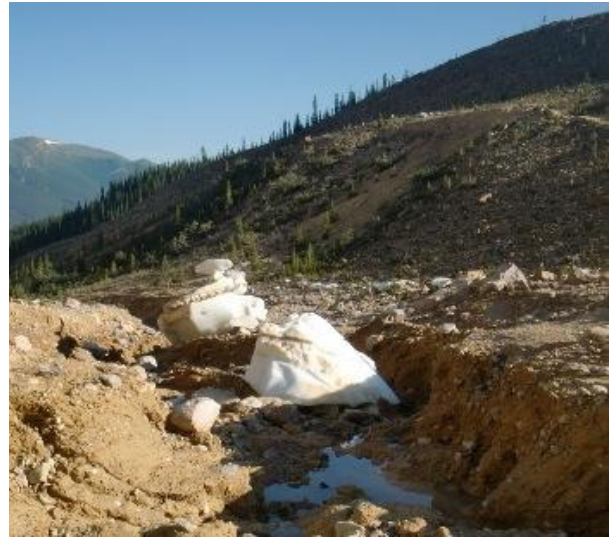
The channels cutting across the flanks of the moraine dam were considerably enlarged, one up to 5 m deep and 30 m wide, by the exiting water. Massive blocks of glacier ice were carried into the larger channel (Fig. 6). The two overflow channels ran down the relatively steep face (ca. 9 degrees) before joining, about 205 m from the tarn. At this

Fig. 6: Glacial ice blocks deposited in an enlarged downstream channel. (Parks Canada R.Wedgwood)

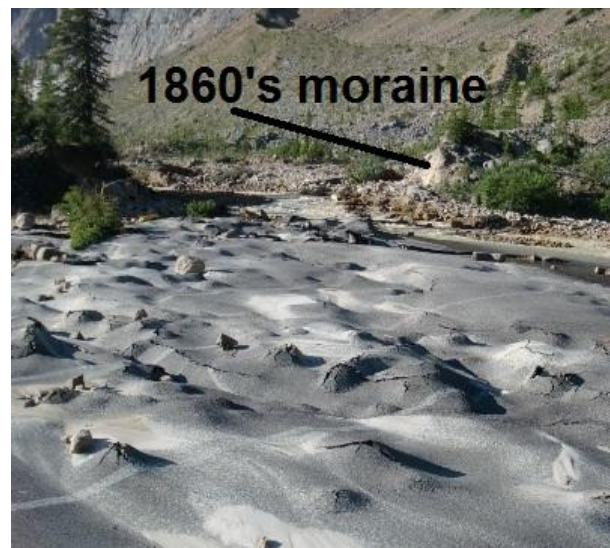
Downvalley a terminal moraine, dating from the 1860s, constricted the flow of the water adjacent to the parking lot, 1,020 m from the tarn. Surge marks on nearby trees and rocks indicate the water was at least 1.6 m deep here. The relatively narrow creek channel through the 4 m high moraine wall was widened to 40 m by the surging water. Just below the moraine the floodwaters excavated the material from below the pavement in the parking area (1,170 m) causing the asphalt to fold and sag over the larger rocks below (Fig.7).

Fig. 7: Collapsed pavement in the parking area (Parks Canada R.Wedgwood)

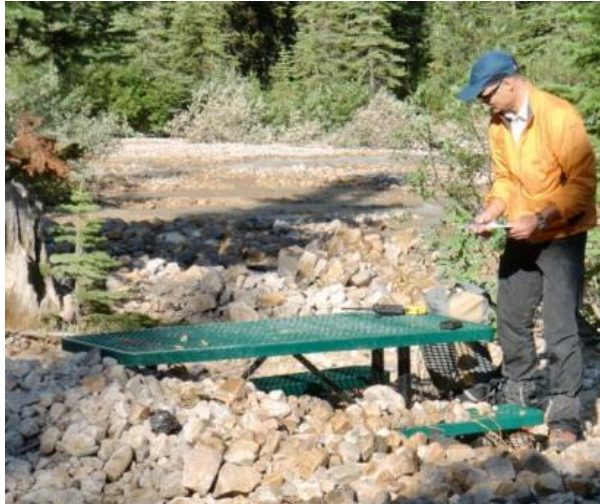
One of the four outhouses was undermined and toppled over, while the nearby picnic area between the road and creek was buried by rocks and gravel (Fig. 8). Part of the flow was diverted into the lower quarter of the parking area and down the area access road for approximately 100 m. Some of the quartzite boulders pushed onto the road measured 1 m x 0.75 m x 0.25 m. In the outwash downstream of the parking area a maximum water depth of 1.6 m was estimated from the mud drape against a large standing snag (Fig. 9).

Fig. 8: A picnic tables partially covered by rocks carried by the surging waters. (Parks Canada M.Eder)

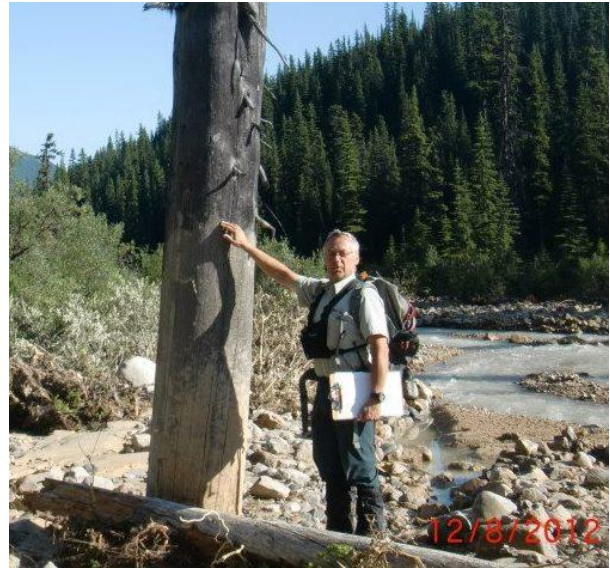
Fig. 9: Water surge marks left on a snag (Parks Canada R.Wedgwood)

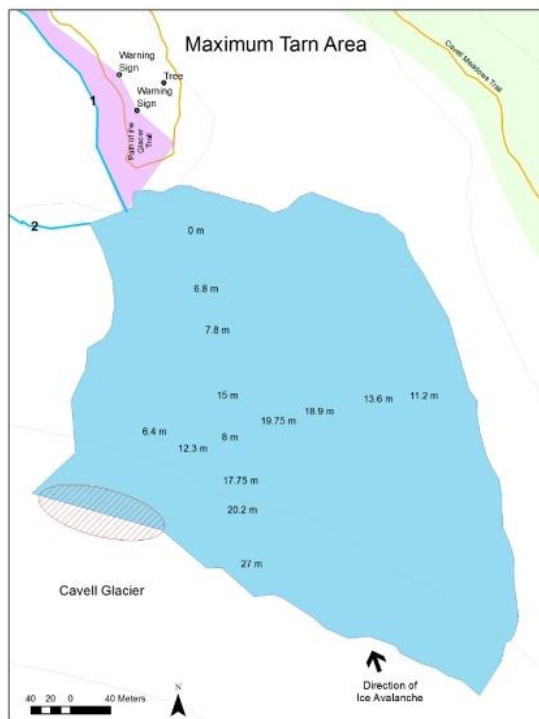
Fig. 11: Cavell tarn showing the maximum tarn area and the depth measurements taken from the ice cover in October 2012. The primary (1) and secondary (2) drainage channels are shown in blue (top of map) and the pink polygon shows the area flooded by the overflow.

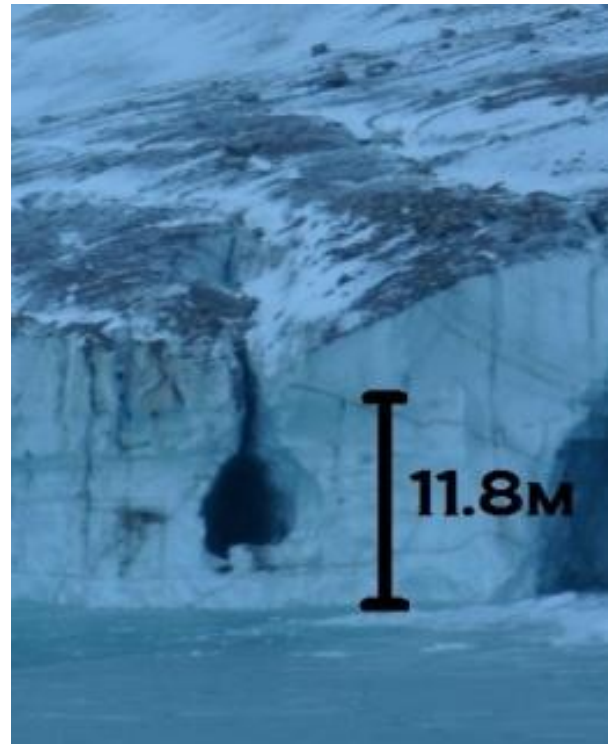
Over the course of the field trips the tarn drained noticeably. This could be inferred by the melt line on the ice cliffs of the Cavell glacier and the relative distance to the surface of the tarn (Fig. 12), the high water line on the shoreline and relative position of the tarn surface and the sagging surface ice of the tarn ice. In the late winter, an avalanche forecasting field team, noted that the tarn appeared fully drained. The snow covered ice surface sagged noticeably (Fig. 13). The lowest point (deep spot) lay close to where the bathymetric survey had placed the deepest part of the tarn three months earlier. The greatest recorded water depth was 27 m, measured 46 m from the ice cliff of the Cavell Glacier. During the time of the bathymetric survey it was calculated that the water levels had dropped between 5 m (minimum drop), and 11.8 m (maximum drop) since the GLOF. This

Fig. 12: The drop in water level of Cavell tarn between August 10th and early October 2012. (Parks Canada R.Wedgwood)

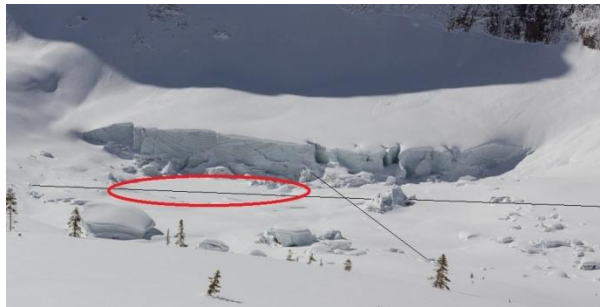
Fig. 13: Cavell Tarn with the presumed deepest spot marked by a red circle. The black lines show the two axes along which depths were measured in October 2012. (Parks Canada R.Wedgwood)

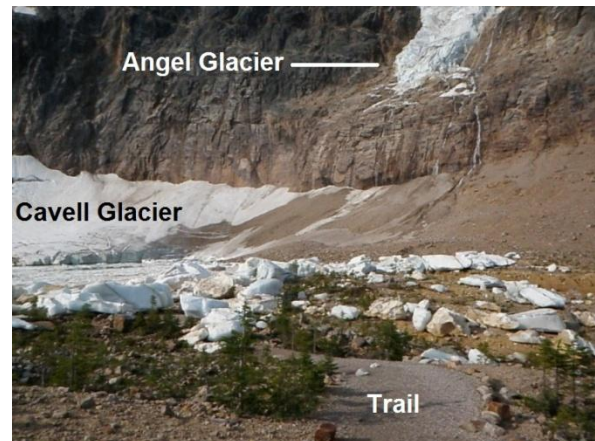
Prior to the GLOF a high use trail led from the parking lot, located one kilometer downstream, to the tarn shoreline. At the terminus two cautionary signs were positioned warning the public of icefall danger from the Angel Glacier (Figure 14). On a busy day in August upwards of 100 people may, at any given moment, be hiking the lower trail between the tarn and parking area. It was extremely fortunate that the event happened during the night when there was nobody present.

Fig. 14: The Angel Glacier located to the West of the tarn also threatens the tarn and those hiking below it. (Parks Canada R.Wedgwood)

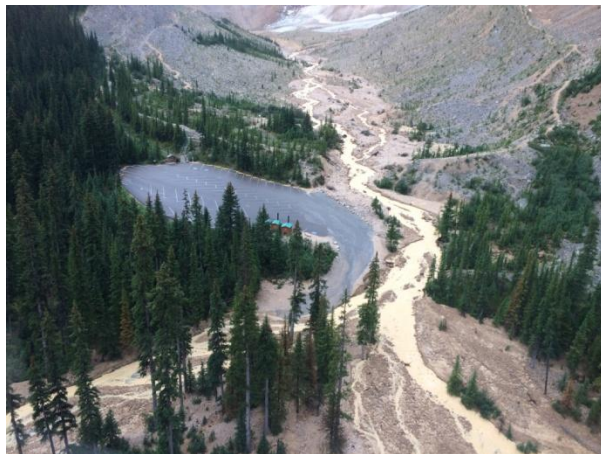
During the evening of August 15<sup>th</sup> 2014 an intense rain event occurred as reported by climbers returning from Mount Edith Cavell. Images from a stationary camera near the mountain recorded this event. The following morning at 08:00 AM a member of the public reported the road being impassable as it was covered in rock, mud and water. Images from the camera, established for long term monitoring, showed large volumes of water coming from the Angel Glacier and the north face of Mount Edith Cavell. There were indications of small landslides and icefalls from the Angel Glacier. It is thought that water broke through a restriction in the west drainage channel and picked up additional material from the banks. As in 2012 approximately 100 meters of road was impacted as the water slowed and the debris deposited (Fig.15). No park visitors were in the area at the time. In the immediate aftermath of this event access to the area was restricted.

Fig.15: A debris flow August 2014 (R.Wedgwood).
