# A CASE-STUDY OF HIGH LOAD HUMAN-TRIGGERED AVALANCHE ACCIDENT IN L'ESTANYÓ (ANDORRA): LESSONS LEARNED AFTER CONDITIONS ANALYSIS

**ABSTRACT:** Two different groups of skiers planned to descent the south-west face of Estanyó peak at 2.550 m altitude. They had different objectives, the first group (9 persons) with a professional discipline mind-set, and the second group (5 persons) with recreational objective. The second one included large variety of ski levels within the group members.

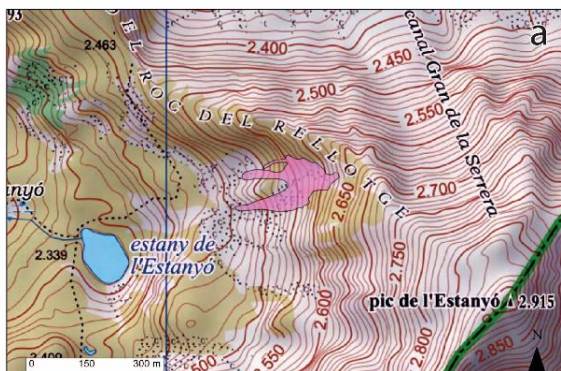
Figure 1: Avalanche location and total extinction

At around 13:00 hours (local time) on the 5th of March 2024, an avalanche was triggered by a high additional load on the south-western slope of the Estanyó peak. The top starting zone was located at 2,600 metres and the weak layer caused a large propagation crosswise along 150 meters (fig 1).

Approximately the volume of snow mobilised was 7.000 m<sup>3</sup>, therefore, the avalanche size according to the scale proposed by the EAWS would be 2.5. Once the avalanche was triggered, the avalanche deposit split in two due to a small spine that characterises that slope, a fact that reduced its destructive potential. The avalanche danger level was 3 in north zone (fig 2) with wind slab and new snow avalanche problems.

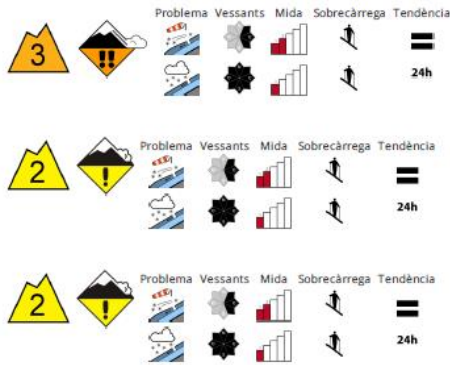
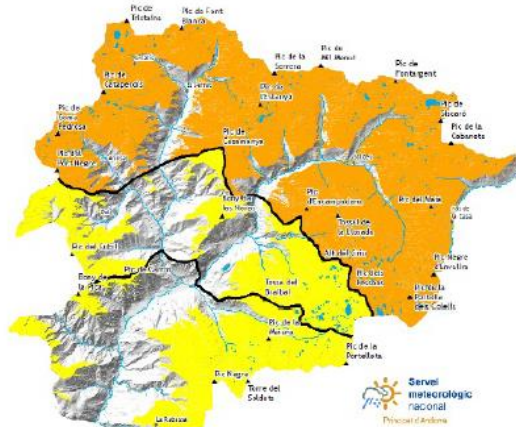
Figure 2: Avalanche bulletin for the 5th of March 2024, The avalanche bulletin is made the day before at 16h.

The other key point is to avoid an accident is the main one: the avalanche bulletin. First of all, the danger level for the day of the accident was 3, chosen as shown in Figure 6. In terms of danger level and popular opinion it was a correct danger level. But in terms of avalanche problems and aspects the bulletin wasn't sufficiently accurate. Furthermore, after the accident, the forecasters discovered that our knowledge of snowpack was poor, or very poor due to few and short field trips to analyse the snowpack stability and their distribution the previous days to the accident. The predictors didn't know the existence of weak layer below the first big snowfall (27th). Our consideration was that with 4-days compaction the eventual weak layer was ended their activity and the main problem was with wind drifted snow during the last snowfall (3th).

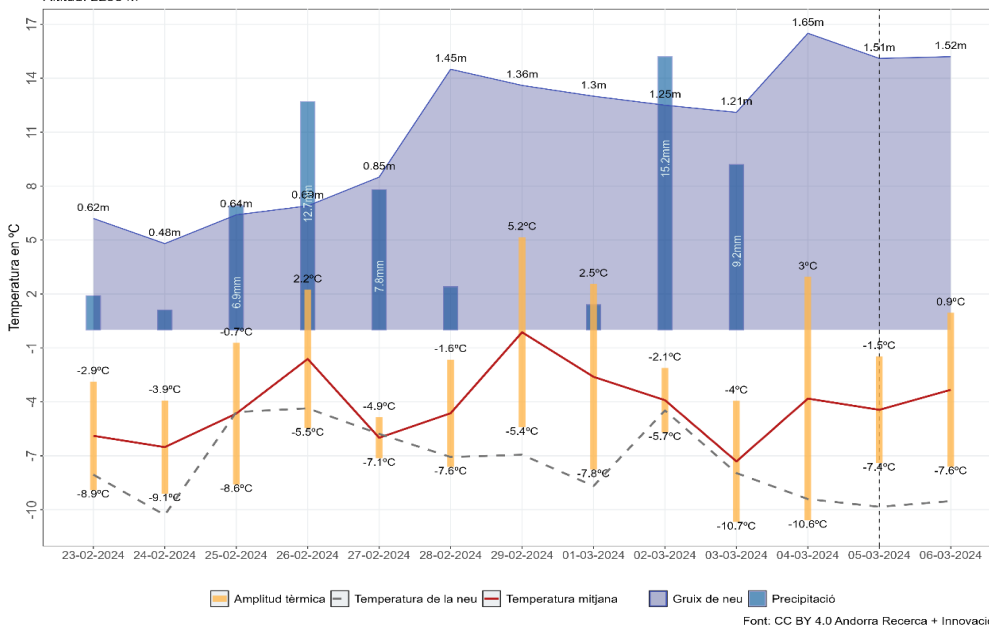
Figure 3: weather conditions evolution 12 days before the accident. Legend: snowpack accumulation (blue area), the equivalent amount of precipitation (blue columns), temperatures with their amplitude (yellow columns), air temperature (red line) and snow surface temperature (intermittent grey line).

The snow conditions since 23th February changed drastically, especially in the northern area of Andorra, where the accident happened. There were several light snowfalls before a larger snowfall that accumulated 60 cm on the 27th of February. It should be noted that both the snowfall of the 23th and the 27th included round snow. The snowpack thickness on the 28th was 1.45m. At the end of the snow episode and especially on the 28th, it was accompanied by a strong NW wind of up to 29km/h (8m/s) (Fig. 4). Immediately after, there was a small weather window that allowed temperatures to rise on the 29th with a maximum of 5.2 °C and a progressive compaction of the snowpack during the 4 following days. From the 2nd March, the arrival of an atmospheric depression with a southwest flux, caused instability across the country and up to 44cm of new

snow accumulated. As the day progressed, winds turned NW with 30km/h on the 3rd, as shown in Figure 4. From the 4th onwards, as the centre of low pressures moved eastwards, high pressure moved in, with temperatures rising from -10.6 °C minimum to +3 °C maximum. Even so, instability was maintained in the north of the country due to the passage of a low pressures area at high altitude. The following days, atmospheric stability began to gain ground, bringing widespread clear skies but keeping temperatures low. The 5th of March, snowpack was distributed as shown in Figure 5.

Figures 3 and 4 show weather data 12 days before the accident. It was during these days that the slab that caused the accident was configured.

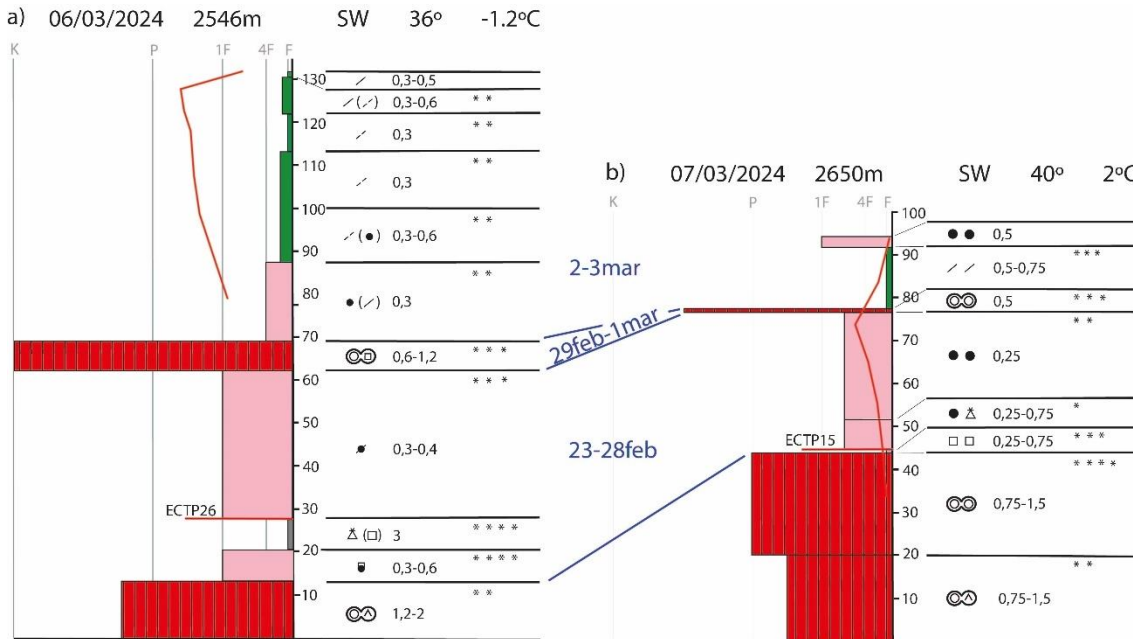
Figure 4: accidental slab snow profiles, 5a performed the day after the accident (6th of March) and 5b two days after the accident (7th of March).

Snowpack stratigraphy on the 5th of March (the day of the accident) is shown in Figure 5. On the left (5a), a snow profile made the day after the accident from one flank of the scar. At this point, the slab was resting on a layer of between 3 and 8 cm of 3 mm round snow that had fallen at the beginning of the first episode (23/02), which was also resting on a large 1-finger hardness (Fig. 7a and 7b). Below these layers there was a crust of

re-icing, the only snow remaining before the snowfalls of the 23th February. At other points of the scar in the immediate vicinity where this profile was made, above the crust there were facets measuring between 1 and 2 mm and there was no round snow or the lower fine-grained layer. On top of this layer, which acted as a weak layer, there were large, recognisable particles and particles in two layers separated by a re-icing crust formed on the 29th February and 1st March. These two layers were visually recognizable at

the scar, and caused the avalanche deposit to consist of larger hard slab blocks on one side and a smaller, softer deposit on the other.

Figure 5b shows another snow profile made above the avalanche scar two days after the accident. Here, above the crust at the base, a thin 1 cm layer of small facets was found, and above it the structure was similar: a package of large till and recognisable particles, with a crust - in this case much thinner - in between. At this point, however, there was less snow accumulated especially during the last episode above the second crust, partly due to compaction during the last 24 hours and the effect of the wind. The ECT test at this point was ECTP15 with evident propagation.

The slab accident involved two big snowfalls (27th February and 3th March) and its origin was the weak layer visible in snow profiles (Figure 5) and caused the ECTP's.

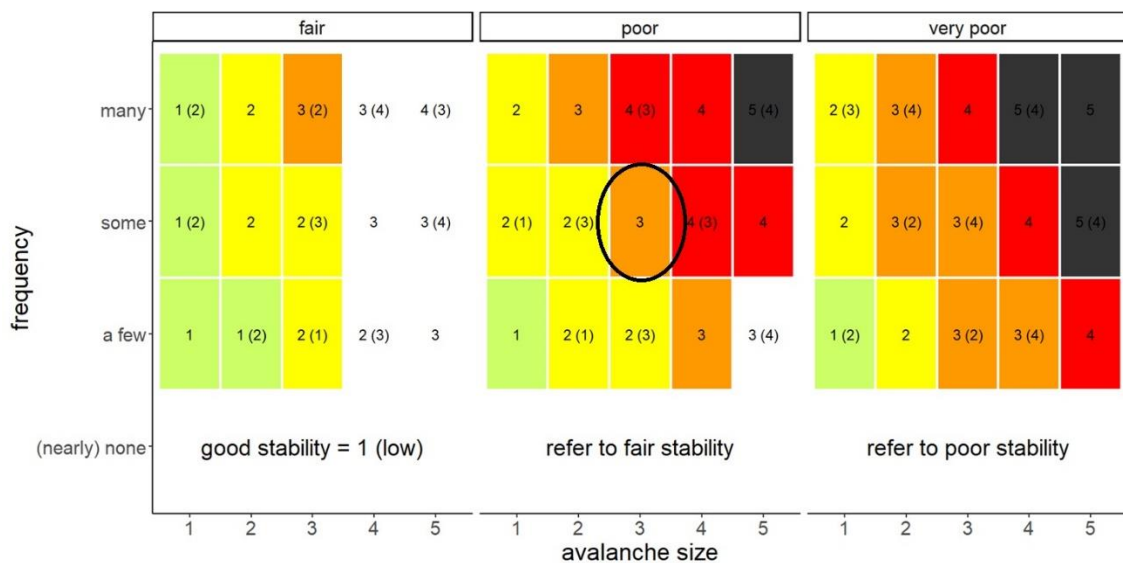
Figure 5: option chosen to establish level 3. Poor stability, in some potential avalanche release and maximum avalanche size of 3.

The danger level for the 5th of March was assigned like shown in Figure 6, and the avalanche problems was chosen omitting the weak layer that caused the accidental avalanche, but if we had known about the presence and activity of the weak layer, the problems would have been new snow and weak layers, as shown in the Figure 7.

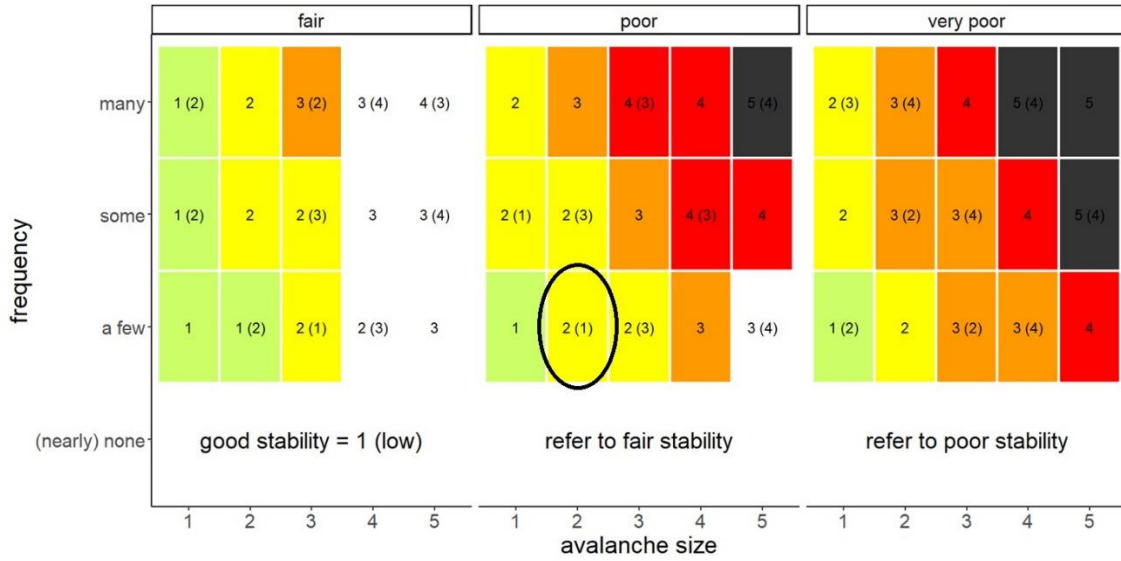
Figure 7: option chosen to establish level 2. Poor stability, in a few potential avalanche releases and maximum avalanche size of 2. This avalanche danger level wasn't published, when we knew the accident, we changed the decision.

The accident occurred around 13:00 h, but as a forecast service we knew about the avalanche at 15:50. The new bulletin for the 6th of March was already drafted and prepared to be published at 16:00 h. As we see that frequency of poor stability class was every day more difficult to find, we descended the frequency as “few”. Furthermore, until before the avalanche we didn’t have had any avalanche of size 3, either natural or accidental, so we decided to change also the avalanche size expected. Our bulletin was ready to be published with avalanche danger level 2 (Figure 8).

But when we knew about the avalanche accident, we immediately changed the danger level and added some details in bulletin, like main aspects and other description details. Our first reaction was “we don’t know why this accidental avalanche have happened”. During the next days, when we analysed the avalanche slab and performed more field observations, we understood which was the lacking knowledge or information

Finally, after 3 days, we went back to the decision chosen in Figure 8, but with the field observations we discovered that it was has been logical to choose this option the 5th even if the accident. The only thing that would have been missing would have been to explain it properly.

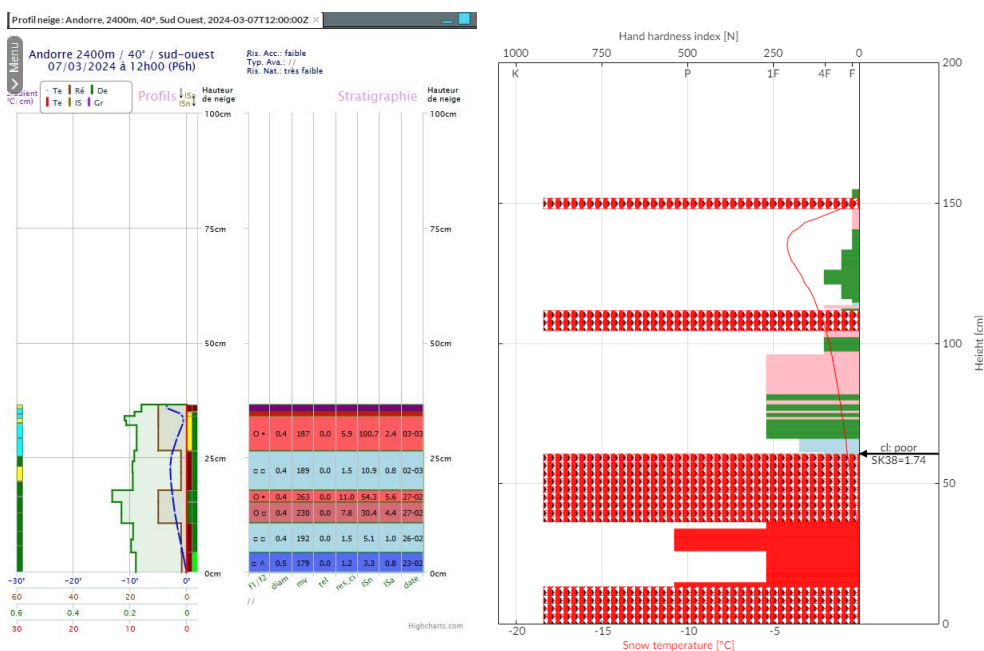
Figure 8: snowpack modelling

We can also rely our decisions in technology. Numerical models of snow cover are becoming increasingly reliable. Figure 9 shows the snowpack modelling for the day of the accident (SAFARN-Crocus-MEPRA in the left and snowpack in the right) clearly shows a faceted layer below compacted layers, compatible with the weak layer that caused the accidental slab. At the right side, another modelling, from snowpack, that shows also the eventual weak layer.
