## LOADING ON STRUCTURES FROM FLUIDIZED AVALANCHE FRONTS OVERFLOWING DEFLECTING DAMS AT FLATEYRI, ICELAND, JANUARY 2020

Kristín Martha Hákonardóttir<sup>1,2\*</sup>, Ragnar Lárusson<sup>2</sup>, Árni Kristjánsson<sup>2</sup>, Gunnlaugur Pétursson<sup>2</sup>

<sup>2</sup> Verkís Consulting Engineers, Reykjavík, Iceland

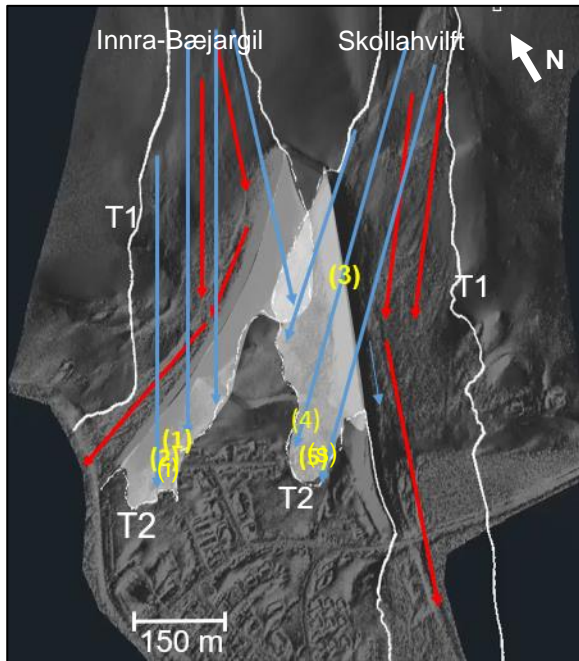
Figure 1: A LiDAR scan by Svarmi of the Flateyri dams and avalanches in January 14, 2020. The outlines of the avalanches are white. The arrows indicate the most likely direction of the avalanche flow (red: dense core; blue: fluidized front), and the numbers correspond to the locations of damaged structures: (1) house at Ólafstún 14, (2) cars, (3) mast, (4) radar, (5) shed. Intact structures: (i) house, (s) gate.

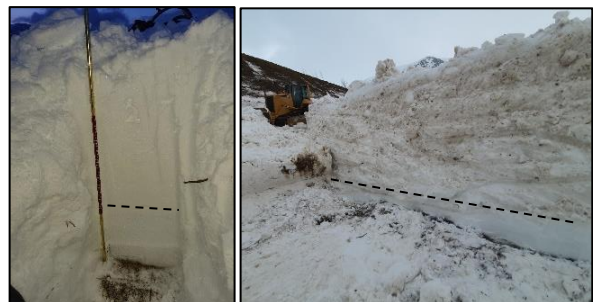
Figure 3: The avalanche debris at the Skollahvilft dam. Left: Type 2 deposit on the lee side of the dam. Right: Type 1 deposit upstream of the dam. The dashed lines indicate the boundary between old snow and deposited snow. Photos: Ó. Hilmarsson.

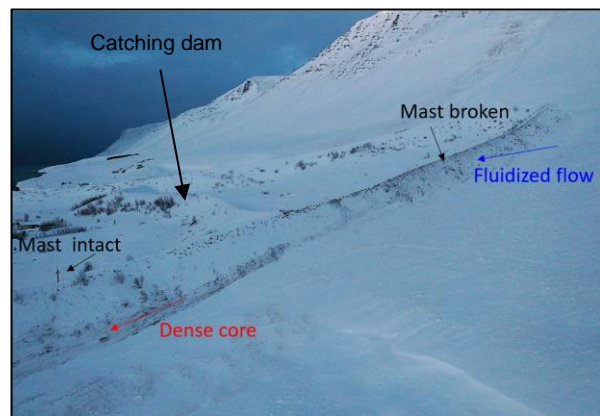
The flow deflected by the Skollahvilft dam reached approximately 10 m vertically on the lower part of the dam, leaving an additional 5 m to the top (see Figure 4). Marks on the dam indicate that the avalanche flowed parallel to it in a thick stream. These marks resemble those observed in the 1999 Flateyri avalanche and were interpreted as the result of an oblique granular jump at the dam face (Jóhannesson, 2001). Granular jumps have been observed in small-scale experiments and reproduced in numerical simulations (Johnson et al., 2020; Pétursson et al., 2019; Jarosch et al., 2022). However, the fluidized flow that

Figure 4: Skollahvilft deflecting dam: Flow marks. The debris thickness is approximately 3–5 by the

dam. The avalanche overran the upper half of the dam. Photo: Verkiš, January 2020.

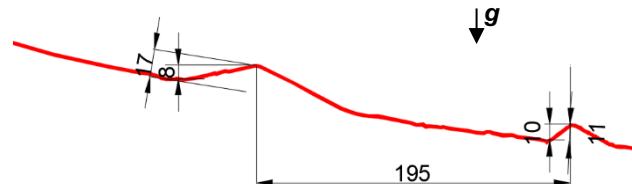
2023). Figure 5 depicts a section through the Skollahvilft deflecting dam and the catching dam in the flow direction. Both dams are earth fill dams with a 1:1.25 (horizontal:vertical) upstream slope. The vertical height difference encountered by the front is limited to 8 m, while the top of the dam rises 17 m above the ground. The retaining effect of the dams was limited, based on radar measurements upstream of the Skollahvilft dam and debris thickness upstream of the catching dam.

Figure 5: A longitudinal section through the Skollahvilft dams along the flow path of the fluidized front, through the mast (see (3) in Figure 1).

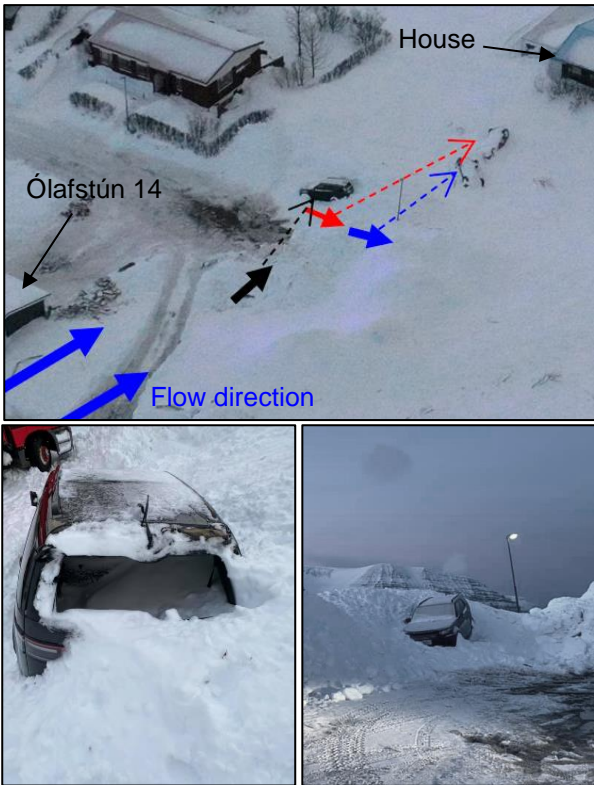
Three cars were parked next to the house at Ólafstún 14, approximately 100 m downstream of the Innra-Bæjargil dam (see Figure 1). Two of them, a 1.9 t SUV (marked blue on Figure 6) and a smaller 1.0 t car (red in Figure 6) were transported over a snowpile approximately 3 to 4 m high. They were found upside down about 15 and 20 meters downstream from their original positions, respectively. The blue SUV sustained dents and broken windows, on its downstream side, including two downstream windows and the rear window. A truck (black in Figure 6), which had its rear window facing the avalanche, was moved about 13 m and ended up in a snow pile. It had a broken rear window, was partly filled with light snow, and rotated 90° from its original position.

Through simplified calculations using equation (1), we conclude that the movement of the cars can be contributed to the dynamic force exerted by the fluidized flow (Lárusson et al., 2022). We find that with flow speed of 20 m/s and an average density of 50 kg/m<sup>3</sup>, a 1.9 t SUV could be accelerated to a

speed of 14 m/s in 1 s, covering a distance of 10 m. This assumes a drag coefficient of 1.5, and a projected impact area of 6.5 m<sup>2</sup>.

There is no indication of the cars rolling, which may suggest that the fluidized front had a vertical component or a frontal vortex that contributed to lifting the cars. The cars may also have experienced lift force due to pressure difference over the car.

Figure 6: Photos of the three cars after the event. Top: A schematic diagram of the cars' displacement. The two smaller cars (blue and red) were transported 15 m and 20 m, respectively. Bottom: The truck. Photos: K. M. Hákonardóttir and E. Ólafsson.

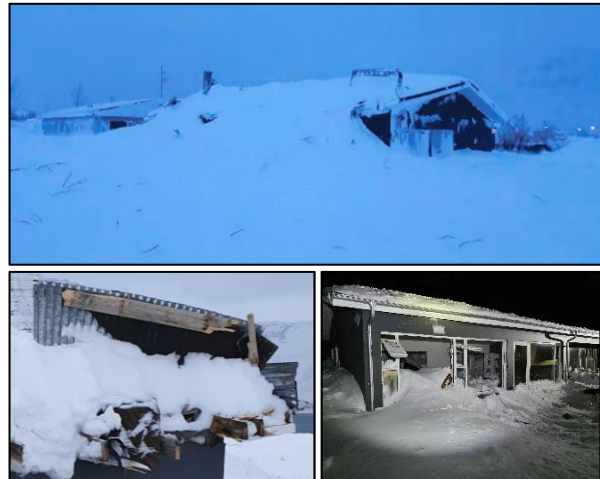
The fluidized front of the avalanche, which overflowed the Innra-Bæjargil dam, interacted with a one-story house at Ólafstún 14, a reinforced, concrete building with a reinforced roof slab and double-glazed windows. It was located approximately 100 m downstream of the Innra-Bæjargil dam. Although there was no structural damage to the house, the upstream side suffered various damages, including to the roof, its edge, broken glass in the windows and a

broken door. On the lee side, three windows were broken (two large and one small), along with the front door (see Figure 7 and Figure 8). Estimates of the impact pressure on the house were calculated based on the observed damage and are listed in Table 1. The flow speed at the upstream side of the house was determined to have exceeded 15 m/s in both horizontal and vertical direction. The downstream side does not appear to have experienced significant suction. Therefore, it is inferred that the downstream windows and door broke due to the flow passing through the house, and that the part of the avalanche that flowed over the house had a lower density.

Figure 7: Ólafstún 14. Top: The upstream side of the house. Bottom: Left: The roof edge. Right: Downstream side of the house. Photos: Ó. Hilmarsson and J. Ö. Bjarnason.

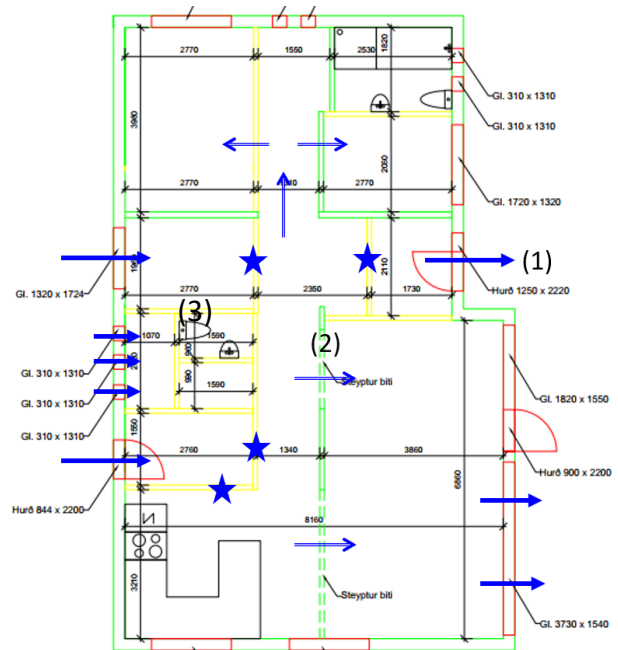
Figure 8: The layout of Ólafstún 14. Blue arrows: The direction of the flow into, through, and out of the house. Blue stars: Broken interior walls. Green lines:

Reinforced concrete walls. Yellow lines: Non-reinforced walls. Red lines: Doors and windows.

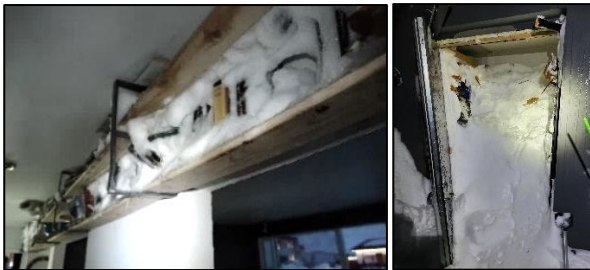
- The kinetic energy of the flow that entered the house through the large window and the back door was sufficient to break the non-reinforced walls, interior doors, and the back door.
- The flow direction through the room (3) and out of the downstream door (1) was relatively direct, and there was more snow accumulation at the door than in the room.
- Snow was found between the books on a bookshelf near the ceiling, even though the room was less than half full of snow.

Figure 9: Photos from inside the house. Left: A shelf near the roof of the house, see (2) in Figure 8. Right: Looking into the house through the downstream door, see (1) in Figure 8. Photos: Ó. Hilmarrson.

We conclude that the flow hit the house at a speed exceeding 15 m/s. The front was 2–3 m thick (main mass of the front) upon hitting the house and may have had a vertical velocity component. The windows and door on the upstream side broke immediately upon impact, possibly due to a brief pressure peak. As the flow passed through the house, it broke non-reinforced walls, the backdoor and three windows on the lee side. Although the flow was turbulent and chaotic, it maintained a consistent direction through the house.

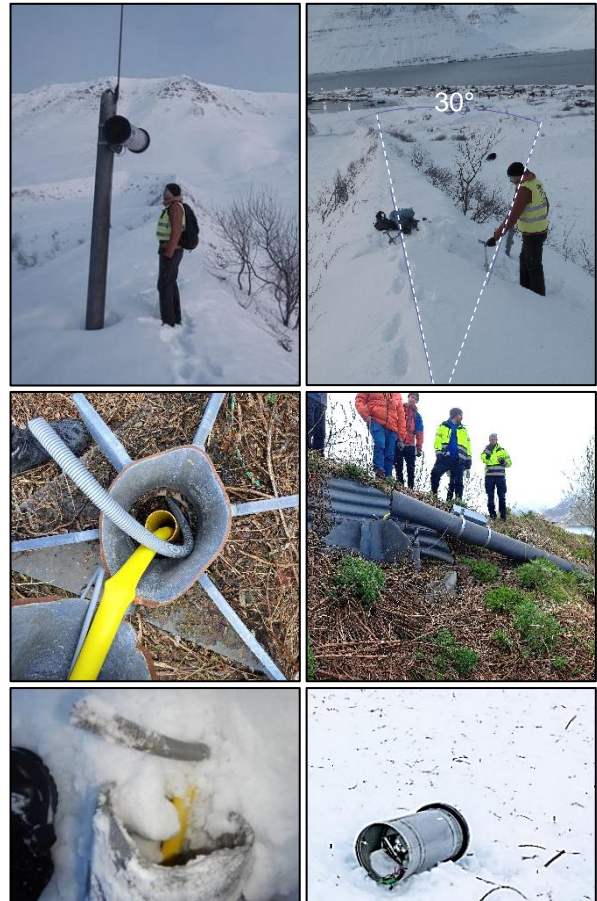
measure avalanche velocities (see Figure 10). The upper mast broke during the avalanche, and the radar antenna was found intact approximately 280 m downstream. Although the mast was cut into two parts, it had not been transported downstream. The steel was slightly deformed and elongated in the assumed direction of the flow. The mast formed a 30° angle with dam, which may be interpreted as the flow direction. The mast was made of 6.3 mm thick St. 52 steel with an outer diameter of 0.22 m. The first and second eigenfrequencies of the mast are 0.4 and 2.6 Hz, respectively.

Figure 10: The radar mast. Top: The mast on the lower (left) and upper (right) half of the dam. Middle: The broken mast. Bottom: A close-up of the broken mast on top of the dam and the radar antenna, 280 m downstream from the mast. Photos: K. M. Hákonardóttir, R. Lárusson and G. H. Halldórsson.

We find that an impact pressure of 60–85 kPa (flow speed of 50 m/s) is sufficient to break the steel mast, given a drag coefficient  $C_D = 1.5$  and the vertical pressure distributions on the mast, as shown in Figure 11. However, the mast may have also failed due to fatigue from periodic loading caused by the fluidized front. Additionally, with a frequency of 0.4 Hz, this could lead to 3–4 pressure pulses coinciding with the mast's eigenfrequency (Brosch et al., 2021).

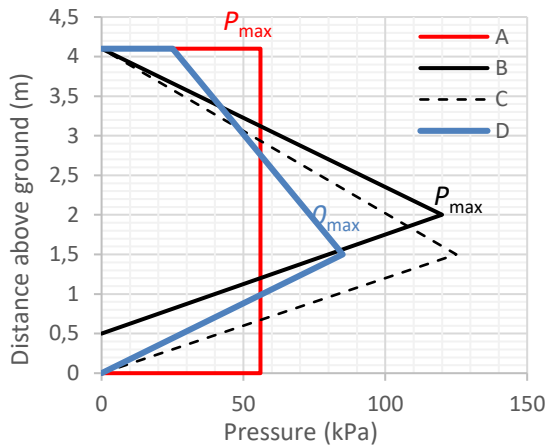
Figure 11: Vertical pressure distribution on the 4.1 m high steel mast for four load cases, A to D, each leading to failure of the steel mast.

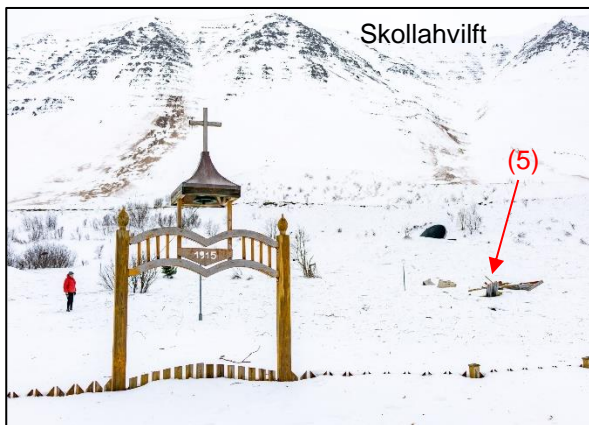
A shed in the Flateyri graveyard was shattered and transported approximately 10 m downstream, coming to rest 30 m from T2. The graveyard gate remained intact (see Figure 12). Despite the damage, the shed's walls stayed relatively intact. Assuming the shed experienced an impact pressure of around 5 kPa, the back-calculated flow speed was 10 m/s.

Figure 12: The Flateyri graveyard, looking upstream into the Skollahvilft starting zone. (5) The broken timber shed and the timber gate 35 m downstream from the shed. Photo: Gísli H. Halldórsson, January 19, 2020.
