# CHALLENGES WITH REMOTE AVALANCHE CONTROL SYSTEMS (RACS)

## TROMS COUNTY, NORTHERN NORWAY

<sup>1</sup> Troms County Council, Troms, Norway

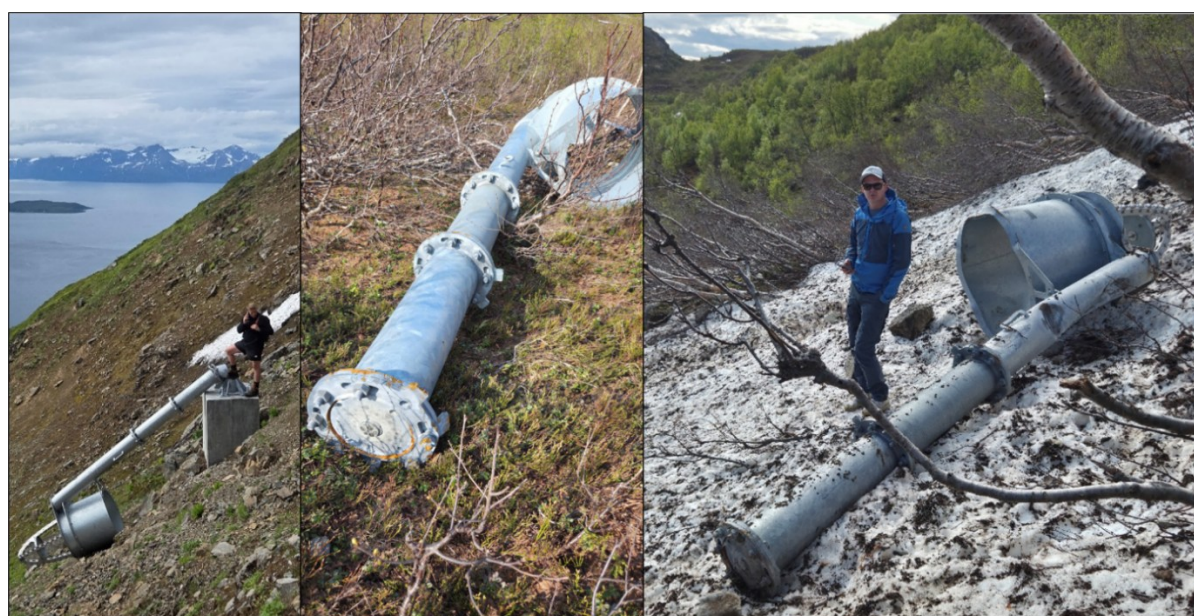
After the season of 2024/25, MHM/MND delivered a damage report showing that the forces experienced by the installations far exceeded the design criteria. The three damaged units displayed a similar failure pattern, with structural failure occurring at the same location just above the base connection (Figure 1).

Figure 1: Damaged installations during the season of 2024/25.

It is evident that several of the units on Arnøya were installed in locations that proved to be more exposed to avalanche activity than anticipated, and that maximum snow depths were underestimated. A damage assessment conducted by MHM/MND shows that the forces acting on the installations significantly exceeded their design capacity. Based on our experience, these issues were likely the result of a combination of limited planning time, an incomplete understanding of the system's operational limitations, and an unclear distribution of responsibilities for the detailed design of the installation sites.

Following the 2024/25 season, it became clear that several installations would need to be relocated to reduce their exposure to extreme snow loads and avalanche impacts. During the summer of 2025, the four most critical units were moved: Reingjerdet, Blåbærdalen Vest 2, Blåbærdalen Øst 2, and Grasryggen. As Blåbærdalen vest 2 had been destroyed, it also had to be replaced. It was decided to use another unit; one believed not to trigger any avalanches anyway. So, the system was reduced from a total of 24 to 23 units.

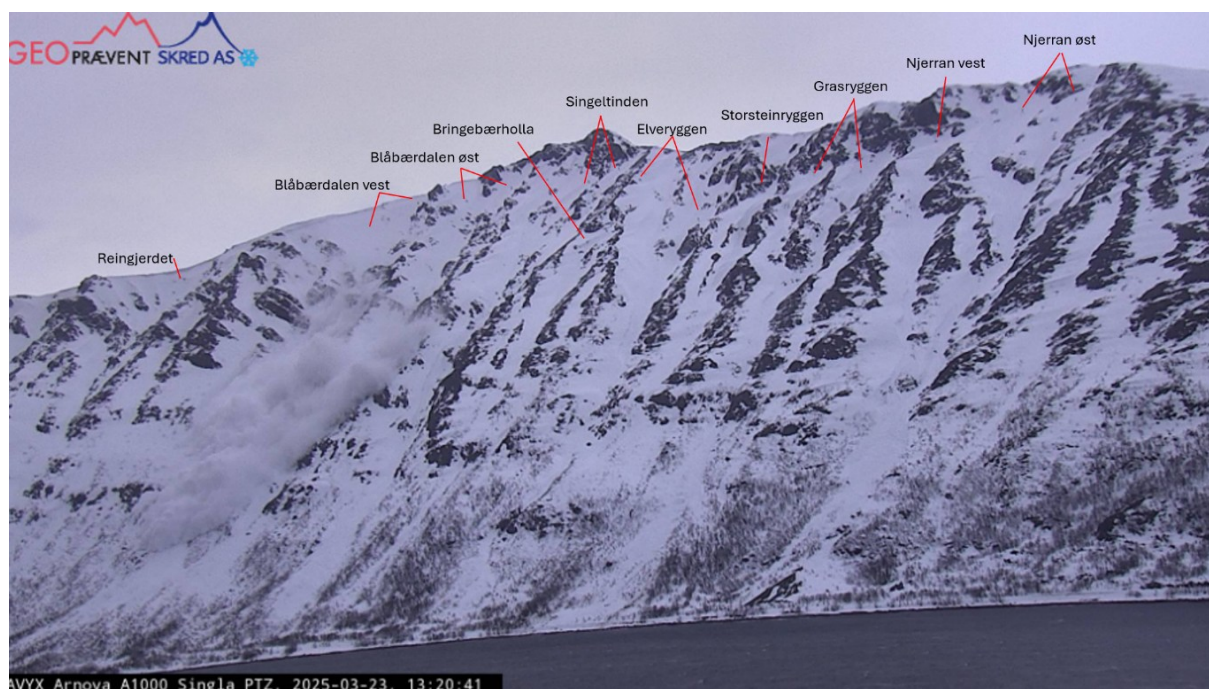
The most significant challenges occurred in March 2025 after several major snowstorms and a substantial increase in snow depth. On the 20th of March, a controlled size-3 avalanche bent the mast of the unit Grasryggen1. The damage was not discovered until the end of the season, as the mast remained supported by the surrounding snowpack and the unit continued to operate normally despite deformation (figure 1). Three days later March 23rd, weather conditions changed and temperatures increased significantly from -4 degrees to +10 degree in 48hours (at 285masl.). The rapid warming triggered a natural size-3,5 avalanche that struck and destroyed the unit of Blåbærdalen Vest2 (figure 2), which later was found in the runout zone, about 200meter from the road. Fortunately, the dense avalanche deposits stopped just short of the road, preventing any direct impact on traffic.

The event on the 23rd, occurred despite having done as many as 5 control missions, after each snow-storm prior to the event (the 10th, 13th, 16th, 18th and 20th of March). At the time, it was believed that

a deep persistent weak layer (DPWL) had become active due to the rising temperatures. Nevertheless, a control mission was also performed in the evening after the incident but did not trigger any avalanche. The temperature had again dropped substantially, probably stabilizing the snow cover.

Figure 2: On March the 23rd. after several major snowstorms, temperatures increased significantly and triggered a natural size-3,5 avalanche that struck and completely destroyed the unit of Blåbærdalen Vest 2, which later where found in the runout sone, about 200meter from the road (figure 1).

Following the incident on the 23rd, and the idea that a potential DPWL had developed, it was decided to remove three additional units that were considered vulnerable to similar avalanche impacts, or close to being totally covered in snow. However, snowfall continued and didn't allow any helicopter-access to the mountain. By the 28th March, as many as 7 units were nearly buried by snow. During a gas refilling campaign on the 9th of April, the units Grasryggen, Reingjerdet, and Blåbærdalen Øst 2 were therefore removed from their masts as a precautionary measure. The objective was to prevent further equipment loss.
