2007 WINTER AVALANCHES ON THE KEMANO KITIMAT POWERLINE

Rod Gee, Chris Stethem, Alan Jones, Kevin Fogolin*, Mike Gajda Chris Stethem & Associates Ltd., Canmore, Alberta

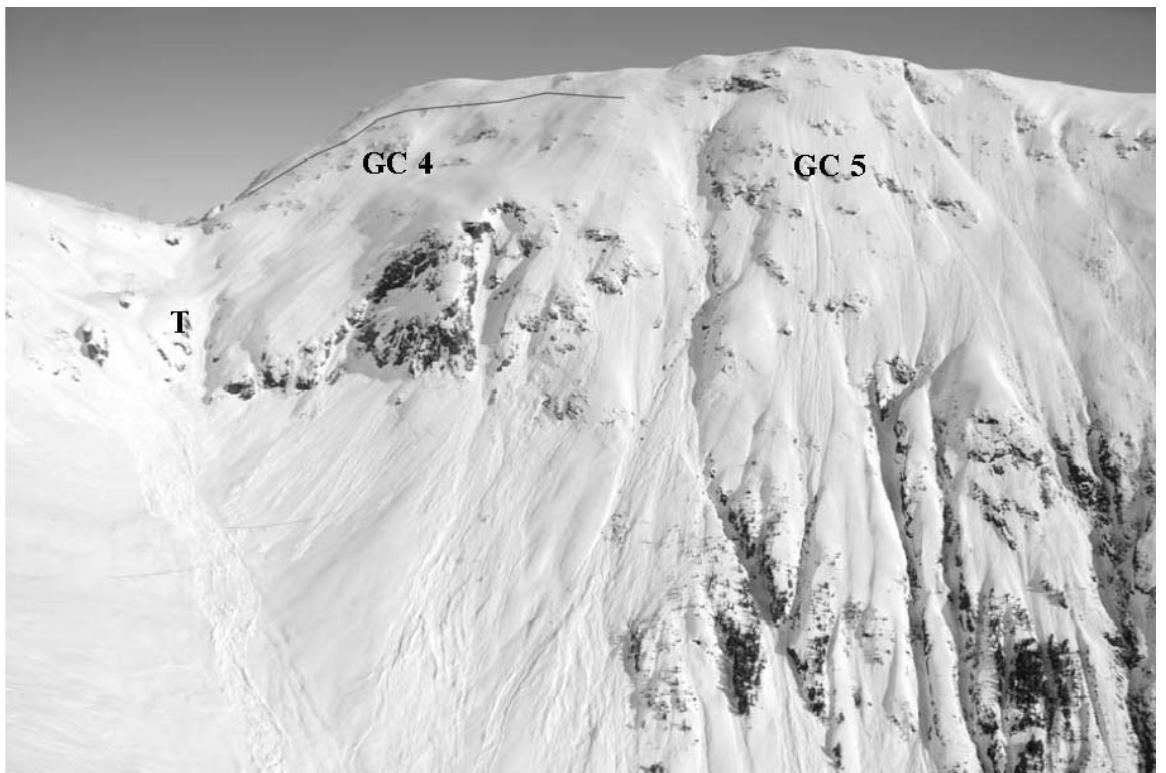
The avalanche of March 28, 2007 which destroyed Tower 113 Right (T113R) was a Size 4.5 dry slab avalanche which started on the southwest-facing slopes of avalanche path GC4 (Glacier Creek #4) (Figure 2). The top of the starting zone of the GC4 path (1800 m elevation) is approximately 420 m above the tower. The average incline of the starting zone is approximately 41°. The avalanche dynamics were those of a fast moving, mixed motion avalanche (combined flow and powder), which overran the knoll in the terrain on which T113R sat.

Estimation of the speed of the avalanche is uncertain given the lack of direct observations at the time of the event. However, estimates of the maximum velocity (McClung and Schaerer, 2006) and application of the PCM model (Perla et al., 1980) to estimate velocity in the starting zone suggest the velocity of the avalanche could have exceeded 50 ms⁻¹ at T113R. The wind during this storm appeared to be from the west and would have been channeled through the pass from the northwest. This would result in wind transport of snow from the north side of the pass into and across the starting zones of the avalanche paths on the southwest facing slopes of GC4, above T113R. When the avalanche occurred it appears that the fractures extended from Powerline Pass across both the GC4 and GC5 starting zones.

Figure 2: The location of the avalanche fracture line on Path GC4 above the Tower 113 location (T). The fracture lines of March 28 would also extend across GC5.

- The speed of the avalanche below the 41° starting zone could have exceeded 50 ms⁻¹ (180 kmh⁻¹) and this high speed of the dry mixed flow and powder would overrun the Tower 113 location.

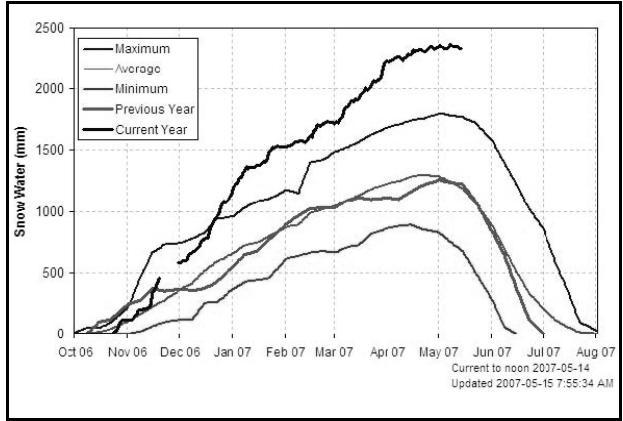
Manual snow survey data has been collected at Tahtsa Lake since 1952 (54 year period). This station is located 35 km southeast of Powerline Pass. The measurements taken on March 28, 2007 are a snowpack depth of 457 cm and a snowpack water equivalent of 1800 mm. These are the maximums recorded for the end of March (recorded as of April 1) in that 54-year period. The same maxima are true for the May 1, 2007 observations of 438 cm and 2073 mm. By applying the method of moments (Watt, 1989) to analyze the data it can be concluded that the 2007 data represents a 100-year return period in snowpack accumulation (i.e. an annual probability of 0.01).

Figure 3 illustrates the data from the Tahtsa Lake snow pillow for the 2007 winter. These snow pillows measure the water equivalent of the accumulated snowpack. The rapid accumulation of snow water equivalent at the end of March stands out in the 2007-year plot (the upper line on Figure 2).

Figure 3: Snow pillow data 2006-2007 Tahtsa Lake (Station 1B02; elevation 1300 m). Source: BC Ministry of Environment, Water Stewardship Division.

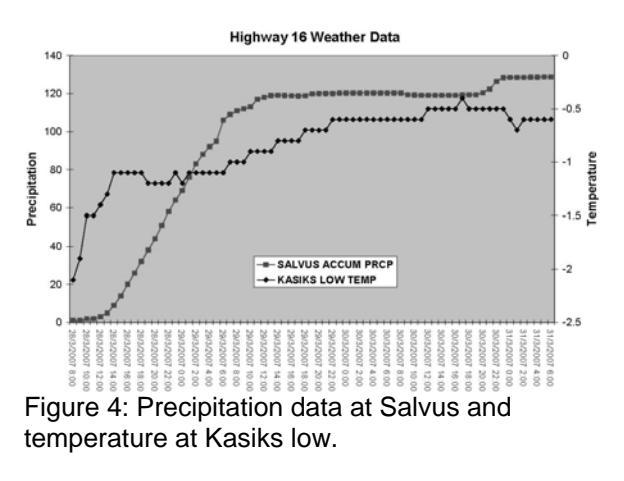
Approximately 111 mm of precipitation was observed to accumulate in the 24-hour period of 0800 hours March 28 to 0800 hours March 29 at Salvus Camp (elevation 12 m ASL) in the Skeena Valley. This precipitation came as heavy snowfall overnight on the 28th. It is reasonable to assume that precipitation values at higher elevations would exceed those observed in the valley bottom at Salvus. This precipitation was accompanied by a slightly rising temperature trend, but one where temperatures remained below freezing at the treeline and above.

The Kemano climate station observers recorded 82 mm of precipitation on March 28 and

30 mm on March 29. This amount implies a similar trend during the storm at Kemano to that observed at Salvus. Figure 3 shows precipitation data take at Salvus (12 m ASL) and temperature data taken at Kasiks Mid (732 m) during the March 28-29 storm.

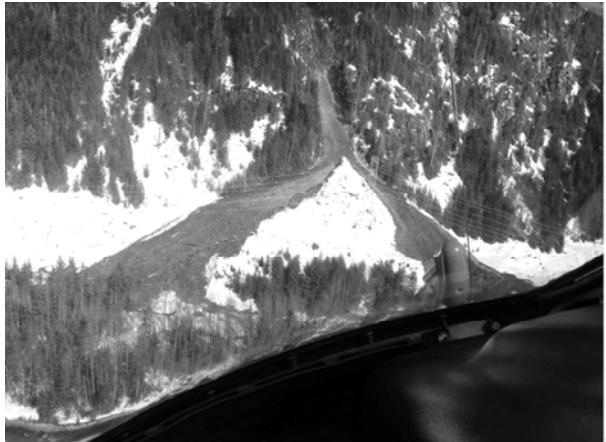
This was a 100 year snow winter in the area. On the night of March 28, 2007 a large destructive avalanche destroyed Tower 113R. A second avalanche in the Kemano Valley spread from its usual track and descended the adjacent path, destroyed a wide swath of mature timber and split around the defenses at Tower 39.

Figure 5: Split avalanche flow at Tower 39.

During the removal of avalanche debris from the Tower 39 splitter hourly radio contact was maintained with the work crews and an observation post was maintaned at treeline across the valley from the Ke 8/9 avalanche paths. This observation post was typically manned during warm, sunny afternoons when rising temperatures resulted in an increased avalanche hazard.

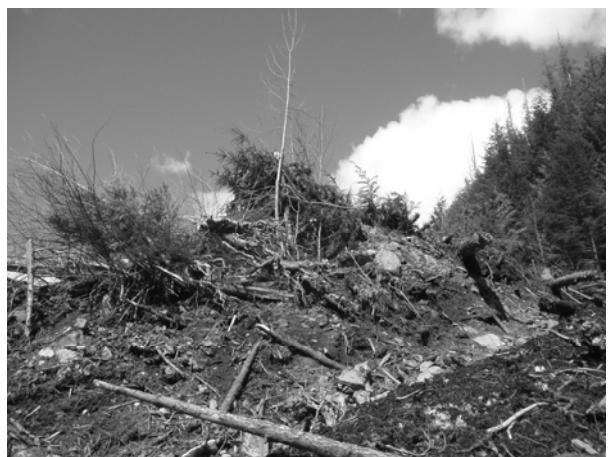
Figure 6: The run-up of the avalanche flow at Tower 39 was < 1m from overtopping the splitter.

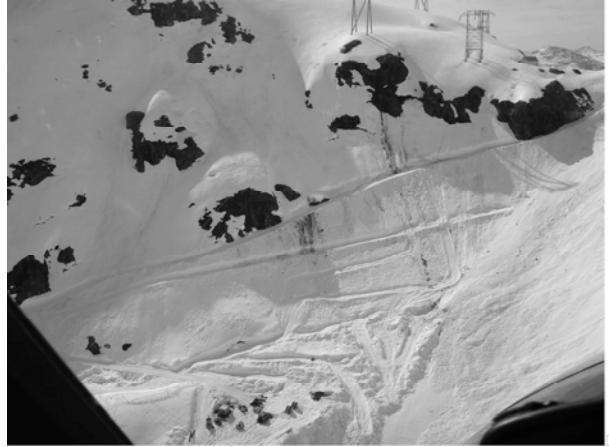
Figure 7: Bench cuts above a cable splicing worksite.

Avalanche control was extensive for the project and involved a combination of active and passive control measures. Passive control measures involved the construction of a series of benches/berms across the slope upslope of the Tower 113R worksite. This combination of benches and berms were constructed primarily with a Bombardier snow cat along with a D8 cat. These benches/berms provided protection from avalanches originating from the GC3 avalanche path.

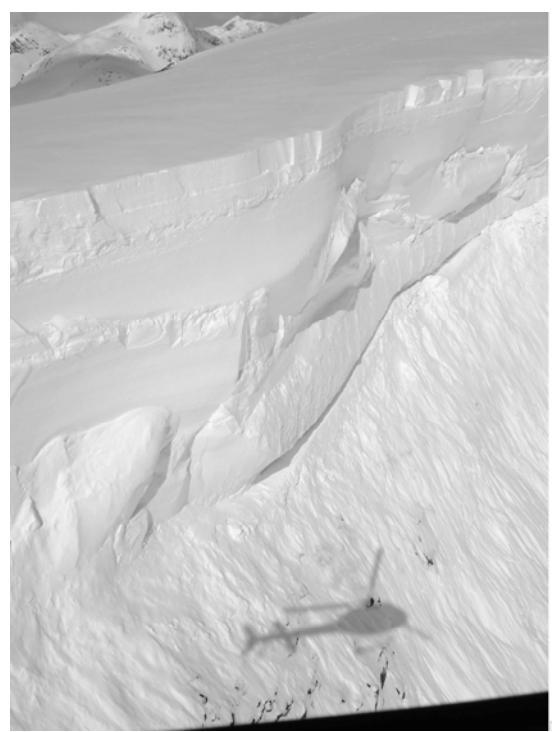
Figure 8: 20 m thick cornice break at GC1.

Extensive glide slabs were also encountered which required large quantities of explosives to release. Typical charges for glide slab work and deep slabs ranged between 250-300 kg of Anfo. Long sections of cornices were also removed, specifically in the GC1 avalanche path.
