THE SVALBARD FATAL ACCIDENT 19TH DECEMBER 2015 – ASSISTING LOCAL AUTHORITIES IN THE ACUTE PHASE

ABSTRACT: The Svalbard fatal avalanche caused massive destruction when it hit part of the village Longyearbyen Saturday morning at the start of the Christmas holiday. The avalanche released after a furious storm and killed two persons, destroyed 11 houses and numerous cars and snowmobiles. The avalanche revealed that numerous houses in the village were endangered in the current situation. Two avalanche experts from NGI arrived at the site on the remote island in the evening and assisted local authorities.

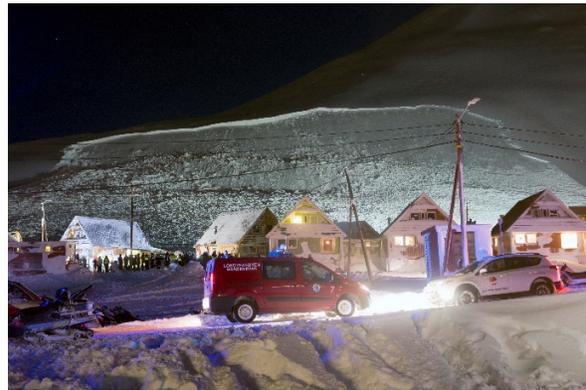
Figure 2: The avalanche shortly after the accident. Photo: Svalbardposten.no.

Saturday 19th December at 10:25 a.m. an avalanche hit part of the village Longyearbyen at Svalbard (Fig. 1). The avalanche killed two persons, destroyed 11 houses and numerous cars and snowmobiles (Fig. 2).

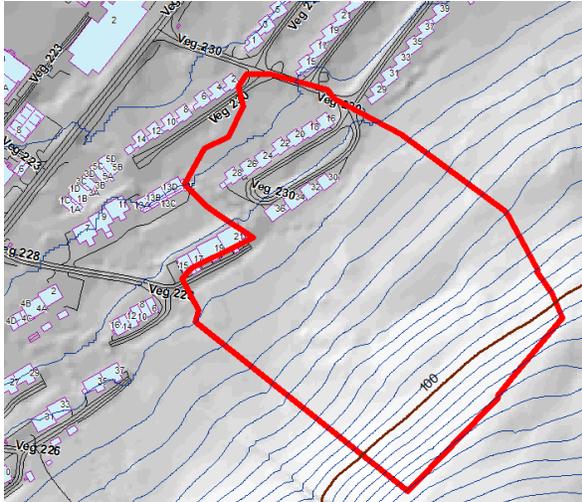
The avalanche was later measured to have started about 125 m a.s.l. and stopped about 35 m a.s.l. (Fig. 3).

Figure 3: Red line indicating avalanche runout destroying the upper two rows of houses in road 230.

The about 200 m wide avalanche started at the top of the steep terrain about 90 vertical meters above the houses. It is estimated that the initial release volume was some 20.000 m³ supposing the

starting zone being 200 x 50 m with average 2 m release thickness. The steepness in the release area was typical 30-40 degrees. NGI measured the runout angle to 15.6 degrees when arriving at the site.

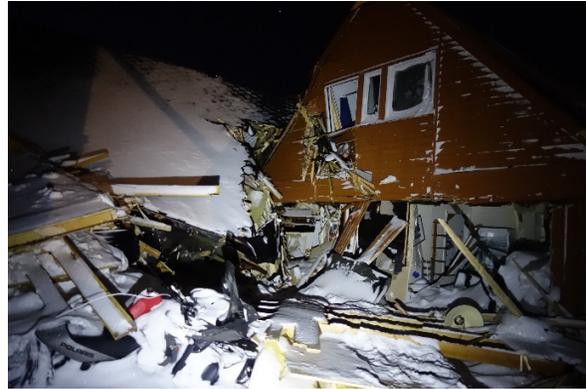
The relatively small terrain above the houses produced a massive slide that caused extensive damage. The power of the avalanche gave an absurd impression of a "chain collision" of houses that were moved up to 80 m (Fig. 4 and 5). The runout was longer than expected on NGI's 1992 hazard map.

Figure 4: Example of massive damage. Photo: Kjetil Brattlien, NGI.

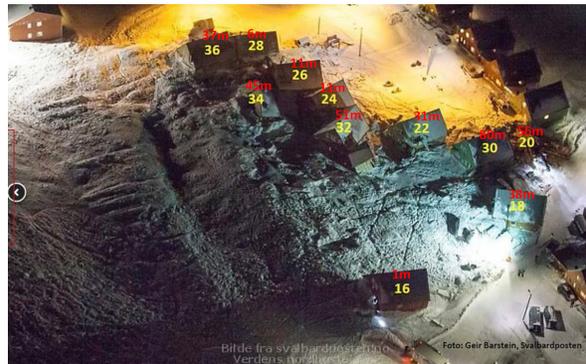
Figure 5: House number (yellow) and preliminary measurements of distance moved (red). Photo: Svalbardposten.

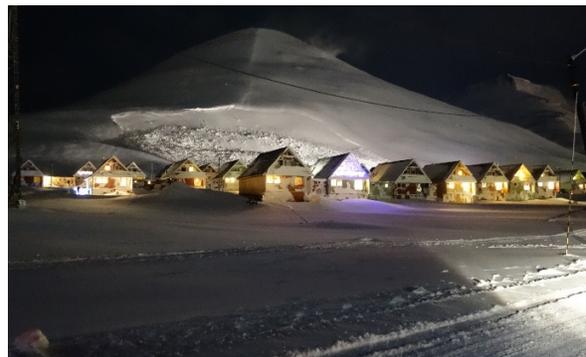
After midnight, some 14 hours after the accident, the weather changed again and it started snowing and blowing with new wind transport into the release areas. NGI and the local police (Sysselmannen) discussed the situation and decided to

Figure 6: New wind-loading of release area about 350 m. a.s.l. at Sukkertoppen. Photo: Kjetil Brattlien, NGI.

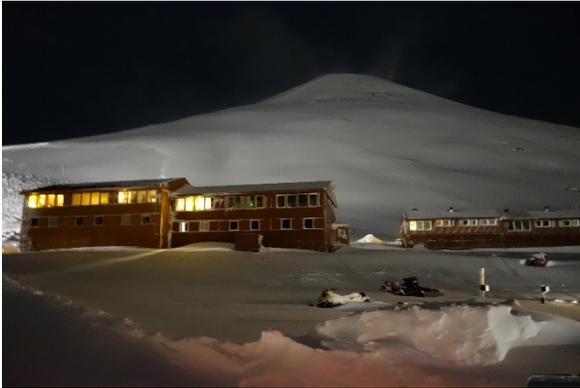
Figure 7: Houses in Lia, below Sukkertoppen, with accident site to the left. Photo: Kjetil Brattlien, NGI.

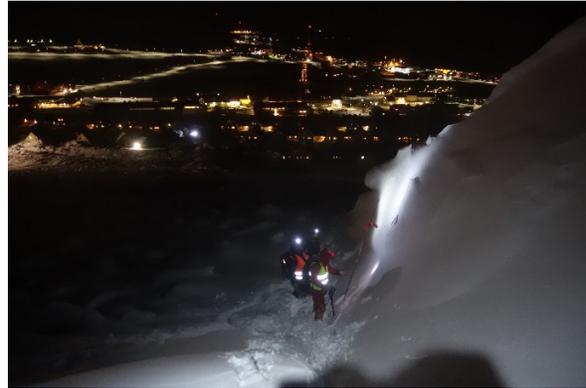
Figure 8: Erik Hestnes, NGI, investigating crown flank. Photo: Kjetil Brattlien, NGI.

The weather improved in the morning the day after the accident. NGI hiked up the avalanche debris about 24 hours after the accident. The avalanche was investigated and profiles were made in the release area (Fig. 8).

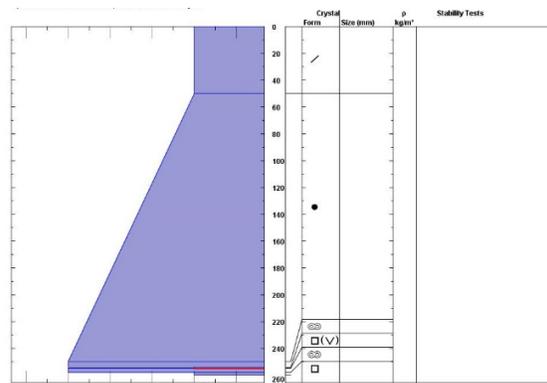
The avalanche released on a persistent weak layer of faceted crystals with 4 finger hardness (4F) near the ground. The crown was partly filled in with fresh snow, but the crown face indicated that the slab was about 2 m of rounded grains (RG) with 4 finger hardness (4F) in the top gradually increasing to knife hardness (K) above the weak layer (Fig. 9).

Figure 9: Snow profile at crown face.

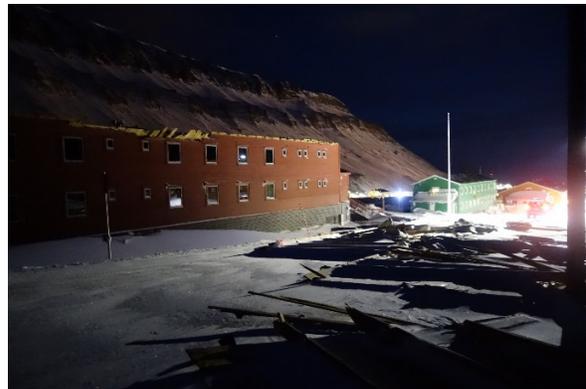
The fieldwork showed that many avalanches had released during the storm and the risk for new avalanches at these places where minimal. In Nybyen a big roof had blown off one off the houses, showing the extreme wind during the storm (Fig. 10)

Figure 10: Roof blown of house in Nybyen. Photo: Kjetil Brattlien, NGI.

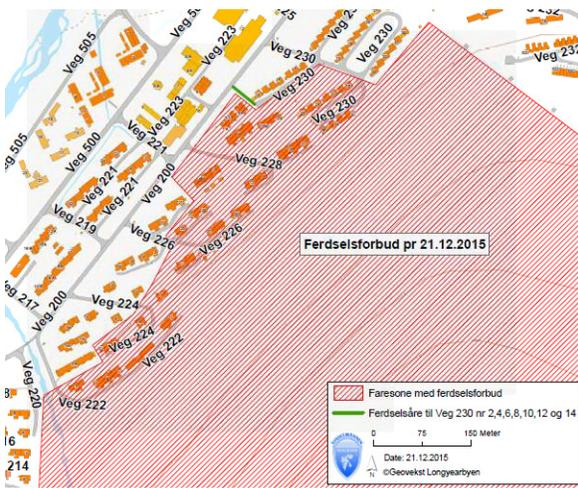
The weather situation improved gradually and NGI recommended repealing most of the evacuation 21st December (2 days after the accident). However, evacuation was still enforced for many houses under the Sukkertoppen Mountain closest to the accident site due to uncertain stability of the

snow in the 300 vertical meters with steep terrain above the houses (Fig. 11). The weather forecast predicted a new storm coming in and NGI recommended that the avalanche situation should be watched carefully.

Figure 11: Remaining evacuated areas after 21st December 2015.

NGI recommended to completely repeal evacuation of all areas 4th January 2016 given that avalanche forecasting continued until end of winter.
