WET-SNOW AVALANCHE INTERACTING WITH A DEFLECTING DAM: FIELD OBSERVATIONS

**ABSTRACT:** In 2008 a large wet-snow avalanche occurred in the region of Klosters, Switzerland. The avalanche reached the valley bottom and interacted with a deflecting dam that was constructed after the avalanche winter 1999, overflowing it at its lower end. To document this extraordinary event, we performed airborne laser-scanning immediately after the avalanche. This data, together with a video sequence made during the avalanche descent, provided a unique data set to study the dynamics of a wet-snow avalanche and its flow behavior around the deflecting dam. The avalanche hit the dam with deflecting angles of 10-30°. We could observe that, for smaller deflecting angles, the friction of the avalanche as it flowed alongside the dam slowed down the avalanche front, but, for higher deflecting angles, the avalanche suddenly accelerated increasing its run-out distance. Additionally, we could observe that snow deposits left by the avalanche exhibited strong pattern formation, which reflected the history of the wet flow. In particular, we could detect high levees running parallel to the curvature of the dam indic

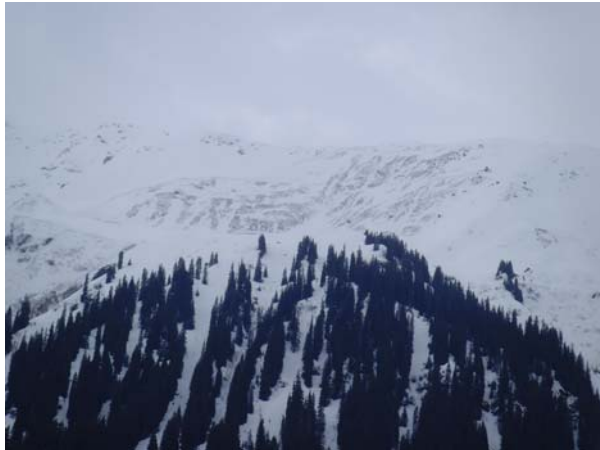
Figure 2. Release zone #1. The Gatschiefer avalanche released directly on the ground.

Both release areas moved as a slab, which involved the whole snow cover (Figure 2 and Figure 5). Information on snow cover depth before the avalanche release have been deduced from laser-scanning measurements in areas adjacent to the starting zones, where the snow was not influenced by avalanches. Snow cover depths near the upper and lower starting zones were ≈2.2 m and ≈2 m, corresponding to volumes of 308'000 m<sup>3</sup> and 42'000 m<sup>3</sup> for release #1 and #2, respectively.

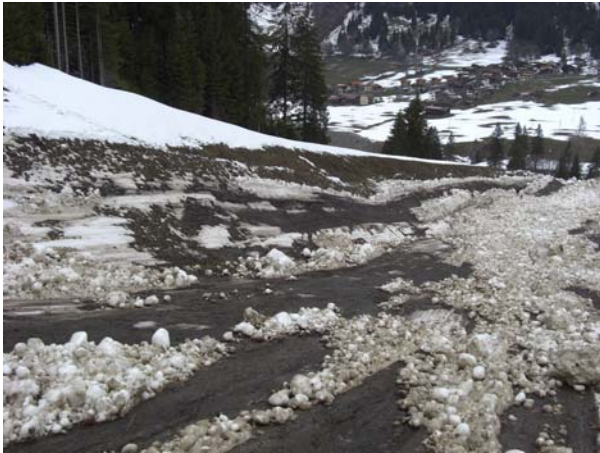
Figure 4. Avalanche run-up along the dam side facing the avalanche. Beside the dam location, the ground was the sliding surface of the avalanche.

Figure 3 shows that the dam was able to deviate the 2008 avalanche away from the buildings damaged in 1999. Without the dam the avalanche would probably have reached again the settlement. However, we think that the dam height, designed to deviate a dry-dense avalanche, was underestimated for the deviation of an extreme wet-snow avalanche. The snow traces left by the avalanche on the dam showed that the avalanche flow equaled the dam height (Figure 4). Nevertheless, the avalanche overrun only the

The maximum height reached by the avalanche along the dam could be deduced from the traces left by the flow on the dam embankment (Figure 4). Traces indicated flow heights to be higher than 5 m.

Figure 4 shows that the avalanche glided directly on the ground and it eroded all snow cover in front of the dam. Additionally, we did not observe previous avalanche deposits. Thus, in this case the term  $h_s$  was negligible.

These shapes are easily recognizable from their characteristic pattern: lateral static edges corresponding to the borders of the flow, and a central zone, generally lower in depth, corresponding to the flow drainage. Levees were made of large snow clods covered with dirt on each border of the flow, and at few location, in the drainage channel, the ground was exposed (Figure 4), indicating that the avalanche glided directly on the ground.

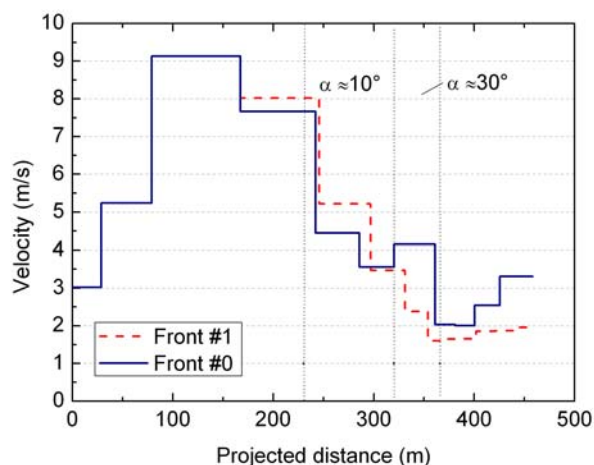
Figure 7. Avalanche front velocity according to the longitudinal profiles shown in Figure 6. The red line shows the average velocity of front #1, while the blue line shows the average velocity of front #0.

The red dashed line in Figure 7 shows the front #1 velocity. From 1370 m a.s.l. (indicated as 0 s in Figure 6) velocity progressively increased to reach a maximum of  $\approx 9 \text{ ms}^{-1}$ . After being reached by the roll-wave fronts the velocity decreases to a minimum of about  $2 \text{ ms}^{-1}$ . Afterwards the avalanche kept constant velocity and crossed the road near the Landquart river, jumping down to the river bed and stopping.

The fronts travelling close to the dam (blue profile) showed a different behaviour. The avalanche reached the deflecting dam with a velocity of  $\approx 8 \text{ ms}^{-1}$  (Figure 7). We estimated that, initially, the avalanche was deflected by the dam with  $\approx 10^\circ$ . At this stage, the friction of the avalanche as it flowed along the dam slowed down front #1 in respect to the corresponding point on the red profile (Figure 7). Then the avalanche entered the lower section of the dam which deviated the flow by  $\approx 30^\circ$ . Here we could observe a deceleration of front #1 and, simultaneously, the formation of two new fronts. The new fronts accelerated up to  $4 \text{ ms}^{-1}$ , and overtook front 1# over the all avalanche width.
