AVALANCHE ACTIVITY ON US HIGHWAY 12

Mick Riffie
Idaho Transportation Department
Lowman, ID

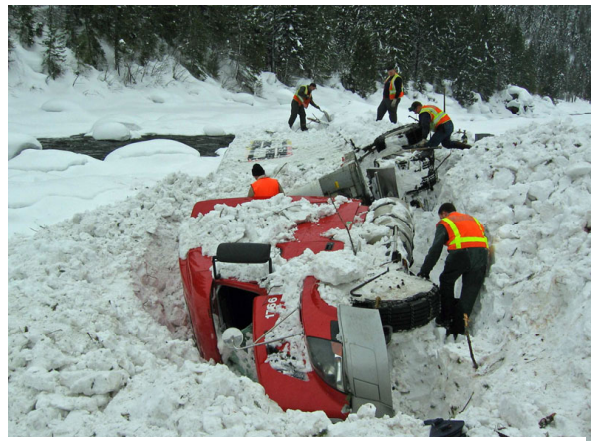
Fig. 5. Crews excavating the truck for removal from the Lochsa River.

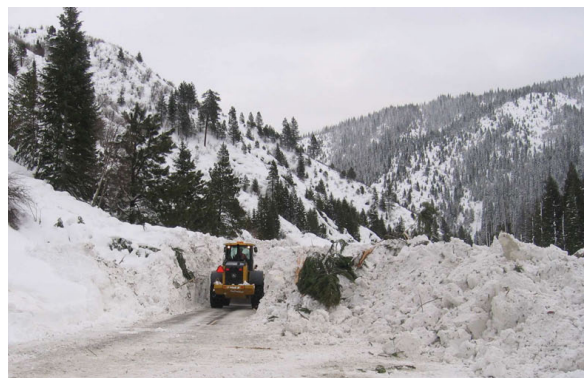
Fig. 6. Heavy equipment removing avalanche debris. February 7, 2008

debris and the trucks rolled out. Several fifty year old trees were found in the dirty debris, which also contained rocks and slowed opening the road. Investigations at the ridgetop starting zones found a buried surface hoar layer at the failure plane under 4-9 feet of windblown snow on the lee side of the ridge, in addition to high precipitation rates likely causing the slides. By the time the road was cleaned up and ready to open, another large snowstorm was forecast for the area. Knowing that a deeply buried weak layer was present in the snowpack, the road was left closed through this second storm. This system was warm and wet, and caused three more large avalanches, the largest leaving 22 feet of debris on the roadway, again containing several fifty year old trees.

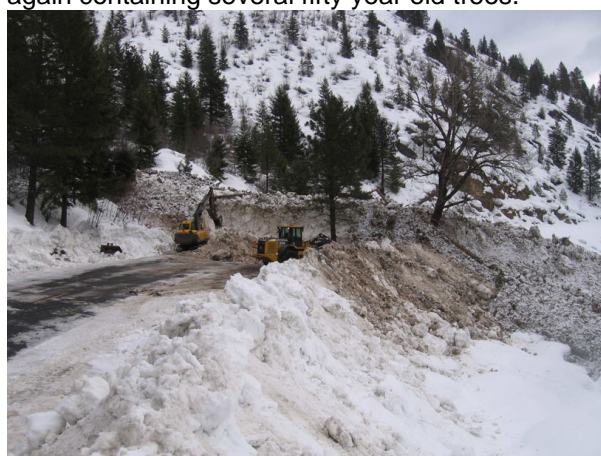
Fig. 7. This pile was 22' deep on the roadway. Rocks and trees in the debris made clean up difficult. This slide occurred during the second avalanche cycle, 2008. February 14, 2008

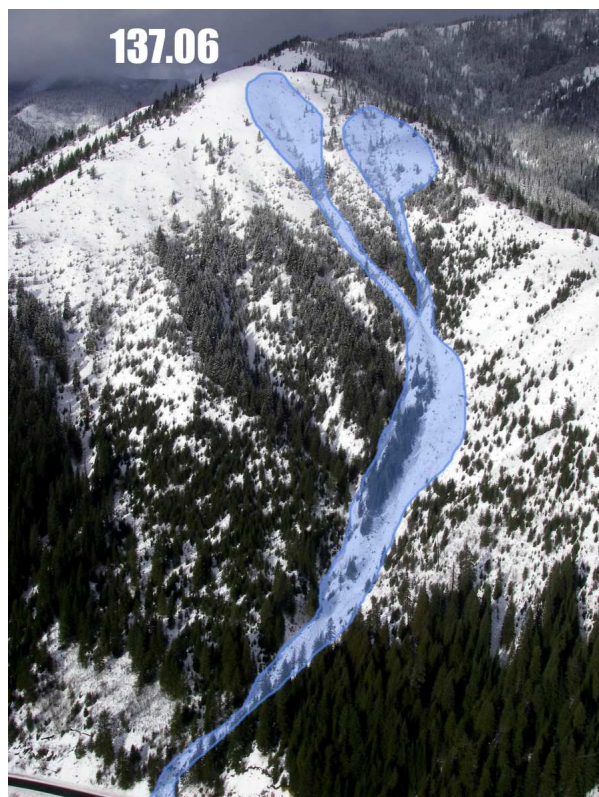
Fig. 8. Most of this path is not visible from the road. Distinct trimlines show the historic reach of this avalanche path. It is possible that many of the paths on US 12 are regularly active, only debris does not reach the road and so the activity has gone undocumented.

Because the route of Highway 12 is relatively new and there are only forty years of recorded history for the avalanche terrain adjacent to the road, it is difficult to judge the return interval for major avalanche activity. Most of the slide paths are not visible from the road due to the dense forest. The dense timber in the area does provide distinct trimlines, which have been useful for identifying much of the avalanche terrain that affects the road.
