AN AVALANCHE TRAGEDY IN CHILE

R.E. León

Caracoles, Chile, August 12, 1941

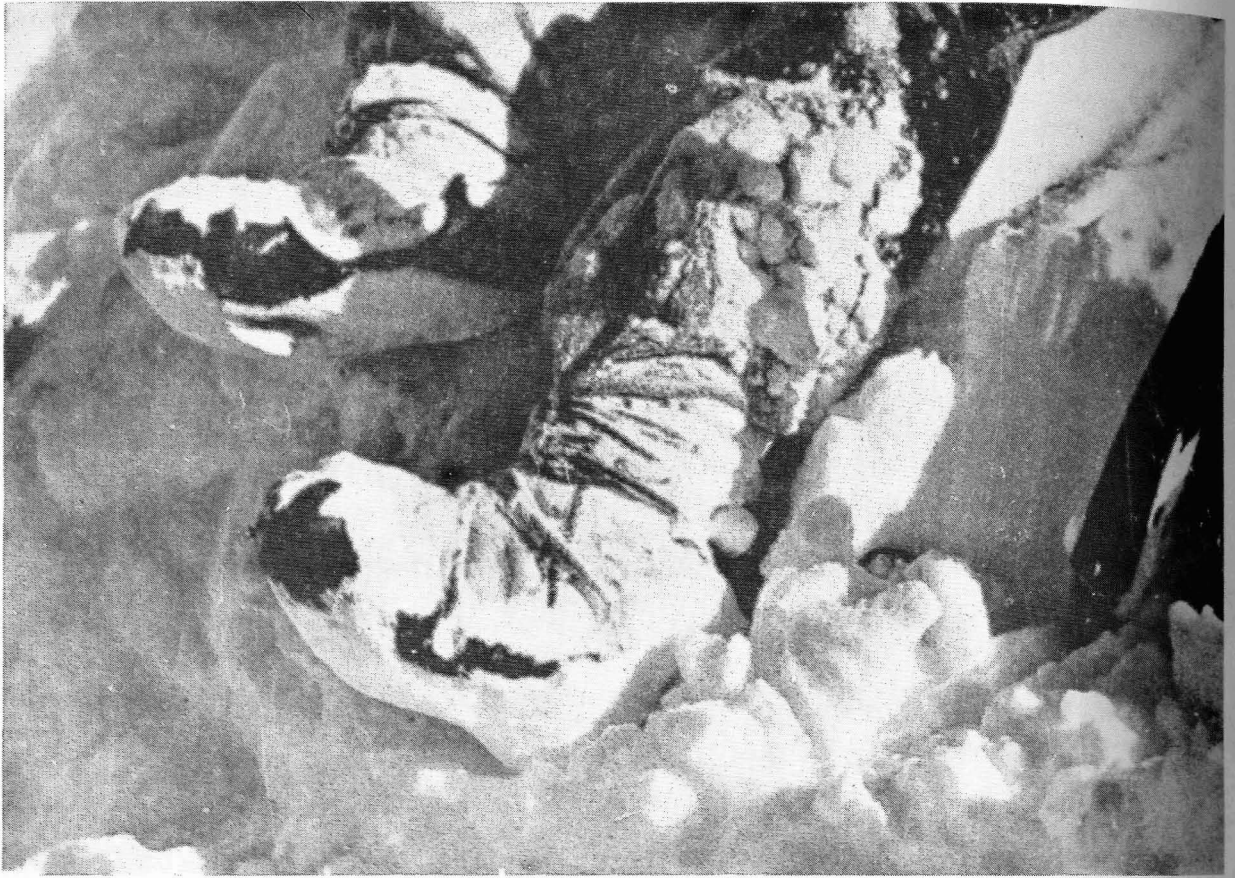
FIGURE 2 RESCUERS WERE HANDICAPPED
BY IMPROPER FOOTWEAR

Three railway crews of 20 men each walked daily the 6 km from Portillo to Caracoles to work in the rescue operations. They did not wear proper shoes, but used footwear called "tamangos", (Fig. 2) which consisted of a piece of sheepskin covering woollen stockings. Over the sheepskin a canvas was fastened by leather ties to form a boot of sorts. These men had to make an excavation approximately 20 m deep to reach the demolished buildings. This was extremely tedious. (Figs. 3 and 4.)
