MOUNT BACHELOR'S PINE MARTEN SNOWFENCE

R. L. Jairell^I and T. C. Rodgers^{II}

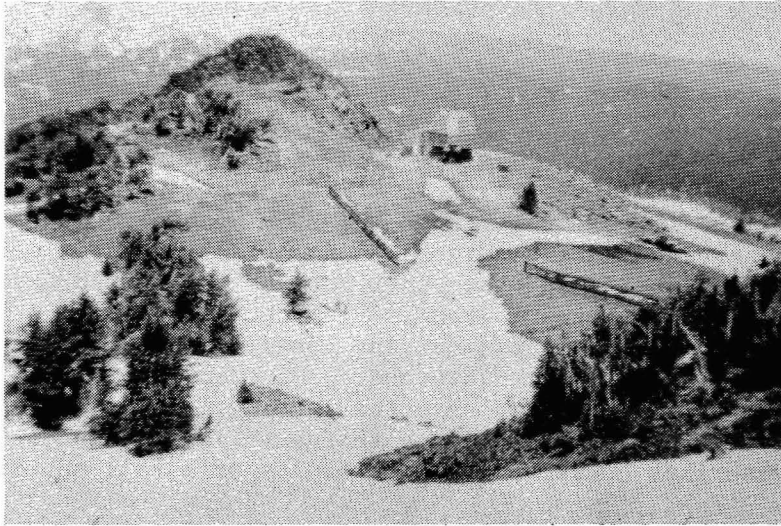
Figure 2 A 1.2-m snowfence near the top terminal of Pine Marten lift did not accumulate enough snow to cover the wind-swept area during the 1986-87 season.

a snowfence greatly reduce the volume of snow stored. Using this information, a 3.7 m (12-ft) snowfence 118 m (387 ft) long was designed to replace the 1.2 m fence. Built in the fall 1987, the new fence uses plastic fabric (TENSAR*) supported on 28 poles of thick-walled steel pipe. The poles are 10-cm (4-in) outside diameter and 5.2 m (17 ft) long, spaced 13 feet apart. Each pole is embedded to a depth 1.2 m (4 ft) below the ground surface, with the bottom of the pole set in concrete (Figure 3). Plastic buckets (5 gal) with the bottoms removed provided forms. To increase pole stability, wooden cribbing boxes 0.6 m (2 ft) in diameter and 0.3 m (1 ft) deep were centered around the pole, wired in place close to the surface, and filled with rock.

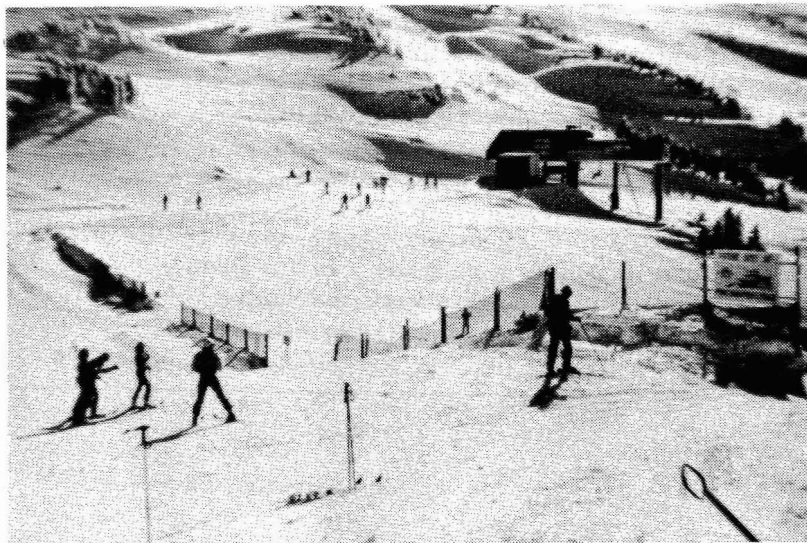
Figure 6 The snowfence provided a source of snow much nearer the problem area, allowing the lift to be used 2-3 weeks earlier and greatly improving snowcover around the landing throughout the 1987-88 winter.

Grooming snow from this snowfence installation allowed the Pine Marten lift to be opened two to three weeks earlier than would have been possible without the fence. When snow depth at the base elevation was only one third the peak depth of the previous year, groomers already had used snow from around the snowfence to provide better coverage around the Pine Marten landing than was possible at peak accumulation the season before (Figure 6).
