Avalanche Hazard "Risk Management" for the Yule Marble Quarry

Christopher C. Landry
President, Yule Creek Avalanche Services, Inc.

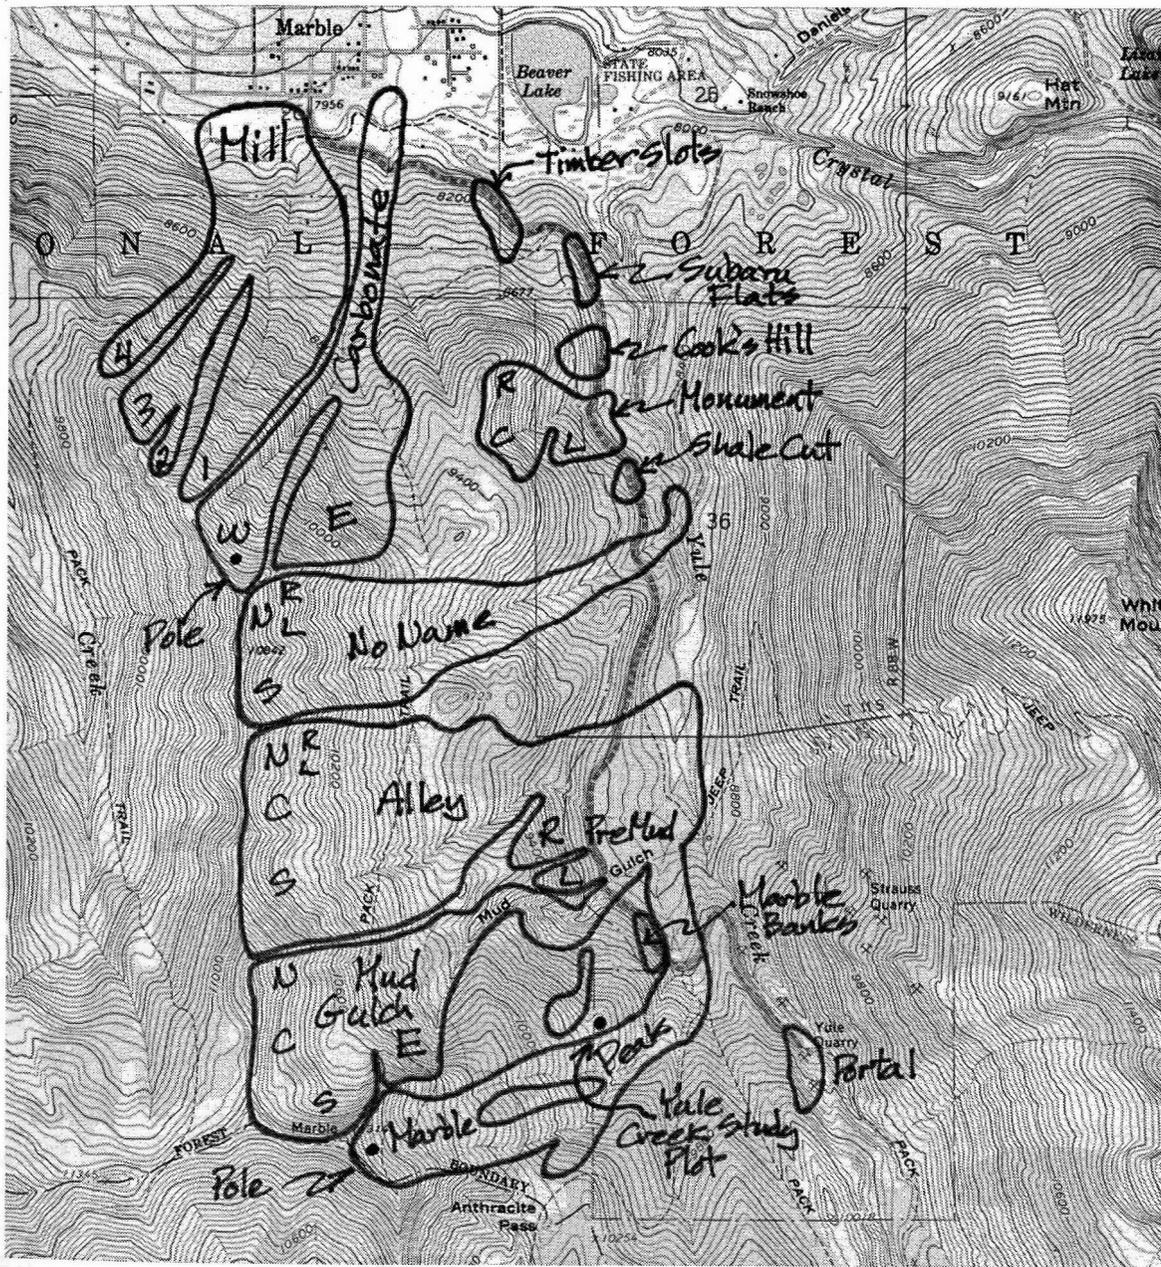
Figure 1. Lower Yule Creek valley.

The following map (Figure 1) of the lower Yule Creek valley and those avalanche paths which affect quarry operations is a compilation of the original mapping done by Mears in 1990 along with additions made by the author over the succeeding years.

Additions to Mears' work include the plotting of the Mill #1-#4 paths. Although the Mill paths do not threaten the quarry access road itself, they do threaten a parking area and material storage yard now used by the quarry operation. Other additions include the Subaru Flats, Cook's Hill and Shale Cut paths, all of which buried the road with significant events during Feb '94. The bank slides noted by Mears in 1990 have been renamed "Marble Banks," and the Portal slide path has been plotted and named. Also noted on the map are the sites of two starting zone poles and the location of the "Yule Creek Study Plot" (YCSP).

As is evident from the slide path map, traveling the 3.4 mile road to and from the quarry requires significant exposure to thirteen distinct avalanche paths. Based on field observations of the four winters from 1990/91 to 1993/94, and of flank trim lines, it is now estimated that some 7,300' (1.4 miles), or 40% of the length of the road lie within avalanche path tracks or runouts. Travel times vary, of course, with direction, conditions, and the type of vehicle. In good conditions, the crew's passenger vehicles may traverse in 30 seconds a section of road which requires two minutes for the "hill truck" to cross when loaded with a 15 ton block of marble. Road plowing operations require the most prolonged exposure, from a minimum of two hours round trip travel time following a small storm, to several days following a major avalanche cycle.

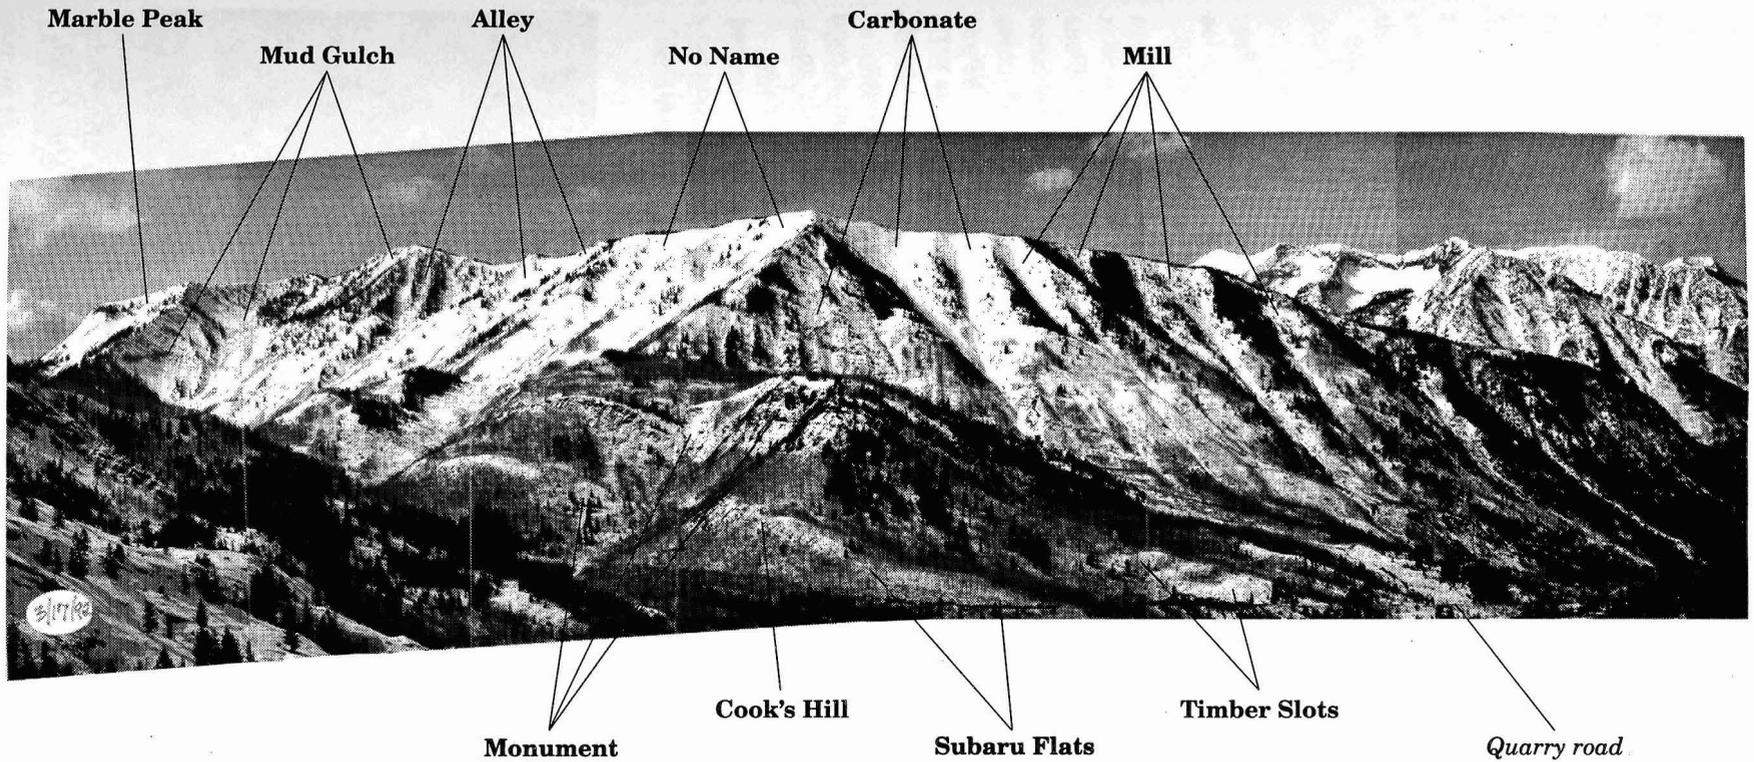
Not shown: Shale Cut, Pre Mud, Marble Banks, Portal

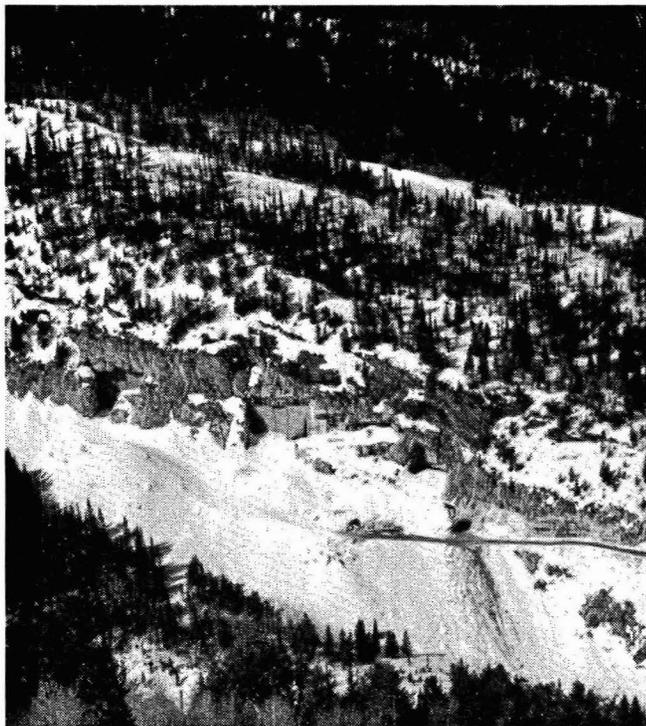
The Portal area showing the two large original portals, now curtained, and the new portal down and right. The generator trailer is visible to the left of the new portal.

the new portal entrance is also cut into a steep rock face. The quarry's electrical generator and radio transmitter are located in a semi-trailer next to the new portal, as is its fuel tank. After the generator trailer was nearly knocked over during the winter of 92/93, it was moved some twenty-five feet away from the slope before the 93/94 winter. Gasoline-fueled crew passenger vehicles are parked outside of the new portal due to mine safety regulations.

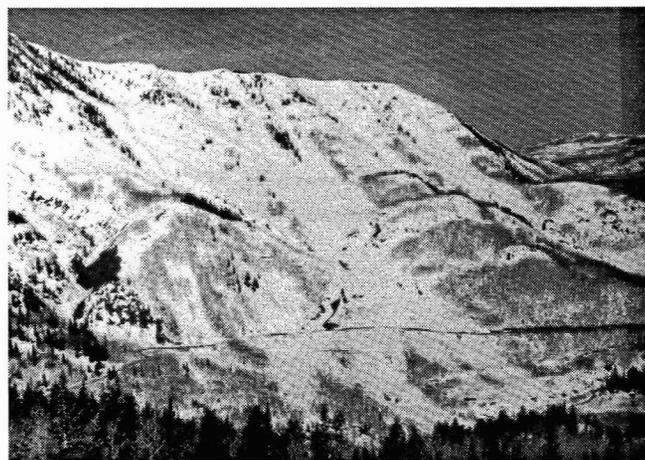
The longest continuous stretch of avalanche exposure on the quarry road runs for 2,300' under Mud Gulch (far left), Pre Mud (lower knob between Mud Gulch and Alley), and the Alley (center).

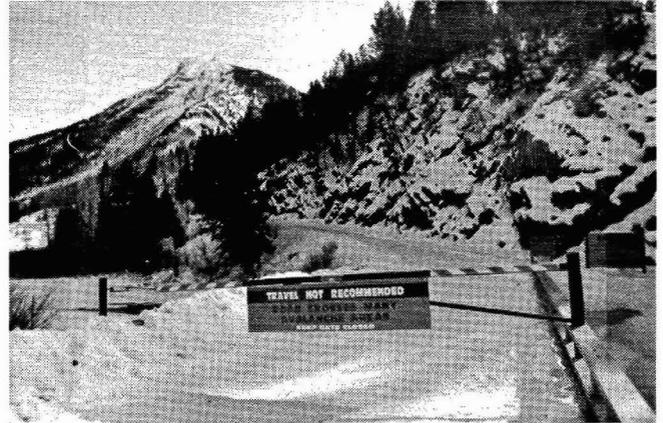
CYMC has installed signs intended to discourage public use of the road, but the effort has produced only limited success.

of its status as a public road, CYMC cannot lock the gate at the bridge at the beginning of the road or prohibit the public from accessing Yule Creek. Signs on the bridge gate designed to discourage public travel are only partially effective.

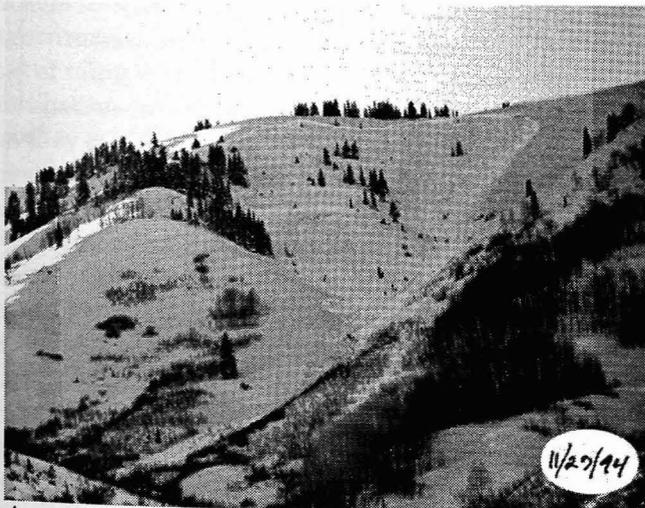
A party of unknown backcountry skiers triggered this event in S. No Name while ascending the shoulder on the left. No one was caught in the slide.

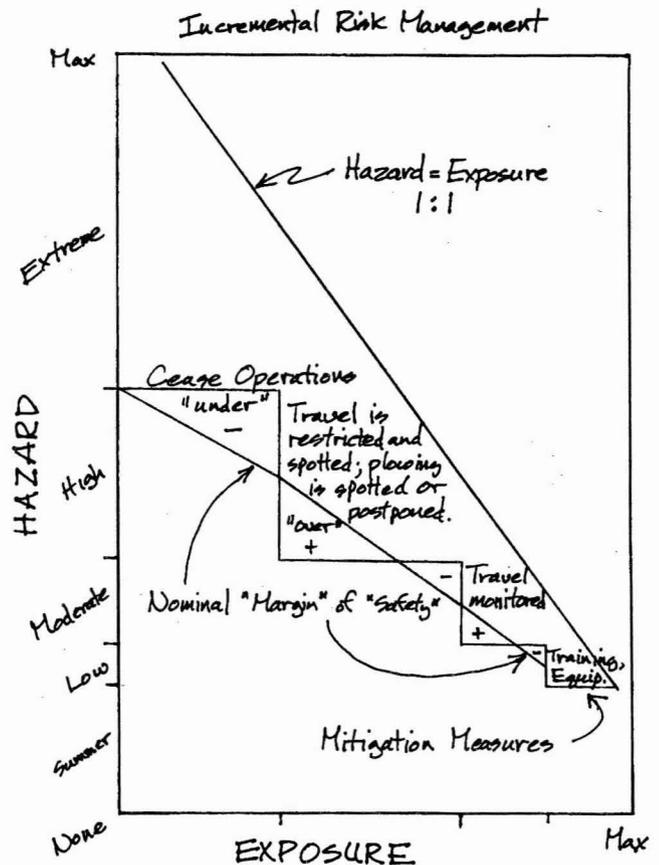
Figure 2. Incremental risk mitigation measures.

The following schematic (Figure 2) relating risk to exposure presents this "risk management" program graphically and reveals a shortcoming inherent in these kind of incremental measures. (The "graph" represents an intuitive interpretation of the relationships).

The vertical axis in the graphic represents avalanche hazard in a weighted scale intended to reflect the gravity of the ratings. The horizontal axis indicates a continuum of exposure, from "none" to "maximum." This scale is also weighted to emphasize the nature of exposure during increasing hazard. The line "Hazard = Exposure" refers to a theoretically possible relationship where a person's "odds" of being hit by a natural avalanche while

The "Margin of Safety" line below and left of that H=E line represents the hypothetical "reasonable risk" produced by the mitigation measures shown as the stepping line. Mitigation at LOW hazard does not include any travel restrictions but does include basic avalanche awareness, rescue training, and rescue equipment. Under MODERATE, in addition to that basic awareness and equipment, basic travel procedures and radio monitoring add to the "margin" of safety. As the hazard increases to HIGH, and the "stakes" (as well as the consequences of underestimating the hazard) increase, exposure is reduced to the bare minimum. Finally, when the hazard is either perceived or seen to be "EXTREME" per our definition (avalanche cycle is imminent or in progress), the margin of safety is intended to be total and all operations (exposures) cease.

For the sake of illustration, the "Margin of Safety" line is drawn through the stepping Mitigation Measures line at the midpoint along the vertical portion of the step, the midpoint being the moment when those measures are implemented. That midpoint designates the "center" of each rated hazard level within the continuum from None to Maximum Hazard. The symbols "-" and "+", labeled "under" and "over," indicate a shortcoming in applying incremental mitigation measures to a hazard continuum. This is well illustrated during a HIGH hazard.

Even assuming that conditions are actually identical among the slide paths, and that the forecaster is able to consistently modify the rating in precise synchronization with actual conditions, a particular set of mitigation measures could represent an overmitigation during the initial phase of a hazard level or they could be less than sufficient to maintain the desired extra margin beyond H=E during and until the transition into the next higher level.

In the event that the hazard is underrated by a level, or the mitigation measures are not employed in step with the hazard, the result may be that the actual margin of safety collapses all the way back to the H=E line, or worse. If, for example, operational procedures were lax and exposure during HIGH hazard periods was mitigated by only radio monitoring of unrestricted travel, then nothing like the desired margin of safety would be achieved.

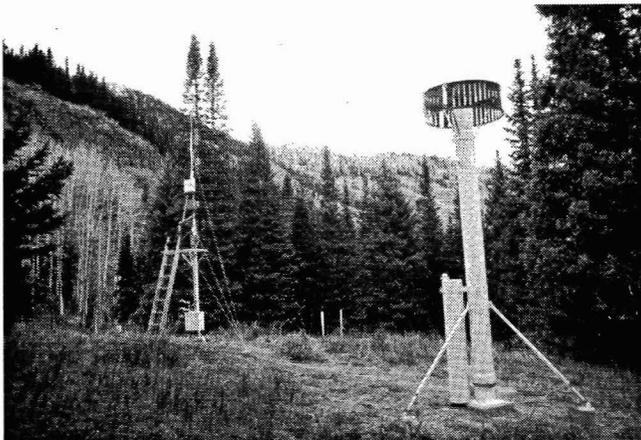
During the summer of 1992, YCAS installed an "automated weather data acquisition system" at the Yule Creek Study Plot location identified on the map. The station is at 9,700' on the highest elevation private property accessible from the quarry access road. YCSP is just a few yards from the Marble Peak slide path track. The station consists of a Campbell Scientific CR10 datalogger, a single sonar unit, a Noah II precipitation (water equivalent) gauge, air temperature and relative humidity gauge, three snow temperature sensors, an anemometer, a pyranometer, and radiotelemetry equipment. The system is photovoltaically-powered. The radiotelemetry base station/phone link is located at a private residence near Marble.

The automated weather data acquisition system at Yule Creek Study Plot. The anemometer, pyranometer, and photovoltaic panel are located on another mast some 200' south of here.

Data is logged in the CR10 for one hour, three hour, and 24 hour intervals and is retrieved via modem from YCAS's Carbondale office, some thirty miles from Marble. Retrieved data is transcribed to a loose leaf "Day Log," a "Month Log" wall chart, and, during storms, to a "Storm Log" using the three hour interval data. Examples of the Month and Storm Logs will be presented below.

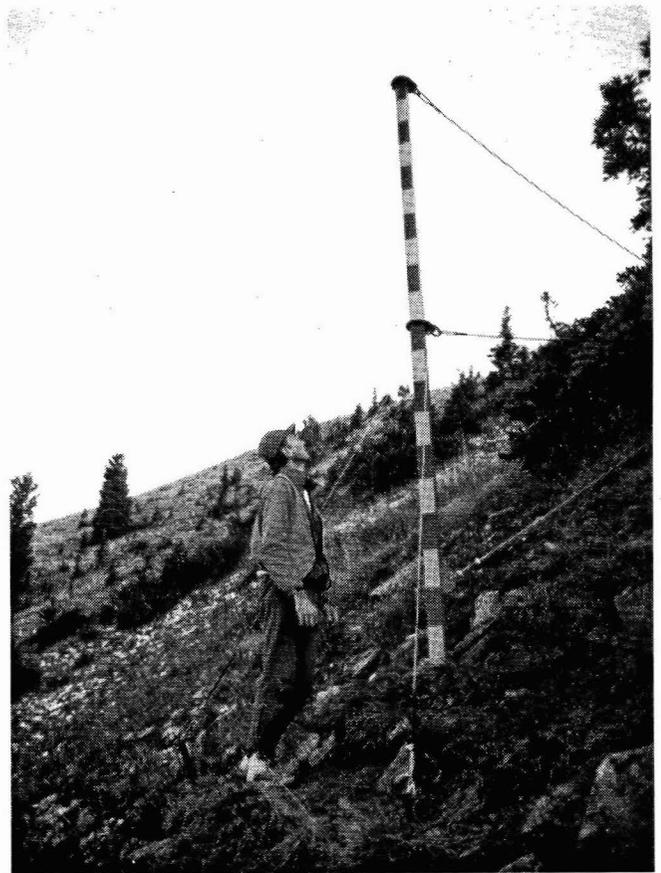
The Carbonate starting zone pole, 4 meters in height.

and are now 5 and 4 meters tall, respectively. (In February '93 the Marble Peak pole, then at 4 meters, was covered by the snowpack and didn't reemerge until mid-May). The poles are read from the quarry road using a 45X spotting scope.

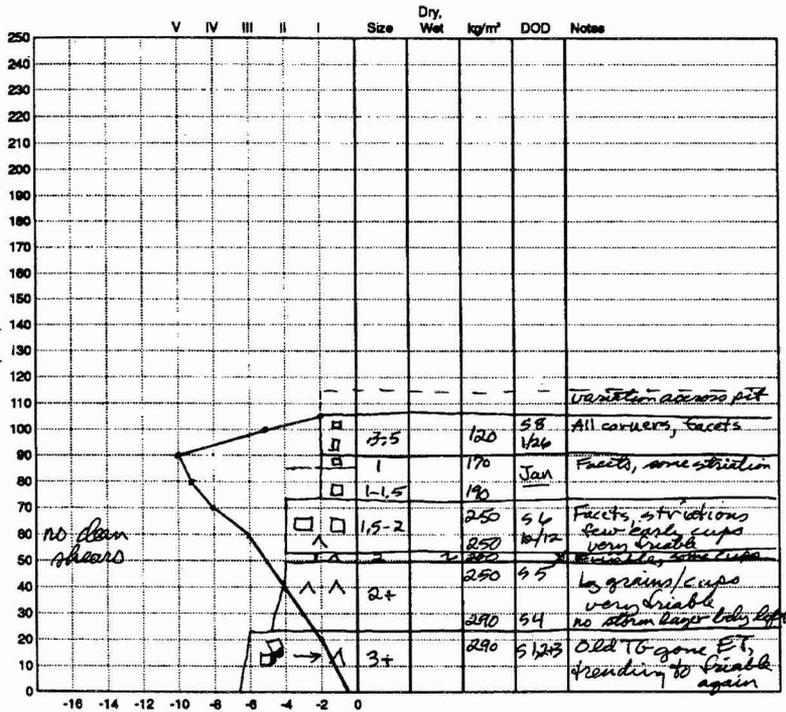
Figure 4. 1993/94 Snow Profile #15.

2/2/94—Profile #15 at YCSP (Figure 4 below): note that the top (Storm #8, 1/26) layer seems to have skipped any intermediate ET reduction and went, instead, directly from new snow to kinetic crystal form. Note densities $\leq 250 \text{ kg/m}^3$. On the Month Log, note the 6.5° C gradient across 20 cm in the snow temperature sensors just below the surface at YCSP. Snowpack has deteriorated dramatically since Profile #14 on 1/22.

Observer: CL Yule Creek Avalanche Services Pit #: 15
 Time: 1140 SNOW PROFILE Date: 2/2/94
 Temp: -5 C Weather: Clear, breeze S M T W T F S
 Location: YCSP E Bench Elev: 9,730
 Aspect: E Angle: 30° Most Recent Prior Pit: 1/22/94; # 14

Discussion: Glopped of thin and sank to crystal, slowly piling down through layers to ~40/50 cm level. Core column stands and flexes; collapse (no clean shears) after several wheels at base which knocked away considerable snow because it's so friable; plugging on wet column produced irregular fracturing. Considered using a probe to load column w/ 3-4" blocks = no collapse

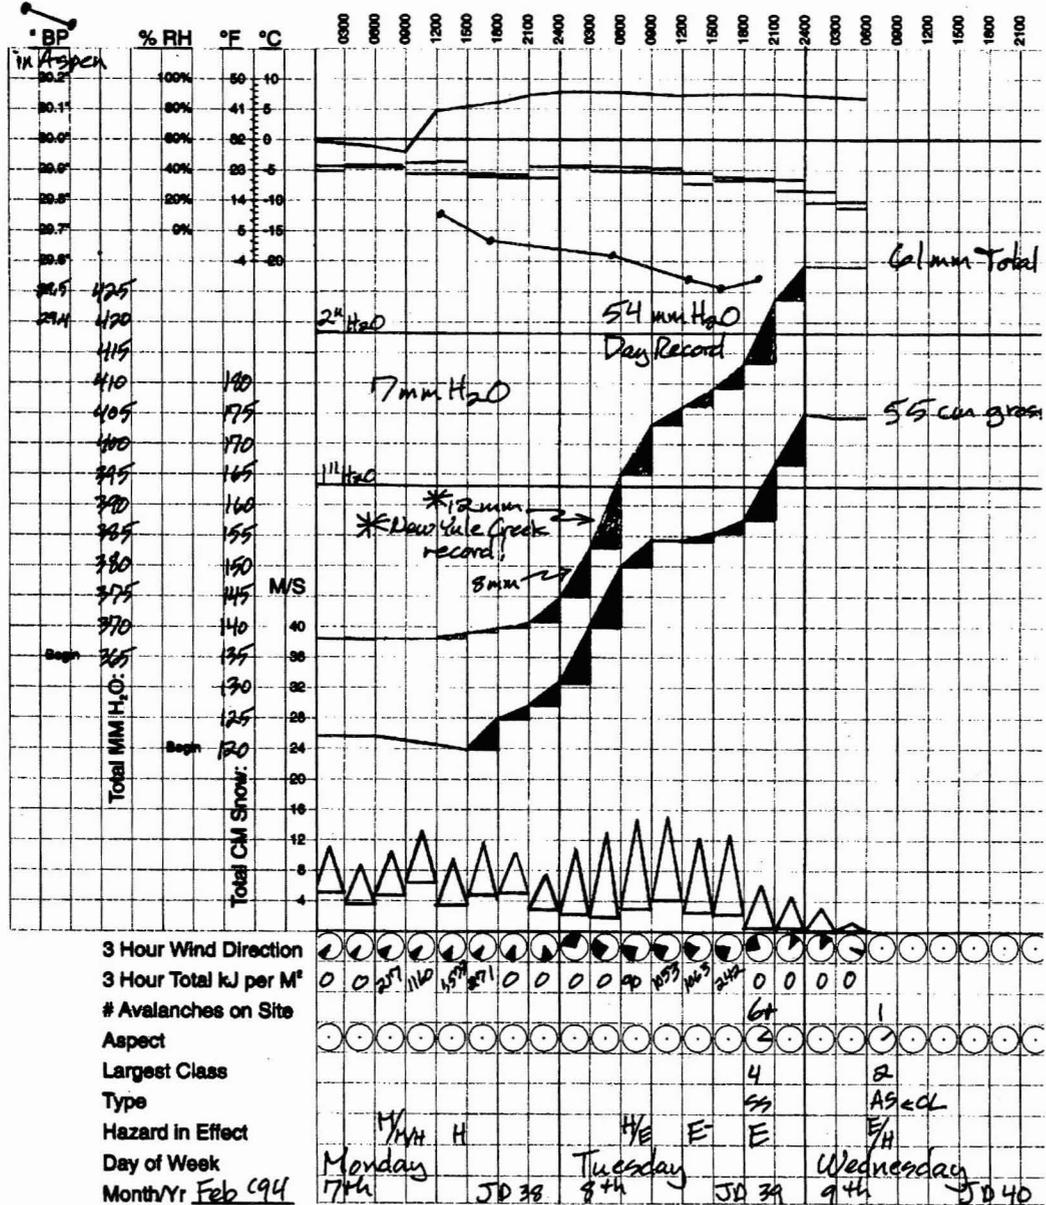
Figure 5. 1993/94 Storm #10 Log.

2/8/94—Storm #10 (shown below): as is often the case, precipitation intensity from midnight to 0600 hours this morning was exceptional; windspeed averages (factored by 2x to estimate ridgetop winds) are at or close to 4 mps, considered a critical threshold. At 0600 the hazard is rated at HIGH trending EXTREME; CYMC cancels operations.

Yule Creek Avalanche Services #10 STORM LOG
