# USE OF RECCO SYSTEM TO LOCATE BURIED ROADS IN A WINTER ENVIRONMENT

By Mike Stanford, Avalanche Control  
Washington State Department of Transportation

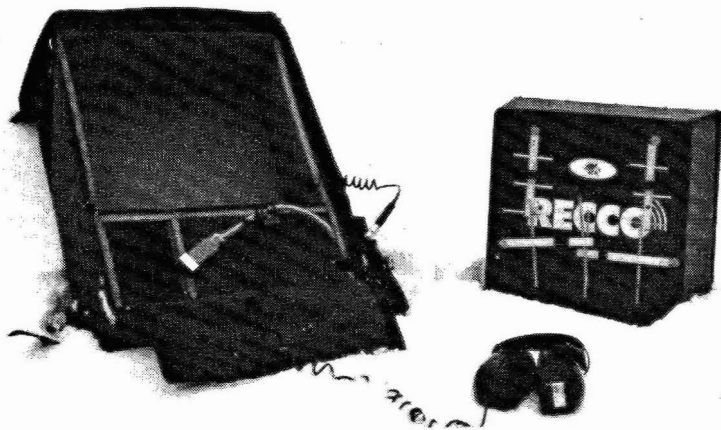
*The unit comes self contained in a semi shock resistant backpack. Total weight of the unit is less than twenty pounds. Enclosed rechargeable battery is good for about 1.5 hours depending on temperature.*

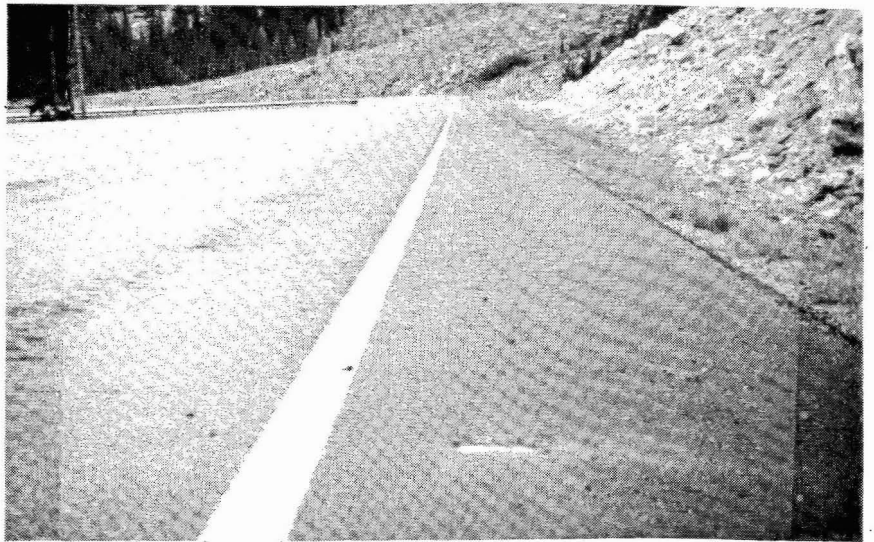
*Tab are embedded 6-10 inches outside of the fog line. hole is then filled with two component epoxy.*

**Washington Pass** was given a total of sixty-two additional tabs. The majority of these were buried in the asphalt just outside of the fog line. The tabs in the road are embedded into the asphalt by chipping out a small groove, and then filling it with the two part epoxy we had experimented with. Where avalanche debris was going to be deposited onto the road, tabs were placed every 100 feet. This way, if for some reason we were unable to get a good signal through the debris itself, we would be able to get a mark on either side of the path and then put a person on the top of the debris and line them up with the other two marks.. The tabs which had been placed on the culverts and guardrail seem to withstand the rigors of the first winter well, so they were left untouched.

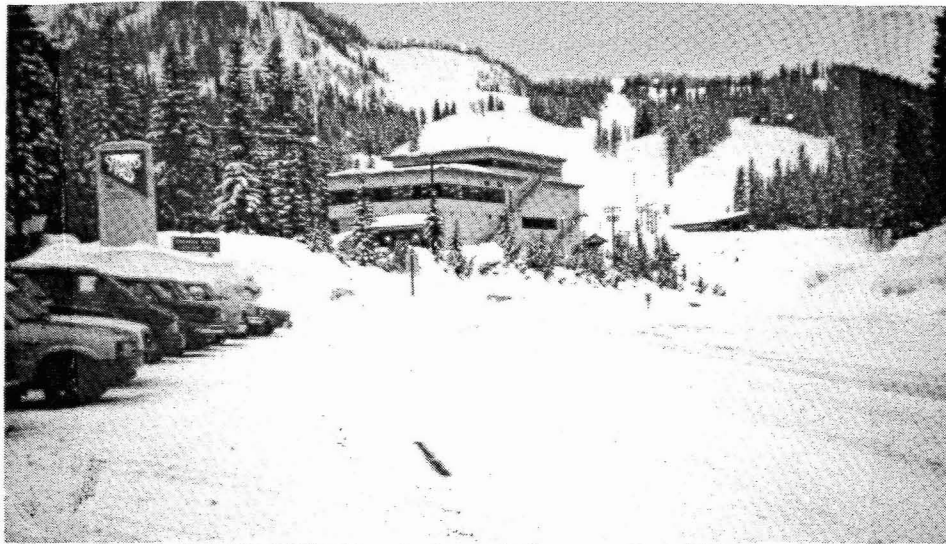
*Fog line is marked with orange spray paint every 100 feet on both sides of the highway.*

On **Stevens Pass**, seventeen tabs were buried in the asphalt just outside the fog line. The situation on Stevens is that the highway runs through the middle of the ski areas parking lot. When the road is covered with a layer of compact snow, it is impossible to know the exact location of the fog line. Therefore, there were many a busy Saturday when the ski area traffic was parked well into the road. With the RECCO system, we are able to mark the location of the fog line with orange marking paint eliminating any guesswork.

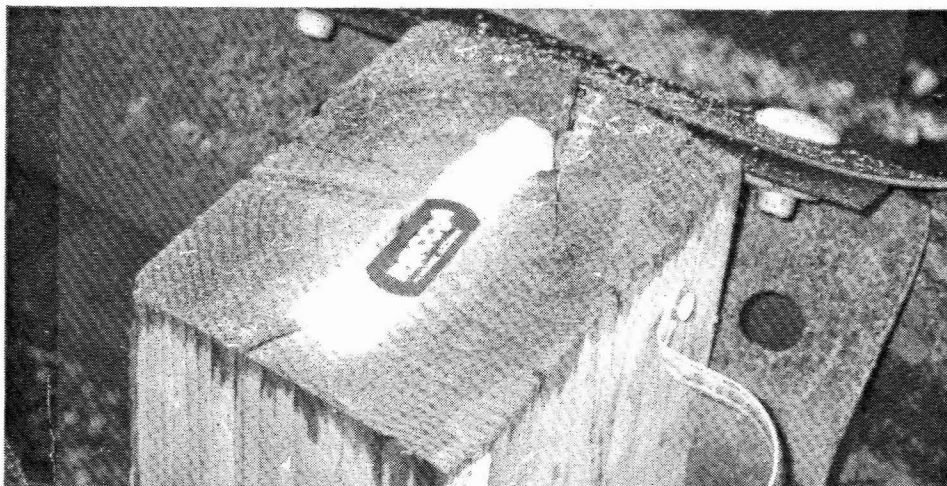
*Groove is routed out of the top of a guardrail post, and then filled with epoxy. Location can then be marked with orange flag.*
