Bridal Veil Falls Avalanche 1996

Kevin Griffith

Utah Department of Transportation,
Region Three Avalanche Forecaster
P.O. Box 993, Park City, Utah 84060 USA

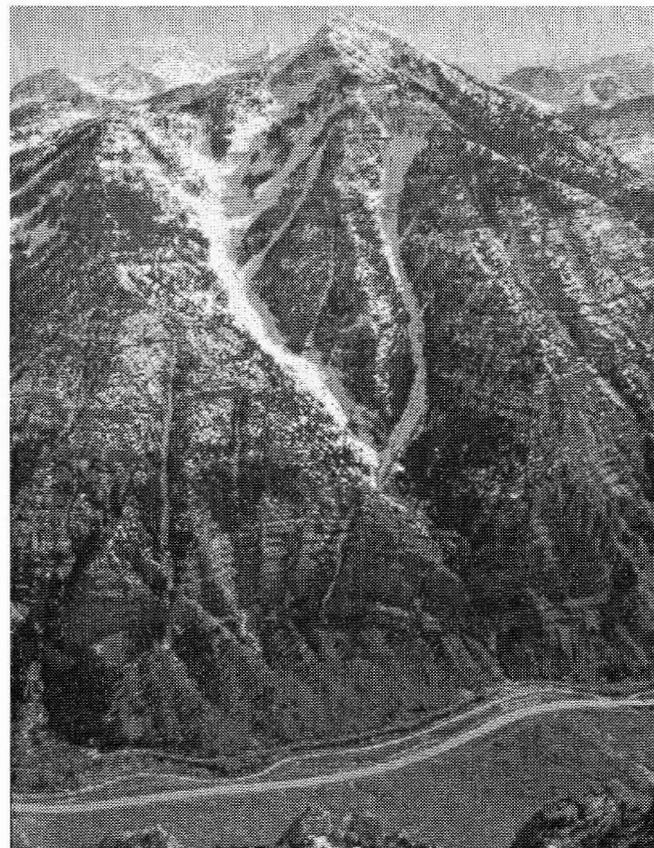
Bridal Veil Falls avalanche path

Located in the Wasatch Mountains of Utah, Provo Canyon is at 40° 21' north latitude, 111° 36' west longitude. Provo Canyon has the three largest slidepaths that threaten a highway in the state of Utah. They are Bridal Veil Falls, Lost Creek, and Slide Canyon. The starting zone and track of Bridal Veil have an area of approximately 160 hectares and a vertical drop of 1626 meters. An interesting feature of the track is a cliff just above the runout zone. About 120 meters in height, the cliff has a perennial waterfall that the slidepath is named after.
