THE "LAVANCHERS" AVALANCHE OF FEBRUARY 23rd 1999, AOSTA VALLEY, ITALY

ABSTRACT: The purpose of the present contribution is to present and analyse in detail an avalanche event which occurred on February 23rd 1999 in the Western Italian Alps, at Morgex, Aosta Valley. The powder component of a huge mixed-type avalanche released from the Lavanchers basin affected the Dailley hamlet, causing great damage to the buildings and one fatality. The avalanche event is firstly framed within a brief presentation of the snowfall conditions and avalanche activity over the Italian Alps during the critical month, February 1999. Then, its observed characteristics are exposed, in order to address the main unknowns of the problem, such as the evaluation of the release scenario and the interpretation of the type of flow and dynamic behaviour of the avalanche. The destructive effects of the snow flow on the threatened area are also presented and discussed, as well as the subsequent countermeasures undertaken. The analysis of this real world case study gives valuable hints for concluding remarks on key aspects of avalanche risk management, such as prevention and planning of structural defence works.

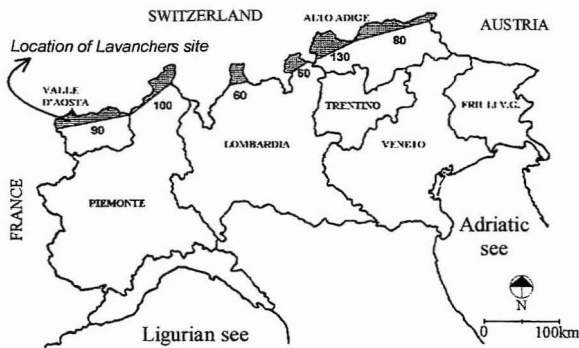
Figure 1: Cumulate snowfalls (in cm) during the week 17.-23.02.99 over the Italian Alpine regions

In the Italian Alps the avalanche activity was in general much less intensive with respect to the northern side of the Alps and was mostly concentrated between February 21st and 23rd, following two successive periods (6.-10.02.99 and 17.-23.02.99) of frequent, weak snowfalls concentrated over a belt of 10-15 km close to the borders (Figure 1). The main avalanche events of this period were:

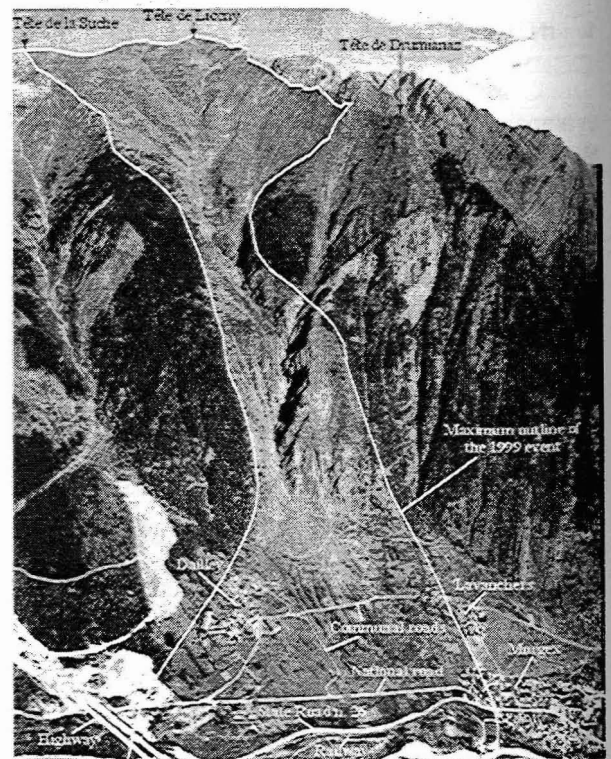
Figure 3: Aerial view of the Lavanchers site

It is a big-size S-faced partly-channelled site, with a total vertical drop of about 2000 m, and a track length of about 4.5 km; the average slope of the whole path is about 25°. The upper collecting basin is represented by an ample (about 2.5 km²) and rather homogeneous open bowl, for the most made up with high altitude grasslands, with a wide crest line that extend between the Tête Suche, the Tête Licony and the Tête Drumianaz (Figure 3). The slopes are rather elevated (in the range 30° to 45°), and the basin is ploughed up from torrential-made channels. In the median part the basin forms a deeply incised gully with vertical rocky walls up to 150 meters in the left orographic side and degrading slopes on the right side. At an altitude of about 1100 m a.s.l. the gully opens on an alluvial fan that corresponds to the usual deposition zone of the avalanches, and where the facilities under threat are located (Figure 3).

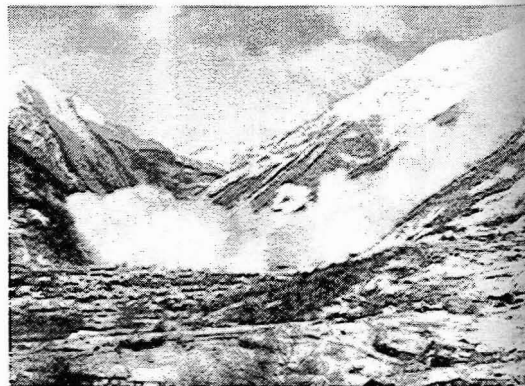
Figure 6: Avalanche of February 26th 1993

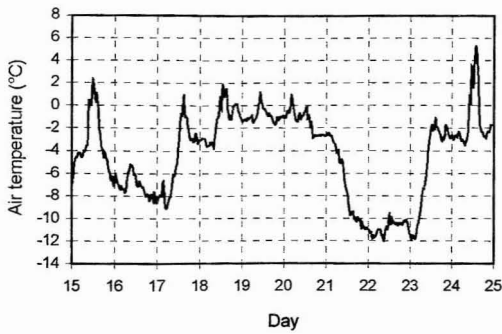
Figure 9: Air temperature during the days 15.-25.02.99. Data recorded at Plan Praz automatic station.

from NW with speed up to 35 km/h, therefore strong enough to allow snowdrift and snow accumulations on SE-faced slope, such as those characteristic of the release zones of the Lavanchers site. In the following days the temperatures rises up to 0° (at 2000 m a.s.l.), and remains on these values until the 21st, when a further snowfall of about 30-40 cm occurs (rain below 1700-1800 m a.s.l.). Starting from the 21st the temperature abruptly decreases by at least 10 degrees while the speed of the wind, always blowing mainly from NW, increases progressively (up to peak values of about 35-40 Km/h at 5:00 o'clock of February 23rd, just one hour before the avalanche release), favouring additional snowdrift accumulations on lee slopes.
