## SNOW PRESSURE ON CABLEWAY MASTS: ANALYSIS OF DAMAGES AND DESIGN APPROACH

Stefan Margreth\*

WSL Swiss Federal Institute for Snow and Avalanche Research (SLF),

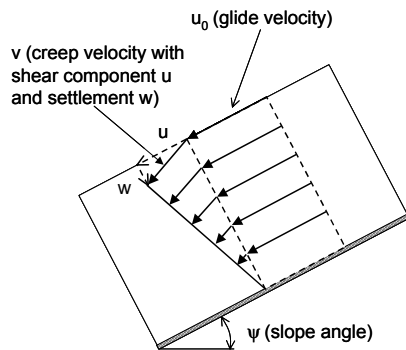
Figure 1: Schematic diagram of the creep and glide movement of the snow cover

The snow pack moves slowly and continually down slope. If these movements are braked or stopped by an object, e.g. a mast from a cableway, then the object is loaded with snow pressure. The following two types of movement of the snow pack are distinguished: snow creep and snow glide (Fig.1).

Snow creep ( $v$ ) is the resultant of vertical settlement ( $w$ ) of the snow cover and internal shear deformation parallel to the slope ( $u$ ). The cause of these motions is the weight of the snow cover that generates forces parallel and perpendicular to the slope. Typical creep rates are mm to cm per day. At the ground the snow creep is zero.

Snow glide ( $u_0$ ) is the slip of the entire snow cover over the ground without essential deformation within the snow cover. Typical glide rates are mm to more than m per day. Gliding affects snow pressure to a large extent. Therefore, snow gliding is a very important component for the calculation of snow pressure. A typical sign of fast snow glide are half-moon to sickle-shaped cracks which are the result of tensile failures. The formation of cracks is generally limited to slopes steeper than  $30^\circ$ .

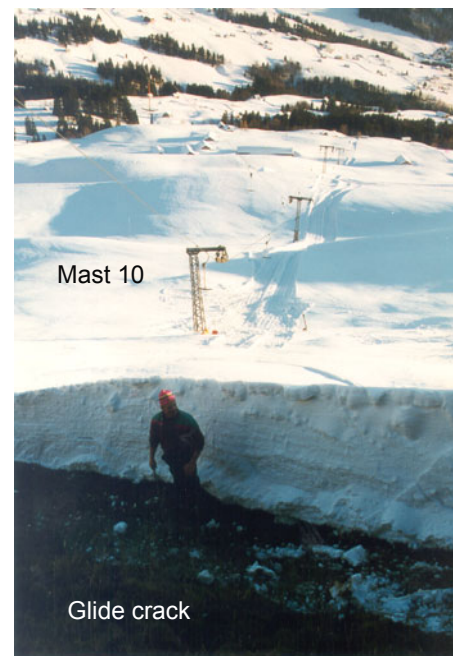
Figure 2: View from the glide crack down slope to mast 10 of the ski lift Bärenfall (case study 1).

On December 6, 1996 mast 10 of the ski lift Bärenfall was destroyed by the gliding snow cover (Fig. 2). In the evening of 3rd of December a crack with a width of 80 m was observed about 43 m above the ski lift mast (Fig. 3). The crack opened at a change of slope angle below a small cliff. Until the afternoon of 4 December the crack opened over a distance of 11 m. A maximal glide velocity of 46 cm per hour could be calculated. Consequently the ski lift mast was bent downslope by the sliding snow cover. Until the 6th of December the crack opened another 5 m, the steel-profiles broke and the mast collapsed. The distance between crack and mast was finally 26.5 m. The vertical snow depth of the displaced snow cover varied between 1.3 and 2.0 m. The slope inclination at the position of the first crack was  $35^{\circ}$  and near the mast  $30^{\circ}$ .

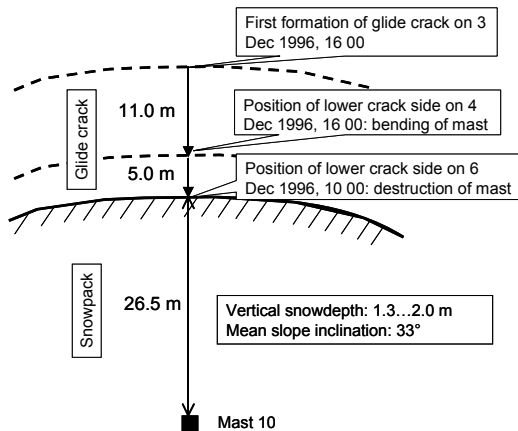
Figure 3: Situation mast 10 of the Ski lift Bärenfall with observed positions of the snow cover.

The grass surface with some indistinct cow trails was very smooth. According to measurements from near by observation stations the mean density of the snow cover was estimated to be  $300 \text{ kg m}^{-3}$ . The ski lift was built in 1984 and mast 10 was not designed to snow pressure forces. It is astonishing that the mast was destroyed so early in winter and by a snow cover with a depth of less than 2 m. The area of Amden is known as a typical snow gliding area: the elevation is 1500 m ASL, the slopes are exposed to south and the area is relatively rich in snow. October 1996 was about  $1^{\circ}$ - $2^{\circ}$  C warmer than average and clearly too wet. November 1996 was also rather warm and also wet. The permanent snow cover started relatively late, in mid November. Between November 21st and December 3rd a huge snowfall of 250 cm was recorded which resulted in snow heights far above average. Before the event a temperature increase of  $6^{\circ}$  C to  $8^{\circ}$  C was observed, but the snowpack still had negative temperatures. We assume that the relatively wet and warm fall combined with the huge snowfall at the end of November were the primary causes for the strong snow glide activity.

The lattice mast had a width of 0.8 m at its base and a height of 7.4 m. The mast was designed for vertical loads. The span of the single profiles was maximally 0.9 m. The structural analysis of the destroyed lattice mast was made with two idealized 2-D plane trusses with fixed joints. We assume that most likely the up-slope lateral angle profiles failed near their lower fixation first. The critical sections were in the angle profiles above the screw fixation of the mast to the foundation. The angle profiles with

the dimensions of 80/80/8 mm were made of steel Fe 360 with a yield point of  $360 \text{ N mm}^{-2}$ . The ultimate bending moment of the angle profile was 4.5 kNm. According to the structural analysis the mast failed with an uniformly distributed snow pressure per unit length of 72 to  $82 \text{ kN m}^{-1}$  over a height of 1.7 m. The computed failure load gives a lower boundary for the snow pressure load. We conclude that the total snow pressure acting on the mast was at least 130 to 150 kN. Mast 10 was rebuilt at the same location and protected with about 60 tripod structures to prevent the gliding of the snow cover (Fig. 10).

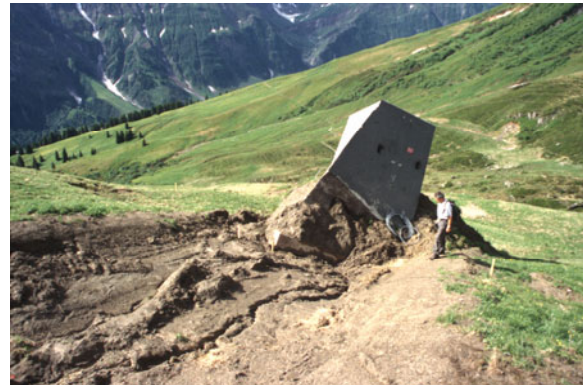
Figure 4: Destroyed foundation of mast 7 of the chairlift Pleus. The shallow foundation was displaced over more than 8 m (case study 2).

On 23 February 1999 the gliding snow cover displaced mast number 7 of the chairlift Pleus over a distance of approximately 8 m down slope. The concrete foundation of the mast was pressed through the ground like a plough (Fig. 4).

The shallow foundation was not anchored to the ground. The main reason for the failure was that the snow pressure force was bigger than the shear resistance of the foundation. The ski resort was closed at the time. After snow melting it could be observed that the gliding snow cover destroyed the vegetation layer at several locations. Also rocks up to a diameter of 2 m were displaced over several meters by the gliding snow cover. The area is known for strong snow gliding. The chairlift was built in 1982. Mast 7 was designed for an avalanche pressure of  $12 \text{ kN m}^{-2}$  over a height of 4 m. The mast foundation consisted of a concrete wedge with a height of 5.2 m and a mean width of 3.2 m (Fig.

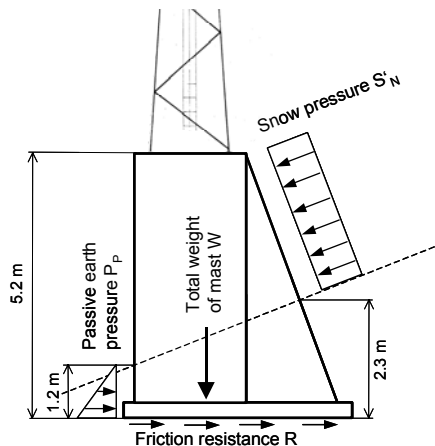
Figure 5: Cross-section of the foundation of mast 7 of the chairlift with resisting and driving forces.

5). The depth of the foundation into the ground varied between 1.2 m and 2.3 m. The mean slope angle is  $28^\circ$ . The slope exposition is Southwest. The SLF was charged to analyse the damage and to determine the snow pressure for a re-construction of the mast.

The snow pressure on the mast could be back calculated from the resistance of the foundation (Fig. 5). The foundation slides if the resisting forces (friction between base and soil, passive earth pressure) are smaller than the driving force (snow pressure). The friction force depends on the total weight of the mast (dead loads and live loads) multiplied with the tangent of the friction angle. With a total weight of 674 kN, a friction angle of  $21^\circ$  and a passive earth pressure of 87 kN the total snow pressure on the mast was at least 472 kN. With a snow thickness of 3.5 m (perpendicular to the ground surface) the resulting snow pressure per unit length was  $135 \text{ kN m}^{-1}$ . Mast 7 was reconstructed

considering the back calculated snow pressure load.

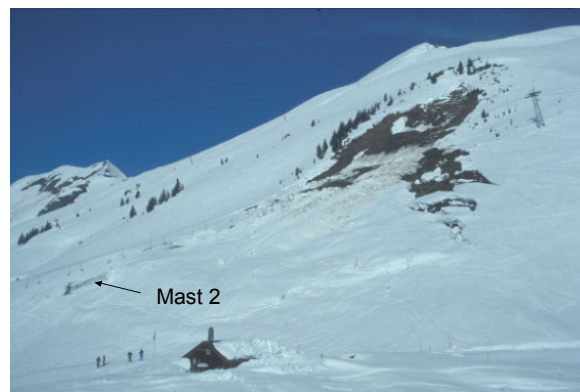
Figure 6: Overview chairlift Käserstatt-Hochsträss with destroyed mast 2 (16.3.1999). Enlargement of glide cracks and formation of folds in the pressure zone below mast 2.

On 14 March 1999 the lateral loading due to the gliding snow cover on mast number 2 of the chairlift Käserstatt-Hochsträss increased continuously. On the previous day the snow cover was removed around the mast on a distance of approximately 2 m. In the morning the snow pressure equalled the resistance of the mast. The mast was bent continuously downslope. At 11.45 a.m. the wire rope jumped out of the cable roll and was held at the very end of the safety cable holder. Consequently the fully occupied chairlift stopped. In a dramatic rescue operation 200 persons were evacuated from the chairs by helicopter. Shortly after the rescue was completed, mast 2 collapsed (Fig. 6).

destruction was caused by the slow gliding of a 20 m long snow-slab. Above this snow-plate a 40 m wide crack with a width of 3 to 5 m had opened. The ground surface was wet and very slippery. The mean inclination between the crack and the mast was 25°. The ground temperature was +0.2° C and the snow temperature varied between 0° C and -1° C. The mean snow density was 390 kg m<sup>-3</sup>. The snow pack was very hard (hand test: pencil to knife blade) and near the bottom a horizontal ice layer of several cm was observed. The snow pack acted on the mast more like a stiff slab than a viscous fluid. A first glide crack with a width of approximately 120 m was observed on 26 February around 70 m above the mast (Fig. 7). Until 14 March several new glide cracks formed and the total glide distance was between 10 m and 35 m (Fig. 8 and 9). The mean glide velocity was estimated to be between 0.6 and 2.0 m per day. One of the reasons for the high snow gliding activity at Hasliberg was the huge snow depth of 3.5 m in February 1999, which corresponds to a return period of 10 to 20 years. At the location of the mast a snow thickness of 2.7 m was measured. The increased glide rate around the 14 March might originate from the air temperature increase of 15° C from -8° C to +7° C in the week before. In the morning of 14 March the air temperature was +3° C.

The chairlift Käserstatt-Hochsträss was built in 1967. Mast 2 was designed for vertical loads. Horizontal snow pressure loads were not considered in the design. The lattice mast, made of steel Fe 360 with a yield point of 360 N mm<sup>-2</sup>, had a width of 2.5 m at the base and a height of 14.2 m. The span of the single profiles was at most 2.4 m. The most likely failure scenario was due to local failure of the up-slope lateral profiles. The critical sections of the angle profiles were in the middle of their span. For the computation of the ultimate failure load a simplified structural model of the 3-D lattice mast was idealized consisting of two 2-D plane trusses with fixed joints. The ultimate bending moment of the angle profiles with the dimensions of 100/100/8 mm is 7.2 kNm. According to the back calculations the angle profiles failed with a evenly distributed lateral snow pressure per unit length of minimally 60 kN m<sup>-1</sup>. The ultimate bending moment gives a lower boundary for the snow pressure load. We assume that after the local destruction of the profiles the global stability of the mast became critical. For a global destruction of the up-slope

angle profiles at their lower fixation the horizontal snow pressure had to be larger than 90 kN m<sup>-1</sup>. The total snow pressure on the mast was at least 160 kN. In summer 1999 the chairlift was replaced and mast 2 was moved up-ward out of the main hazard area. For the design we proposed to apply a snow pressure of 70 kN m<sup>-1</sup> over a height of 3.0 m which corresponds to a return period of 50 years.

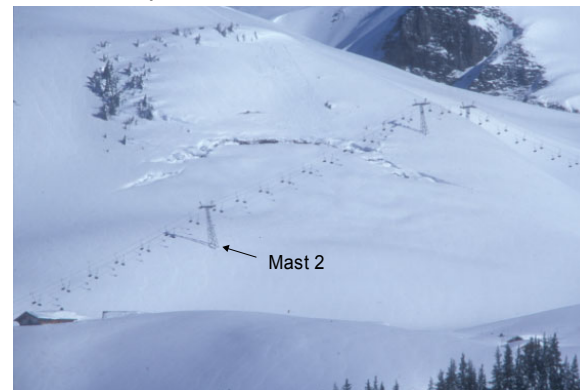
Figure 7: Chairlift Käserstatt-Hochsträss on 26.2.1999. First glide cracks have opened.

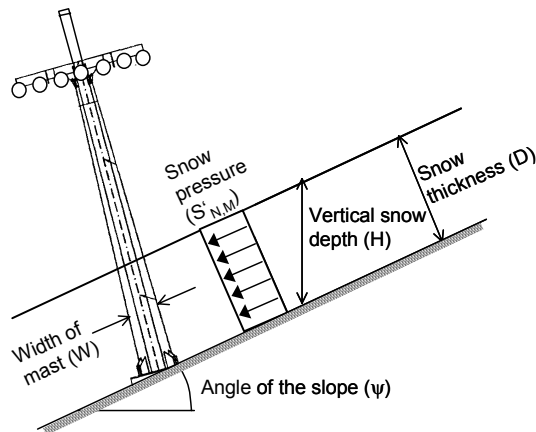
Figure 8: Schematic drawing of snow pressure acting on a mast.

To get the total snow pressure  $S_{N,M}$ ,  $S'_{N,M}$  has to be multiplied by the snow thickness  $D$ . Equation (4) is used in Swiss practice for the design of small obstacles as masts of cableways or poles to snow pressure forces. Normally only the snow pressure parallel to slope is considered and the force component perpendicular to the slope is neglected. The snow pressure is assumed to be uniformly distributed (Fig. 8) over the snow thickness.

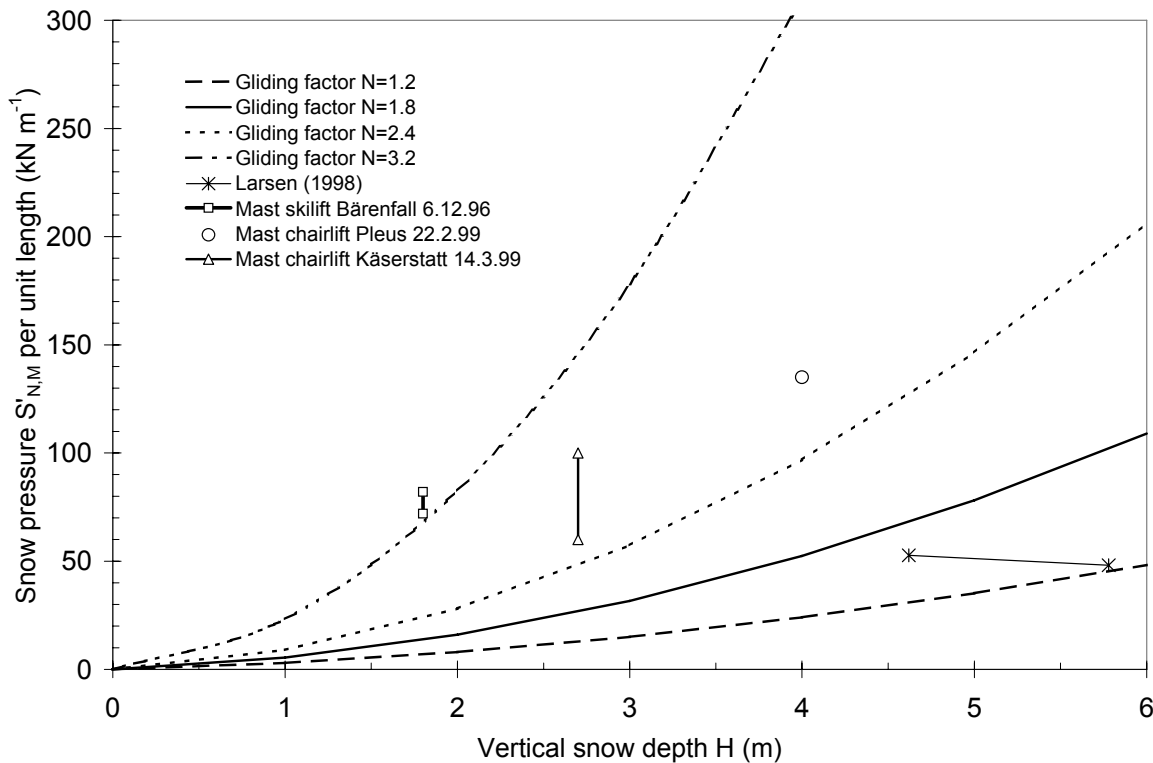
Figure 9: Calculation of snow pressure on a mast with a diameter of 1 m on a 30° slope in relation of the gliding factor N. Additionally the back calculated snow pressure of the case studies and according to the equation of Larsen are shown.

In Figure 9 the snow pressure on a mast with a diameter of 1.0 m on a slope with an inclination of  $30^\circ$  was calculated in relation of the snow depth. The calculations with the model according to the Swiss Guidelines were made with four different snow gliding factors and corresponding  $c$  factors. In Figure 9 the snow pressure calculated with the Larsen-model and the back calculated failure loads of the three case studies are also given. The Larsen model should not be applied in situations where snow gliding is expected. The Swiss Guidelines-model reproduce the back calculated snow pressure forces in the three case studies rather well. The correct assessment of the snow gliding factor and the snow depth, however, is crucial for a reliable calculation of the snow pressure.

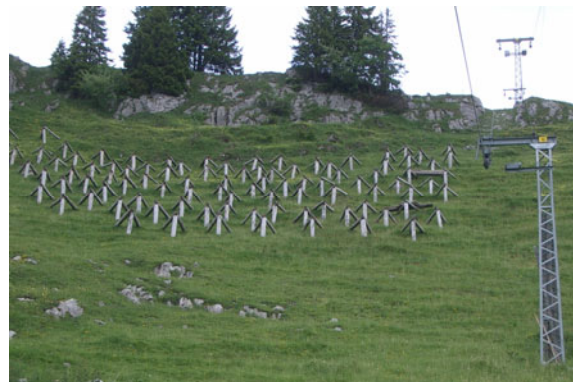
Figure 10: Tripod structures for the protection of the repaired mast 10 of the Bärenfall ski lift (case study 1).

**Tripod structures:** Tripod structures made of wood prevent the snow pack from gliding and also creeping (Figure 10). Typical structure heights are 150 cm and structure width is 200 cm. The structures are anchored to the ground with wire ropes or steel pilings. Tripod structures are best arranged in a triangular grid where the intermediate distance varies between 150 cm and 250 cm. For the protection of one hectare approximately 1'000 tripod structures are necessary.
