Experiences on a storm causing avalanche cycles in south-west Norway

Njål Farestveit* and Sara Skutlaberg
Norwegian Public Roads Administration, Norway

KEYWORDS: Orographic precipitation, Road administration, Storm cycle, Case study

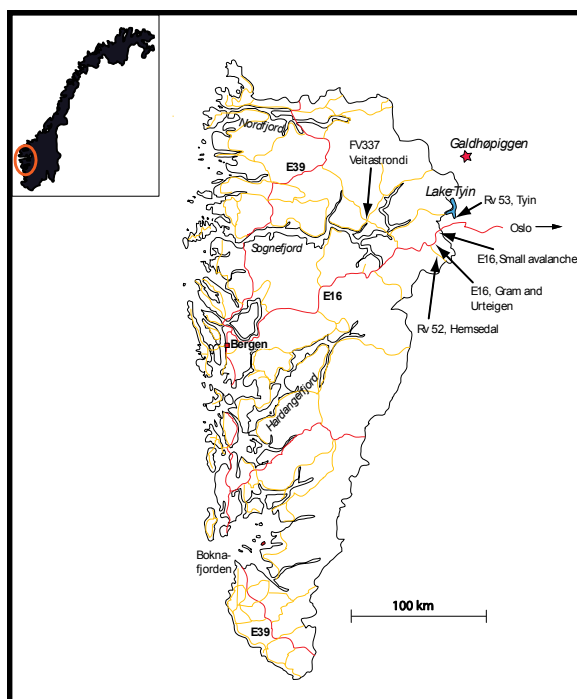
Figure 3. The Western Region of Norway, according to the organization of NPRA. The arrows show the location of several avalanche events in this region during the Sondre storm cycle.

The western region of Norway is shown in figure 3. Key localities are marked in the figure. E16 is the main road interlinking the 2nd largest city, Bergen, on the western coast and the capital, Oslo, on the eastern coast. The highest elevated part of this road runs over a mountain pass situated in the border area between the

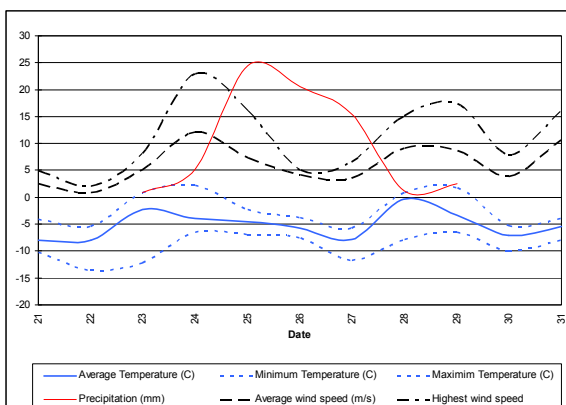
Figure 4. Weather observations during the Sondre storm cycle. The graph shows temperature, precipitation and wind speed, as observed at representative weather stations in the area.

In southern Norway, a storm cycle named the Sondre storm event took place from late evening on Thursday the 24th to early morning on Saturday the 26th of January in 2008. Meteorological data for 10 days, including this period, is presented in figure 4. The data are sampled at the Maristova (precipitation), Sognefjellhytta (wind) and Finsevatn (temperature) weather stations. Maristova is at 806 m asl and is situated close to the avalanches on E16. The Sognefjellhytta is at 1413 m asl, in a mountain area some distance further north while Finsevatn on 1210 m asl is some distance to the south, but on about the same elevation as the release areas of the avalanches on E16. Figure 4 shows a high amount of precipitation in addition to strong winds during the Storm. During 24-27 January, about 65 mm precipitation was recorded at Maristova, most of it during the first period of the storm. Assuming that 1 mm precipitation corresponds to 1 cm of snow, this means 65 cm snowfall. The highest wind speed measured at Sognefjellhytta, 23 m/s, was measured on the 24th of January. The temperature at around 1200 m asl was decreasing during the storm and increased to around zero degrees after it.

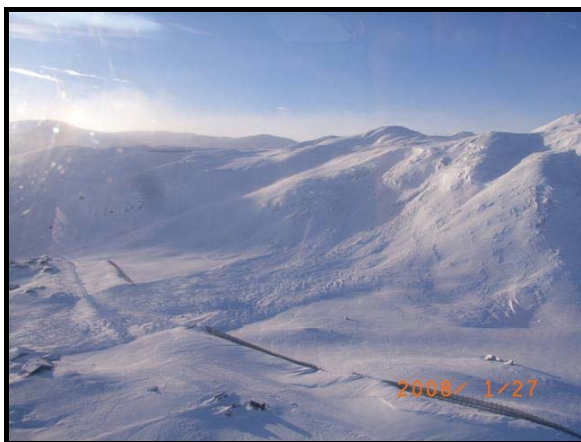
Figure 6. On Sunday the 27th, extreme avalanches overrun the road and reached a recreation village at the Tyin Lake. (Photo: Svein Helge Frækaland, NPRA, 27th of January)

The next day, on Sunday 27th of January, the weather condition was improved. Clearing and reopening of the mountain passages started. Better weather condition allowed for a short aerial inspection of the affected areas. Large avalanches with extreme run out distances were observed. At the local mountain road Rv 53 Tyin-Årdal, an avalanche had passed over the road and displaced a private mountain cabin, located 350 m away from the mountain foot at the Tyin Lake (see figure 6). The release area for this avalanche is located 200 m over the valley floor.

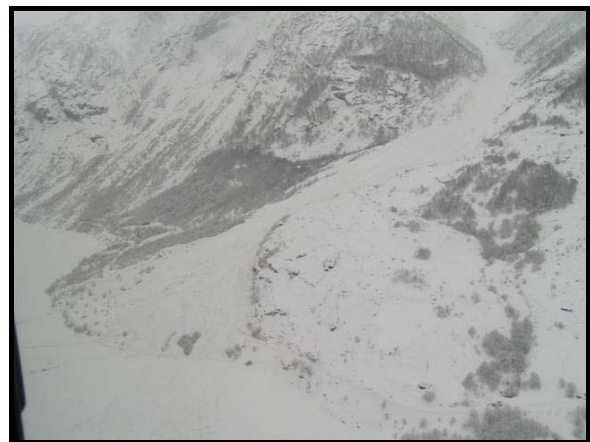
Figure 7. An avalanche slide through a gully at Veitastrondi. The avalanche covers the whole avalanche fan at the end of the gully. (Photo: Njål Farestveit, NPRA)

Monday 28th of January, the temperature rose above zero degree up to an elevation over 1000 m asl. This resulted in another avalanche cycle. Figure 7 shows a big avalanche cutting the road connection off to the small community of Veitastrondi. This avalanche had a thickness of up to 8 m on the road. During this mild weather, also the E16 main road was once again closed. The avalanche at "Urteigskreda" ran as a wet slab avalanche. Such a big avalanche had not occurred here for 30 years (see figure 8). Luckily, there were no cars or personnel injured, but the road was closed for the rest of the day. The release area of the Urteigskreda avalanche, shown in figure 5, is close to the release area of the Gram avalanche.

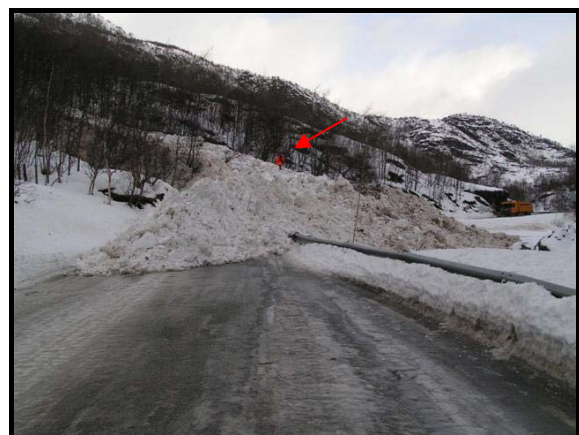
Figure 8. The Urteigen avalanche hit the road on Monday 28th. Observe the man standing on the avalanche! (Photo: Njål Farestveit, 28th of January NPRA)
