The History and Evolution of Track Machinery used for the purpose of Avalanche Clean up on the Alaska Railroad

Bruce A. Gough, General Road Master, (District 1) Avalanche Master Gunner
Alaska Railroad
Anchorage, Alaska-United States

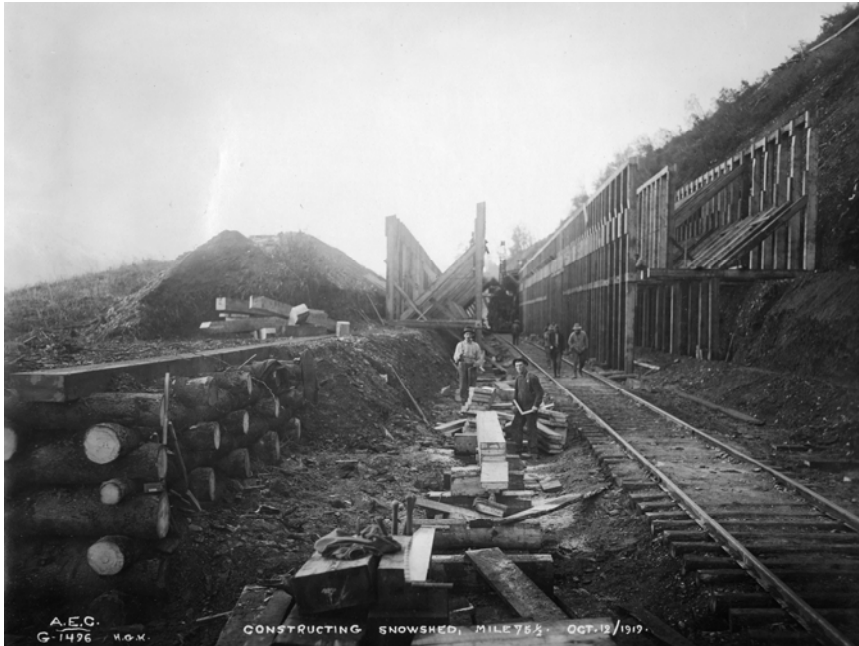
(Fig. 1)

Figure 1: Actual construction of snow shed at mile 75.5, October 12th, 1919

The actual construction of the Alaska Railroad started in 1904. Railroad construction began in Seward, and cut through the Kenai Peninsula, edged around Turnagain and Knik arms, and up to Fairbanks. The "Kenai Peninsula," extends the first 100 miles (160.9 km) of track starting at Seward to Anchorage, traverses through mountainous terrain with 3% grades and multiple avalanche paths along the railroad route. A maritime climate exists on the Kenai Peninsula, with average annual snowfalls of 15 meters (+) of snow, thus creating unique hardships and challenges for the men and equipment. Avalanches repeatedly halted work along the construction route. Colonel Fredrick Mears, the builder of the Alaska Railroad, understood, that avalanches would continue and could not be ignored. He estimated about 8000 linear feet of fortress type sheds, strong enough to withstand the shock of an unpredictable slide would have to be built.

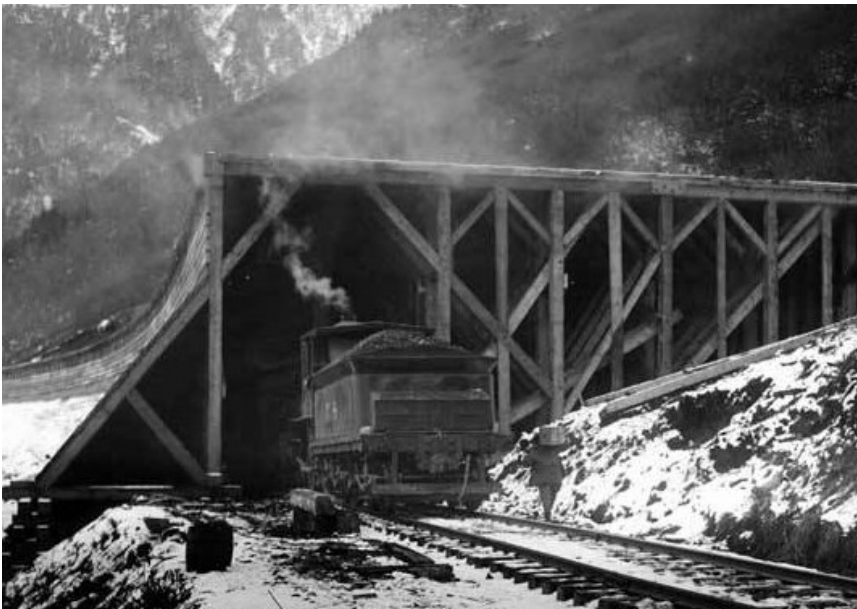
Figure 2: Alaska Railroad snow shed 1920

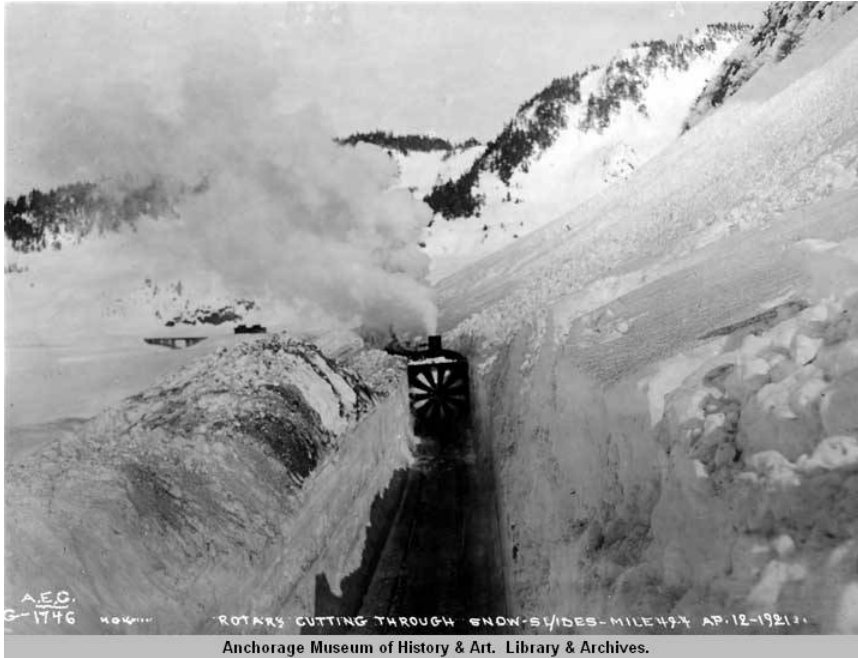
Figure 3: Rotary snow blower working avalanche path 49

Snow Rotaries were often used in the early days for avalanche clean up. Rotaries augured into the avalanches, leaving slotted paths behind. Workers with shovels and picks often helped feed the snow to the rotaries, a particularly hazardous and a laborious job at best. Some of the hazards associated with using rotaries in slide paths were trees and rocks transported down from

the slopes above. The blades or paddles had the potential to be damaged during the clearing process. Another known risk was derailing the rotary while auguring into the slide path. Weight compression forces of the avalanche would often create an ice layer on top of the tracks, thus prohibiting movement of the rotary wheels. There was little room to get men and tools in position to re-rail such a large piece of equipment. Avalanche control measures were non-existent, leaving work crews vulnerable to post-avalanche releases.

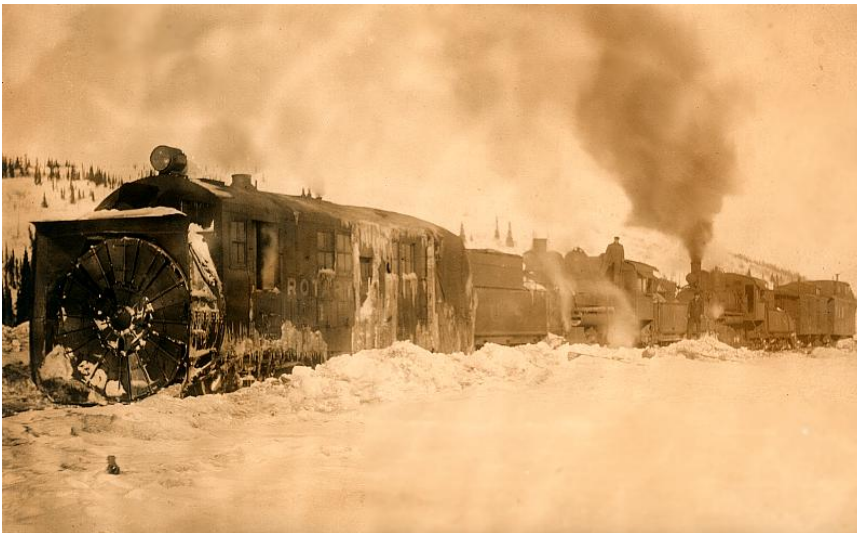
Figure 4: Rotary number 1. Alaska Central Railway

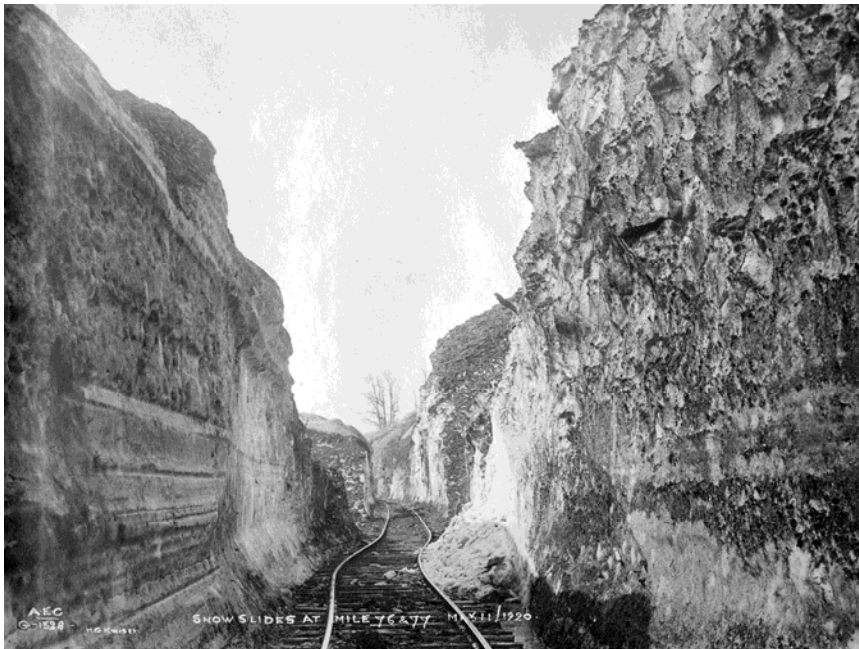
Figure 5: ‘Slotting’ through avalanche with Snow Rotary

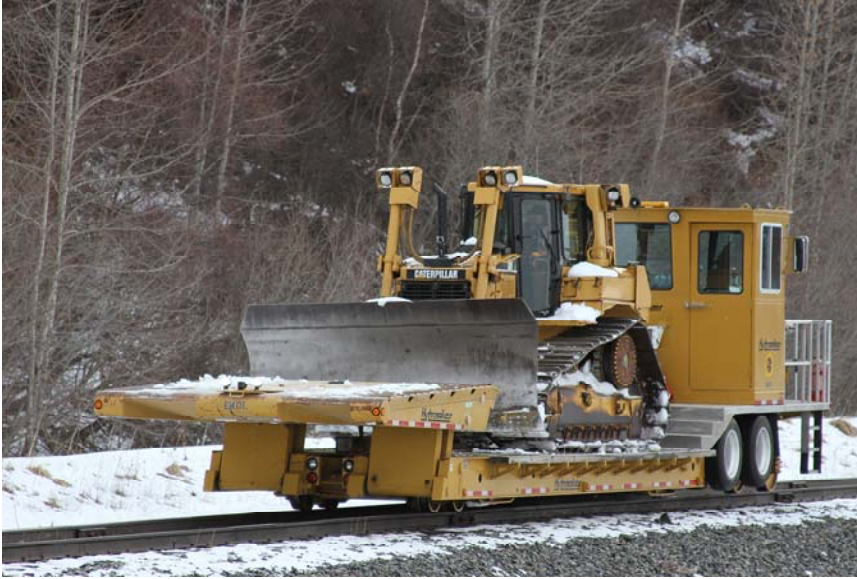
Figure 6: Modern railroad equipment mover hauling a D6 wide pad cat

Presently, the Alaska Railroad is using a mixture of equipment ranging from wide track bulldozers, to excavators (“diggers”) with a 5 yard (4.57 m) snow bucket and transported by a modern tracked equipment mover. The equipment mover makes it possible to bring the required large machinery to the remote avalanche areas, that are not accessible by roadways, in rapid time. Currently using the 345 excavator, coupled with the 5 yard (4.57 m) snow bucket, 20 + yards (18.28 + m) of snow can be removed per minute. This equates to over 1200 yards (1,097.3 m) per hour at the sustained rate. Back walls of the avalanche can be dug back to allow for any unusual high wide loads transported by rail, allowing for extra snow storage. Modern bulldozers work alongside the excavator in the avalanche cleanup process. Wide tracks on the D6 bulldozers offer better flotation on the snow and are not as apt to get stuck in loose dry snow. Another feature of the modern bulldozers is the ability for the operator to adjust the pushing blade angle inside of the cab for maximum advantage. The Alaska Railroad now uses a modern rail equipment mover for transporting equipment to the avalanche. The equipment mover can safely transport a 90,000 lb. (40,8233 kg) at speeds up to 25 m.p.h. (40.2336 km) on flat grade. The equipment mover can also climb a 3% grade with this same load but with less speed and the ability stop with air equipped brakes. For smaller slides and sloughs, a modified D6 bulldozer with “notched tracks” can position itself onto the running rails where the notched section of track overlap the rail and then follow the tracks to any trouble spot without having to get off the tracks. This system is valuable for getting over bridges and through tunnels.

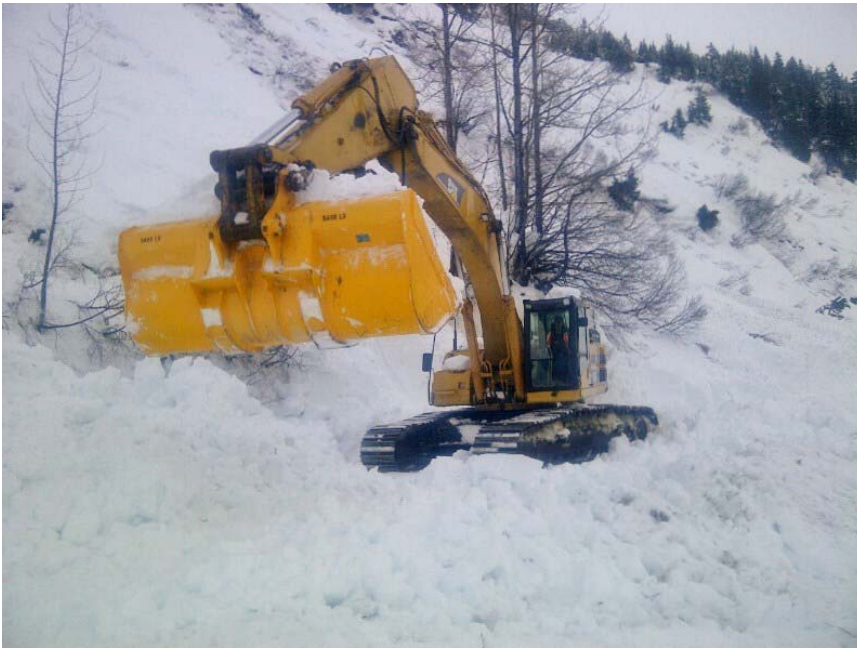
Figure 7: 345 Caterpillar excavator with 5 yard (4.57m) snow bucket
