# ANALYSIS OF AN ARTIFICIALLY TRIGGERED AVALANCHE AT THE NEPHELINE SYENITE MINE ON STJERNØYA, ALTA, NORTHERN NORWAY

ABSTRACT: Since 1961, a Nepheline Syenite mine is operated on the island of Stjernøya in the Altafjord, Northern Norway. The facilities are located in Lillebukt, on the southern side of the island. Above the facilities, the Nabbaren mountain is rising to a height of 727 m a.s.l. Rockfall during summer season and snow avalanches during wintertime pose potential hazards from its slopes. Due to this setting, the mining company has long experience with both physical and non-physical hazard mitigation measures. Apart from physical installations against rockfall and snow avalanches, artificial triggering of the Nabbaren avalanche forms part of this mitigation strategy. The winter of 2013/2014 was characterized by an unusual snow scarcity between December 2013 and March 20, 2014. After this date, large amounts of snow fell during a short period. Due to this new snow loading, together with intensive snowdrift, the mining company decided to artificially trigger the Nabbaren avalanche on April 8, 2014. A D4 slab avalanche was released, subsequently evolving into a mixed dry av

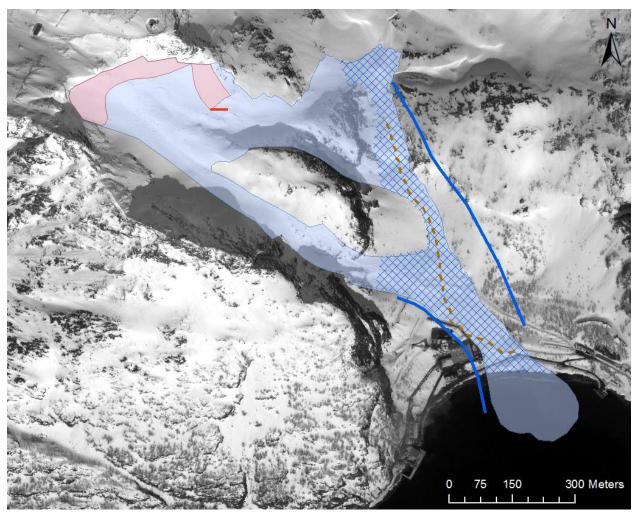
Fig. 8: Outlines of the Nabbaren avalanche draped on a WorldView-1 image from April 17<sup>th</sup>, 2014. Pink areas = release area, red line = observed additional fracture line, light blue area = outline of the avalanche (mostly excl. powder cloud impacted areas), blue lines delineate approximate impact area of powder cloud, blue cross-hatched area = area taken for volume estimation of deposited debris, brown stippled line = GPS track. (Satellite image: Copyright © DigitalGlobe/WorldView-1)

The explosion led to the release of the entire upper part of the release area (cf. Fig. 8), subsequently developing into a large mixed dry avalanche. The fracture line at the blasting site is at an elevation of 650 m a.s.l., but reaches down to 570 m a.s.l. on the ridge on the orographic left side. The total width of the fracture line is ca.

Fig. 8 shows the outlines of the entire avalanche, the release area, an additionally observed fracture zone, and the total impacted area, i.e., including areas with traces of the passing-by of the powder cloud.

During the site visit we surveyed one profile over the avalanche debris with a Differential GPS (cf. brown line in Fig. 8). The surveyed surface was compared to a digital elevation model (DEM) complied from contourlines with 10 m equidistance. The accuracy of the elevation difference between the existing ground and the snow cover/avalanche debris is approximately ±1 m. The height of the snow cover prior to the avalanche is not known but is estimated to be ca. 3 m in the creek bed (snow bridge visible prior to the avalanche) and around 0.7 m uphill from the creek.

If we just consider the main deposition area (blue cross-hatched area in Fig. 8), the area of deposited snow encompasses roughly 80,000 m². Assuming an average snow height (remaining after avalanche erosion of unknown order of magnitude) of ca. 1 m, the snow cover volume can by estimated as 80,000 m³. Note that the snow transported to the sea is not included. It is assumed to be negligible here.

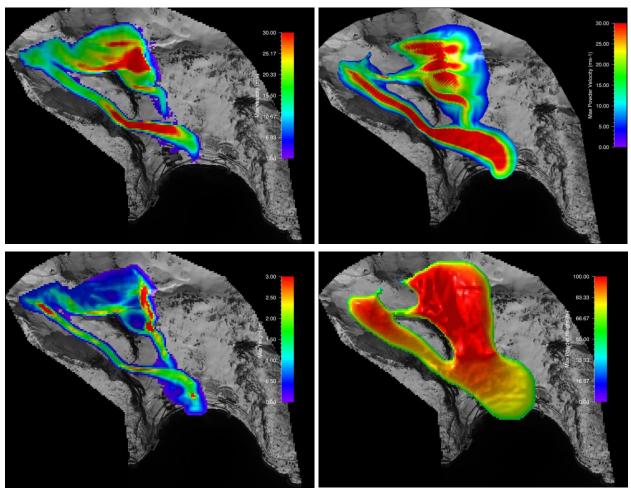
Fig. 9: RAMMS modelling results: Upper left) core velocity (m/s); upper right) powder cloud velocity (m/s); lower left) core height (m); lower right) powder cloud height (m).

The model results indicate velocities for both the core and the powder cloud of 30 m/s or more (Fig. 9a, 9b). Note that the absolute maximum velocities are not shown in the figure. Maximum core height is estimated at ca. 3 m with average core heights over larger areas between 1.5 to 2.2 m (Fig. 9c). The height of the powder cloud is estimated to ca. 100 m (Fig. 9d).

According to the model, the core of the orographic right part of the avalanche reaches the valley floor prior to the core of the orographic left part. In the simulation the flow part of this arm is not reaching the sea.

This finding is in contrast to the interpretation of the field observations which seem to imply that the orographic left part of the avalanche reaches the valley floor prior to the orographic right part. However, the findings from the field observations are based on observations of the powder cloud front and not of the core. More detailed analyses of the available imagery and video footage need to be carried out in order to get an even clearer picture of the event. This will be carried out within a next phase of the study.
