## MONITORING AVALANCHES ON CA 120 IN YOSEMITE NATIONAL PARK

Sue Burak <sup>a</sup> and Edward H. Bair <sup>a,b</sup>

<sup>a</sup> Snow Survey Associates, Crowley Lake, CA, USA

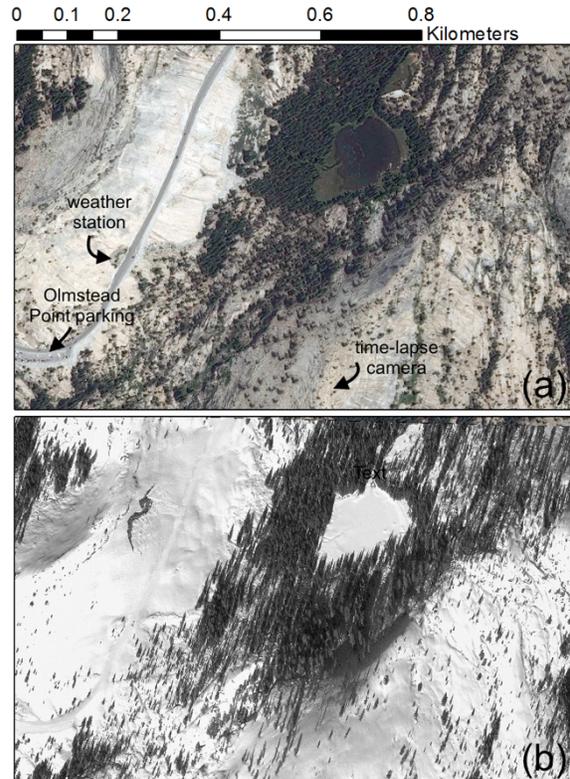
Figure 2 Summer (a) and winter (b) Worldview-3 satellite images of Olmsted Point from 2015-08-06 and 2016-01-12, respectively. Glide cracks and debris from what we hypothesize is a dry glide avalanche is clearly visible crossing the road in (b).

Olmsted Point (Figure 2a,b) is smoother at the km scale than other granite domes the pose avalanche hazards to the roadway. Cornice drops from the ridge above the smooth steep slopes of Olmsted Point are another unique feature. Photographs of glide cracks in February 2010 and glide avalanches

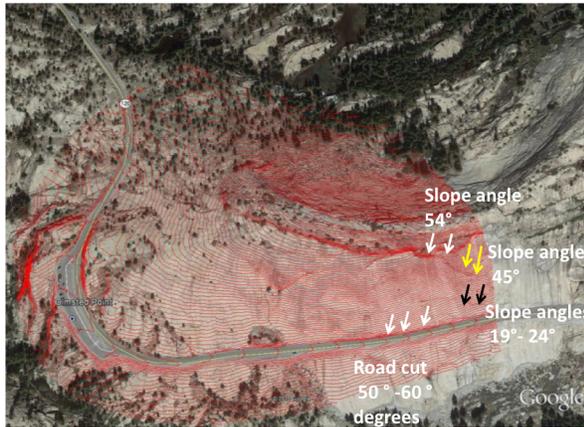
Figure 3 Topographic contours at 1 m intervals from a LIDAR scan of Olmsted Point.

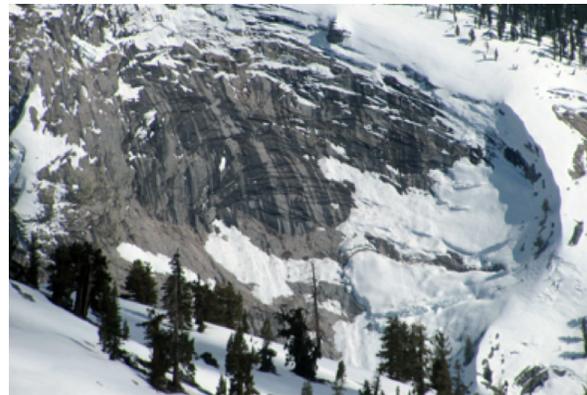
Figure 4. Glide cracking opening, 2016 May 2 16:31. Photo credit Steve Lynds.

off in blocks onto the steep slopes below. Cornice drops can break up the slabs into large blocks on the steep  $38\text{-}45^\circ$  stauchwall areas downslope from the ridge. Cornice drops may also trigger glide avalanches. Buckling and rippling of the slab below glide cracks has been observed in photographs (Wilson, 1999) and in April 2016. Possibly due to anomalously warm temperatures in February 2016, a widespread glide avalanche cycle occurred in the Tuolumne Meadows and Olmsted Point areas and the avalanche cycle was photographed by the Tuolumne winter rangers. During April 2016, widespread glide cracks and glide avalanche activity was observed on granite domes along the Tioga Road and on Clouds Rest (Figure 4), a prominent north facing formation above the Tenaya Creek Canyon.

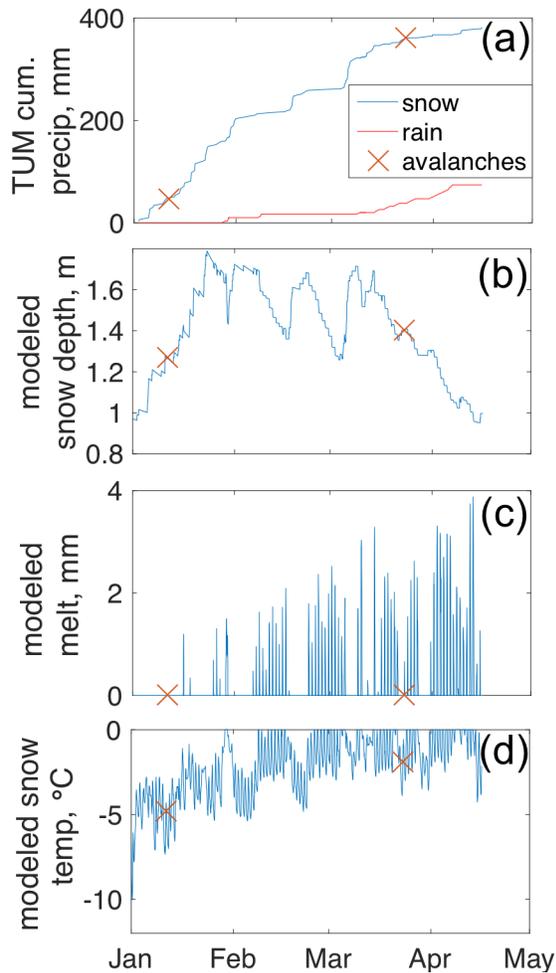
Figure 5 SNOBAL input and outputs for 2016-1-1 to 2016-4-16; cumulative precipitation at TUM (a); snow depth (b); snowmelt (c); and bulk snowpack temperature (d).

Based on photographs taken in January 2010 and Worldview imagery from 2016, glide cracks and buckling were observed during early winter. The snowpack modeling suggests melt water reached the bottom of the snowpack in the starting zones at Olmsted Point in February 2016 (Figure 5a-d).
