CONCEPT TO OPTIMIZE ROAD CLOSURES DUE TO AVALANCHE HAZARD ON LOW TRAFFIC  
ROADS IN NORWAY  
INTERNATIONAL SNOW SCIENCE WORKSHOP 2016 IN BRECKENRIDGE, CO

Dag Theodor R. Andreassen<sup>1</sup> and Ole-André Helgaas<sup>2\*</sup>

<sup>1</sup>Norwegian Public Road Administration, Bodo, Norway

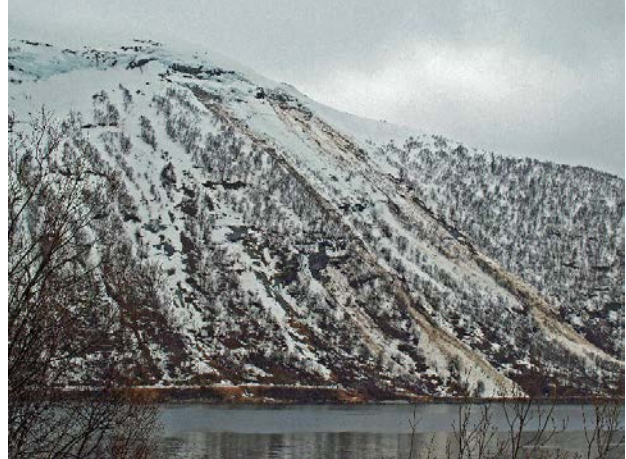
Fig. 2: Sandneslia has several avalanche paths. (Photo: Dag Theodor Andreassen)

An ongoing pilot project for a wireless geophone system on county road 472 at Sandneslia south of Bodo seems promising. Sandneslia has several avalanche paths and annual avalanches (Fig. 2). One of the old, analog geophone systems is here. It has been out of service for more than 15 years. An inspection revealed that cables were torn and the circuit board destroyed.

The new digital system will be less vulnerable to damage due to the wireless transmission of signals, and has the possibility to filter the signals to avoid false alarms. It will also be established a radar monitoring installation in Sandneslia to compare the two methods.

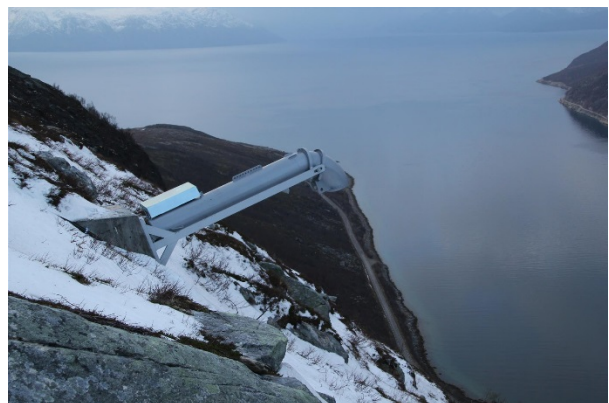
Fig. 3: Skillefjord Avalanche Area and road 883, Gazex exploder installed 2014. (Photo: Ole-André Helgaas)

Gazex is a fixed system with a limited range, but not affected by weather conditions, such as strong wind and poor visibility. This system is in use on county road 883 in Skillefjord north of Alta (Fig.3).

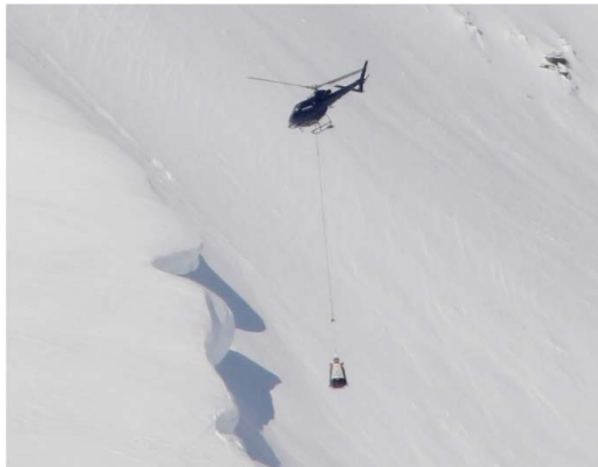
Fig. 4: Active avalanche control with Daisybell, here used near the city of Tromsø, Northern Norway. (Photo: Ole-André Helgaas)

The DaisyBell give more range and flexibility as it is a helicopter carried system (Fig. 4). This system make it possible to operate in a large area, testing several avalanche paths. One of the drawbacks is that the weather conditions must be right to fly helicopter. The NPRA own three DaisyBell-systems, two of them in the northern region.

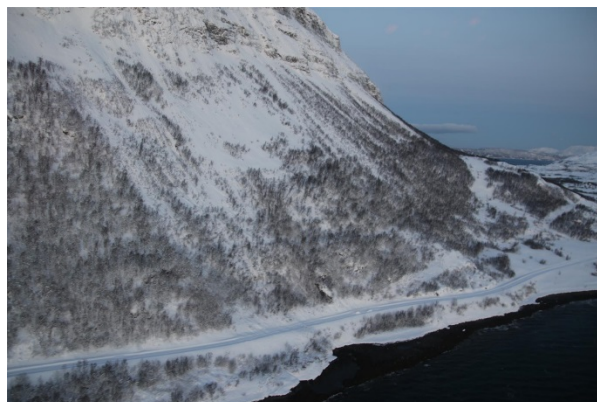
Fig. 5: Gjovalden Avalanche Area and road 866, in the middle of photo two abandoned cars that were hit by an avalanche January 8 2016. (Photo: Ole-André Helgaas)

January 8 2015, an avalanche from the Gjovalden Mountain hit two cars driving on county road 866 to Skjervøy in Northern Norway (Fig. 5). It happened in a well-known avalanche area that until the 1990s had avalanches annually. Over the last 20 years, however, there are almost no reported incidents, and therefore this accident was surprising and unpredicted.

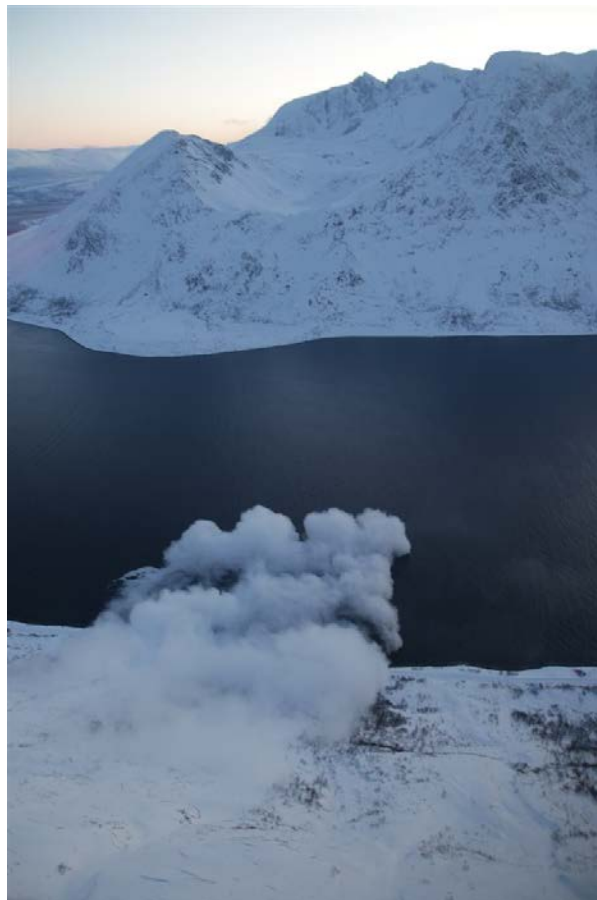
Fig. 7: DaisyBell used to trigger avalanches prior to opening the road on the Arnoy Island, just before daylight fades. (Photo: Ole-André Helgaas)
