COUGAR CORNER – THE LARGEST SNOW NET INSTALLATION IN THE WESTERN HEMISPHERE

Brian Gould^{1*}, Cam Campbell¹, and Andi Buechi²

¹ *Alpine Solutions Avalanche Services*

² *Geobruigg AG*

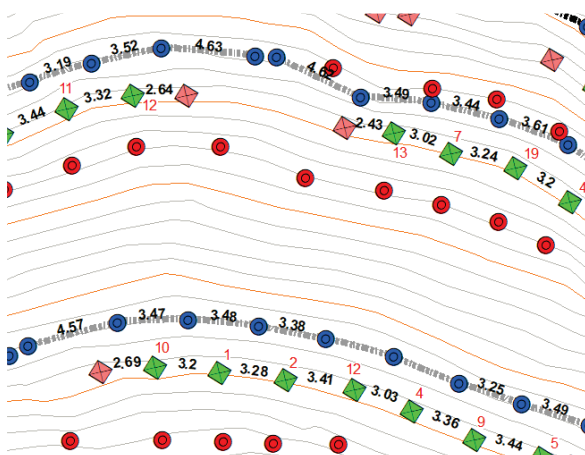
Figure 5: Screenshot of the layout drawing for the lower section of the Cougar Corner 7 starting zone (red outline) showing post (green and pink squares) and anchor (red and blue circles) locations with spacing distances between points (black numbers (m)) and post inflection angles (red numbers (°)).

Ongoing quality control occurred during the field layout phase to ensure the layout conformed to the Swiss Guidelines and Geobruigg specifications. The high-accuracy GPS system was used to survey anchor and post locations that were laid out in the field according to the methods outlined in Section 3.3. These coordinates were analyzed using a Geographical Information System (GIS) to determine spacing between points, distance between rows of fences, separation between adjacent fence segments and inflection angles at post locations (Figure 5).

These parameters were then compared to the Swiss Guidelines and Geobrug specifications and areas that needed adjustment in the field were highlighted. This was an ongoing iterative process with feedback to the field layout crew and new survey points to the GIS technician on a daily basis.

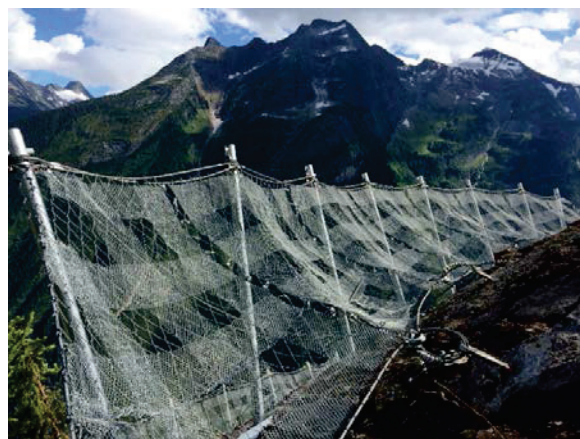
Figure 6: Continuous snow net system.

Initial field investigations discovered extensive discontinuous terrain, sloping benches, rock fins and ribs, and other complex micro-terrain features that would not allow for a continuous snow net system (Figure 6). In order to adapt to the discontinuous terrain, as well as wildlife permeability and practical installation considerations, fence segments of 7 to 30 m in length, were used. However, there were several isolated slope features that would only accommodate a single central panel of net with two triangle end panels, which was referred to as a 'two-post system' (Figure 7). Although these 7 m two-post systems had isolated use previous to this project, Cougar Corner incorporated 23 such systems, which accounted for 24 % of the rows.

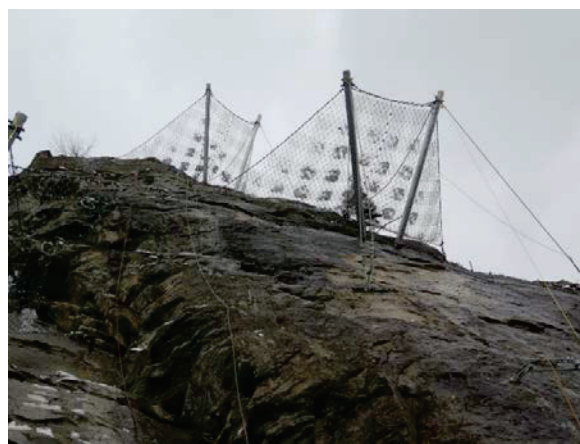
Figure 7: A 7 m two-post system.

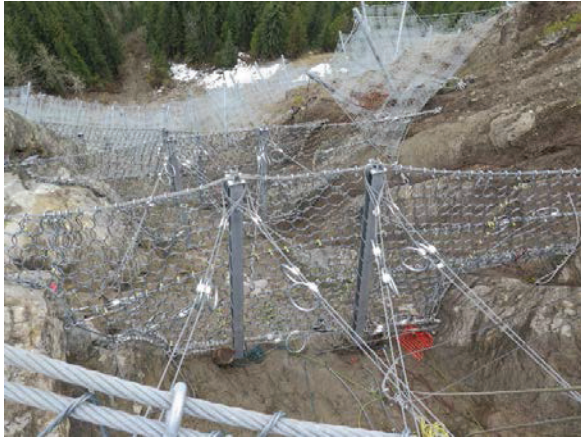
Figure 8: Use of debris flow net barrier in CC7 gully.

The central section of Cougar Corner 7 path is a narrow converging gully that is over 5 m deep and 10 to 15 m wide at its narrowest point. Terrain investigations determined that standard snow nets were not suitable for this location. After discussing with the manufacturer's technical representatives, it was realized that a debris flow barrier system could effectively be employed. The system is designed for significant loading from debris flow mass, which is much denser and heavier than even the densest snow pack. And the debris flow nets could act as a catchment for any loose snow sloughs that occur between rows of nets. The final installation is illustrated in Figure 8.

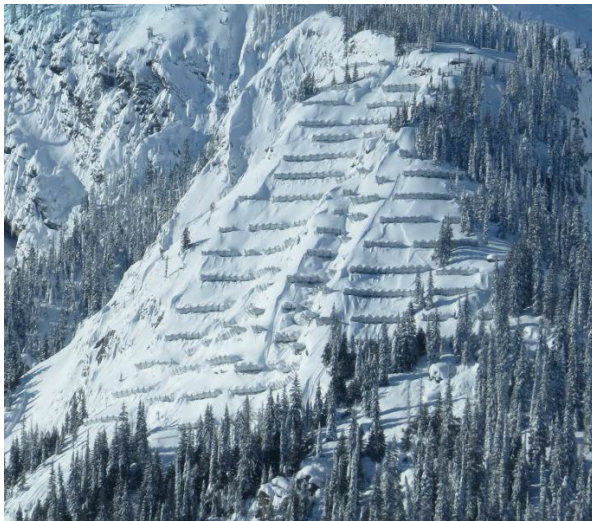
Figure 9: Cougar Corner 7 and 8 path snow nets, March 2018.

The Cougar Corner snow net project represents a milestone for avalanche mitigation in Canada and the world. Not only is it the installation significant in size, it also incorporates innovative design concepts that would not have been possible without the collaborative effort that ensued on the project. Installations have successfully protected the TCH throughout winters of 2016-17 and 2017-18 (Figure 9).
