## HISTORICAL AVALANCHE PROTECTION BARRIERS AS TECHNICAL AND CULTURAL HERITAGE

**ABSTRACT:** The project investigated more than 100 years old protection barriers in the Kleinwalsertal, Austria and results in a “Wall Inventory” but also an instrument for the responsible authority (WLVV) to decide and plan the rehabilitation and development of their historical stock. Beside their protective effects, the buildings show multifaceted significance. They are witnesses to the pioneering work in avalanche protection, they are formative landscape elements and keep the volatile avalanche history in people’s mind.

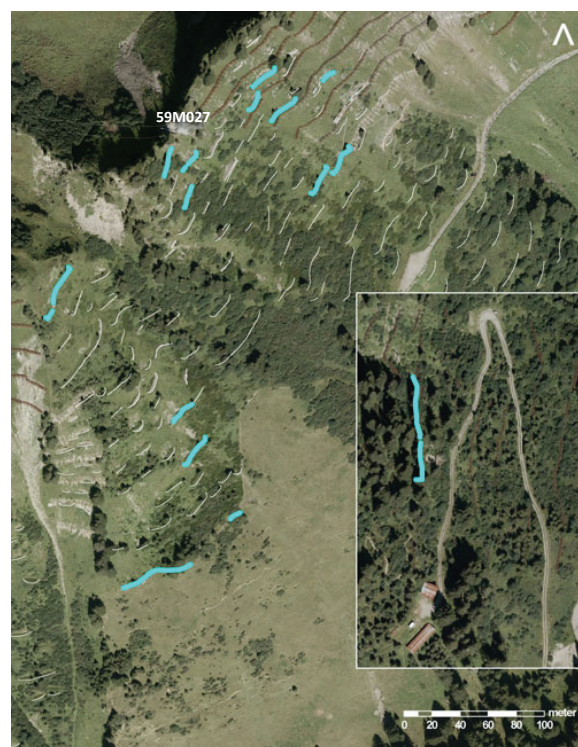
The analyses results in a group of 14 highly ranged buildings on the Walmendinger Horn (see Fig. 4). All of them are “dry stone walls” or “dry stone walls in combination with gabions” and located in the area of Schreckenmähder, Sigunt and Zaferna. They were constructed as dry stone walls between 1907 and 1920.

Figure 4: Location of the 14 most important buildings in the area of Schreckenmähder, Sigunt and Zaferna (IBLB BOKU Vienna, 2018).

The building is located at the highest point of the slope Schreckenmähder and Sigunt (see Fig. 4), directly beneath the ridge. The cable car is running straight above the wall and the object is not easy to reach.

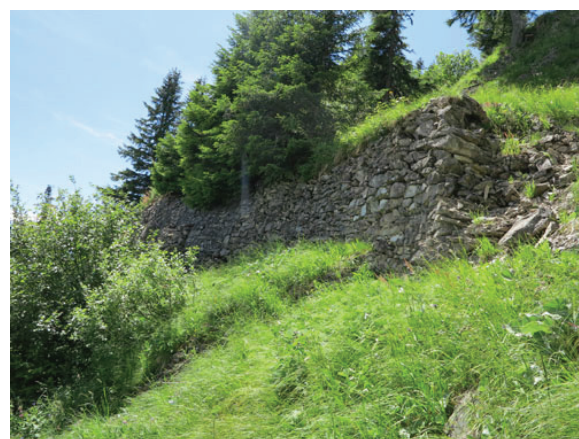
The object was constructed between 1907 and 1920 as a dry stone wall. In 1955 some parts of the wall were removed and replaced with gabions, which is still apparent today (see Fig. 5).

The parameter “age and rarity significance” is rated with 1, because of the extraordinary height of 3.5 meters and the length of 23.7 meters.

Figure 5: Protection wall with gabion – most important building in the area (IBLB BOKU Vienna, 2018).

Due to some lacks in the construction, such as butt joints and missing interlock between the dry stone wall and the gabion parts, the “construction technique” has rating 2.

Today’s condition of the object is 3. This means that damages do not risk the building. Although, some parts are already lost and the dimension of damaged parts is at least 26 m<sup>2</sup>, which is large.

The wall still stabilizes the slope, whereas its effectiveness for avalanche protection is less. This results in a rating of 2.

Without restoration, the construction is a risk for forest development and other avalanche protection barriers in the transit and exit area, but it will not endanger highly frequented areas.

Therefore, the suggested measures are: It is recommended that the wall will be renovated within one year. The lost parts should be reconstructed and the gabions should be replaced with dry stone walls (W + addition). It is necessary to remove wall parts for a damage-free removal of trees and roots. The professional reconstruction should be realized with orientation on the stock (S(G)). At least the bond effect of well-preserved parts must be secured (V).
