## DESIGN AND CONSTRUCTION OF AN AVALANCHE DEFLECTING BERM, MOUNT KITCHENER AVALANCHE PATH, AORAKI MOUNT COOK NATIONAL PARK, NEW ZEALAND

**ABSTRACT:** The Mount Kitchener avalanche path produces large avalanches that have potential to affect parts of Aoraki Mount Cook Village, New Zealand. Numerous buildings located in the runout zone could be affected by avalanches, including the iconic Hermitage Hotel and several residences. Although there is no historical evidence of destructive avalanches reaching the village, statistical and dynamic avalanche modelling combined with field evidence confirmed the potential for Destructive Size 4 or 5 avalanches to reach the village with a return period between 100 and 300 years. The potential runout position of the dense component of 100 to 300-year avalanches was determined to be within the limits of the village. Powder avalanches could penetrate further into the village, as has been evidenced by historical events. Potential impact pressures within the village were estimated in the range of 1 to 70 kPa. The existing 2 m high deflection berm constructed on the debris fan has been overtopped on numerous occasions and was determined to be ineffec

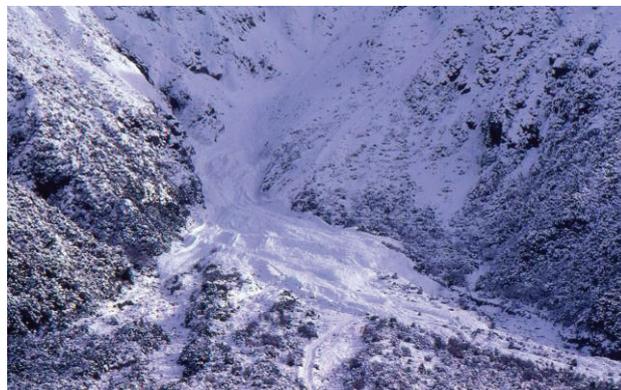
Figure 5: Avalanche debris onto the Kitchener fan in 1995. Debris covered approximately 2.7 ha with 70,000-90,000 m<sup>3</sup> of debris, some of which overtopped the original diversion berm.

Investigations and historical observations of avalanches in the path led to the conclusion that the existing 2 m high berm was only effective for relatively small avalanches and could be easily overtopped by larger (Size D3 or D4) avalanches. This is illustrated by events in 1995 (Figure 5) and 2009 (Figure 6).

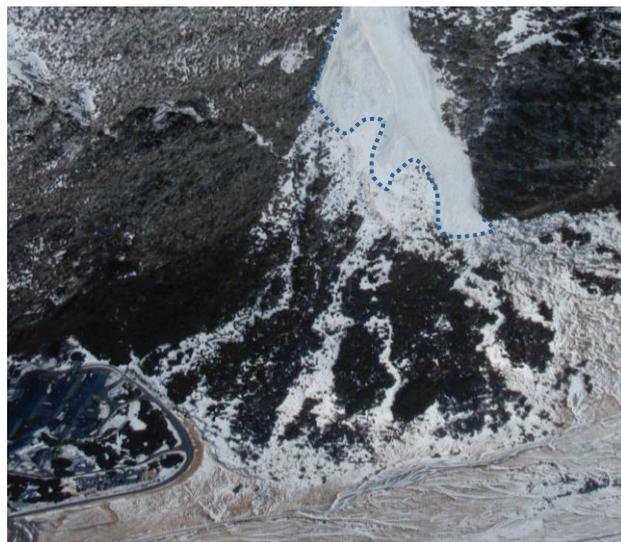
Figure 6: Avalanche in the Kitchener path, 24 July, 2009. Dashed blue line delineates approximate toe of deposit which overtopped the diversion berm (DOC photo).

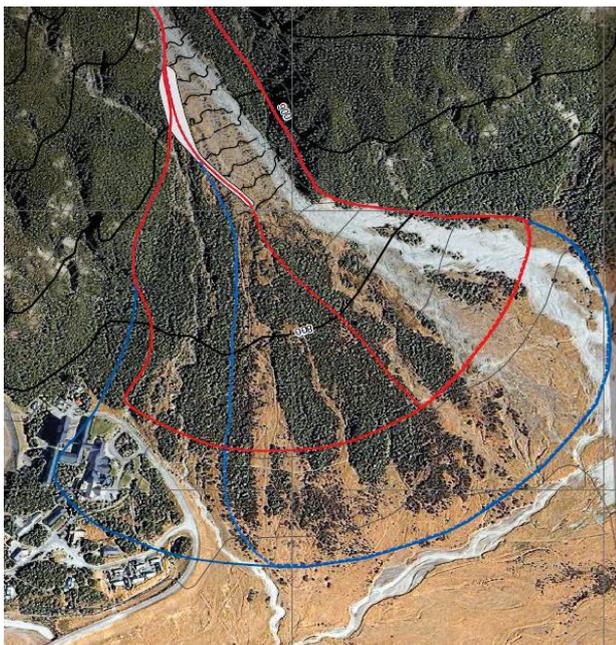
Figure 7: Avalanche hazard zones (Red and Blue) for the Kitchener path with (inside lines) and without (outer red and blue lines) the improved diversion berm. The berm (outlined in white in the upper fan) moves the Blue line outside of the village area.

Avalanche hazard zone mapping determined that the Blue Zone extends approximately 150 m from the upper loop road into the Village. This represents potential avalanche risk from low frequency powder avalanche impact pressures that exceed 1 kPa and with a return period of less than 300 years. Dense flowing avalanches were not expected to flow past the upper loop road, but rather stop on the slope upslope of the northwest edge of the road. The Red/Blue hazard line was interpreted to be located approximately 30 m upslope of the upper loop road.

With the diversion berm, the Red/Blue hazard line (which includes more frequent, dense flow avalanches) will follow the crest of the diversion berm (Figure 7). The berm will direct most avalanches down the main stream channel and away from the village. Once avalanches reach the lower end of the berm they can turn towards the village, but the terrain will direct flow down the topographic fall line. The Blue hazard line was revised to show the diversion berm directing most flow down the fall line into the main stream channel, but with some dense and powder flow expected to overtop the lower part of the berm where it drops to a height of 3.5 m. However, by that point flow will be directed downstream and not be able to turn back towards the village. The revised hazard zoning resulted in a reduction in risk such that avalanches would not affect the upper loop road or the village, thus achieving the project goal.

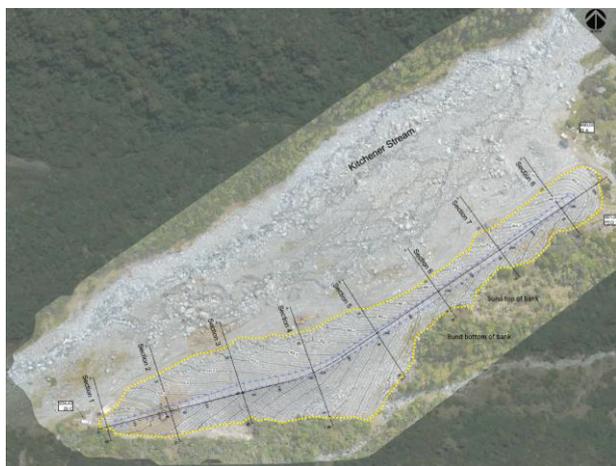
Figure 8: As-built diversion berm in plan view.

The final cost of the project was NZ \$700,000 (€430,000). An as-built survey was completed, which showed the final constructed fill to be 46,369 m<sup>3</sup>, with construction as per the original design concept (Figure 8). Figures 9 through 11 show three views of the completed structure.

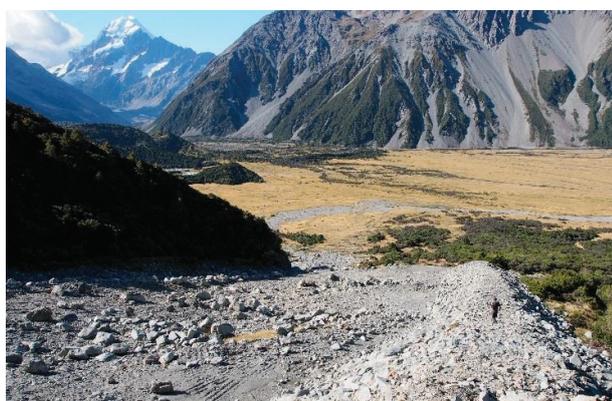
Figure 9: Completed diversion berm looking downslope.

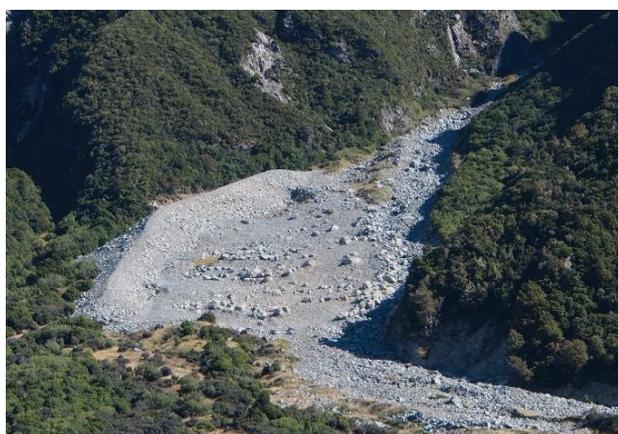
Figure 10: Completed diversion berm.

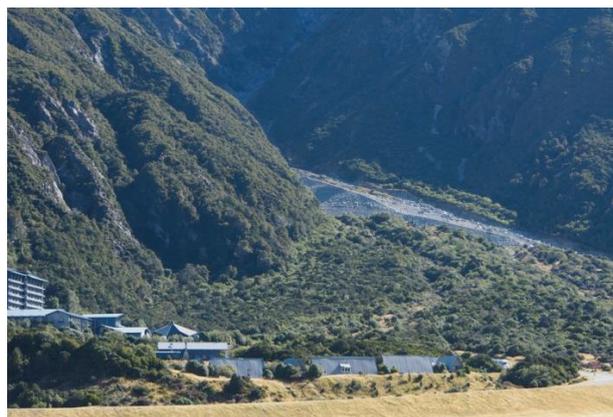
Figure 11: Completed diversion berm viewed from Aoraki Mt. Cook Village.
