## PASSIVE SOLUTIONS TO IMPROVE THE PROTECTION OF A MISPLACED CHAIRLIFT ENDANGERED BY MAJOR AVALANCHES

**ABSTRACT:** Due to an unexplained shift during its construction project in contrast to the avalanche recommendations, The Arcelle chairlift was impacted several times by major avalanches in recent years. A posteriori protection solution based mainly on braking mounds was then developed which has been naturally and positively tested during the Eleanor storm at the beginning of 2018.

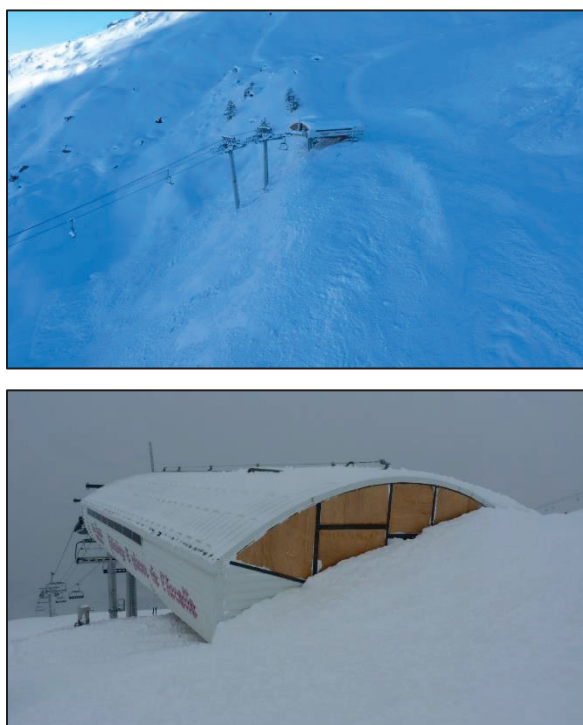
Figure 2: November 2016 (top) and March 2017 (bottom) avalanches

During the winter 2016-17 and despite a small protective dam just above, the top station was partly filled with snow a first time in November and then almost buried in March (see Figure 2). Each time, it was a mixed avalanche whose dense part filled or buried the station to stop rapidly downhill whereas the powder cloud impacted and slightly damaged the siding of the upper machinery shelter.

These two events pushed the ski resort management to firstly understand why such accidents occurred so regularly and secondly look for additional and original protection measures as just multiplying shooting points would be insufficient. So, a general analysis was restarted which rapidly discovered the location problem: indeed, first project schemes before the construction located this top station on the small hill visible behind on the top picture of Figure 2. Effectively, it would not suffer such an avalanche exposure there.

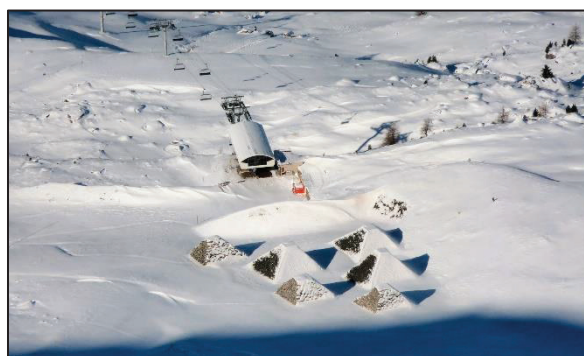
Figure 4: View of the "pyramids" and dam network at the end of 2017

Finally, a staggered network of six braking pyramids was decided in addition to the enhancement of the small existing dam just above the chairlift. The three most exposed mounds directly facing the avalanche were designed sharply and reinforced adequately based on the state of the art of passive avalanche protections (Rudolf-Miklau et al. 2015).

These protections are around 6 meters high and were optimally preferred to a unique (at least) 20-meters high dam. They were built during fall 2017 in a few weeks (see Figure 4).

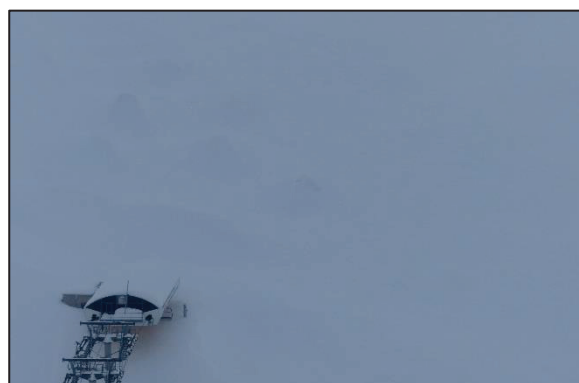
Figure 5: Top station just after the avalanche and lateral braking mounds

but only a limited layer of snow entered under the station: in comparison to previous burying events, the corresponding volume was relatively smaller even though the event was larger (another chairlift situated downhill was deeply damaged during this period where it never experienced any known avalanche before). Within the assumed industrial risk, the upper part of the building was also impacted by the powder cloud and some sheet walls were damaged. But, the network globally played its role very well even showing the expected deflecting effect. Regarding conditions at that time, it might have clearly saved the infrastructure confirming an optimal cost-benefits ratio.
