## The extraordinary 2017-2018 winter season in Aosta Valley – AO (IT)

**ABSTRACT:** In this work we will focus in particular on the exceptional avalanche events that occurred in January. The start of the winter season was not promising, still no snow in November. Finally a strong storm brought one meter of fresh snow on the whole Region on the 10<sup>th</sup> of December. The rising spontaneous avalanche activity forced the local avalanche commissions to take the first preventive closure measures for the valley's road systems. But it's in January that winter got exceptional for snowfalls and avalanches events. A series of storms brought much snow in the first part of the month. Then other two meters of fresh snow fell from 7<sup>th</sup> to 9<sup>th</sup> of January with strong SE winds, mild temperatures and groupel snow for storm effects in some valleys. The avalanche danger degree rose to 5-very high in the Gran Paradiso valleys, Lys valley, Ayas and the upper Valtournenche. The valleys most affected by the strong avalanche activity after the great snowfalls were the Gran Paradiso valleys, in particular the valley of Cogne and Valsavarenche that were closed for several days. T

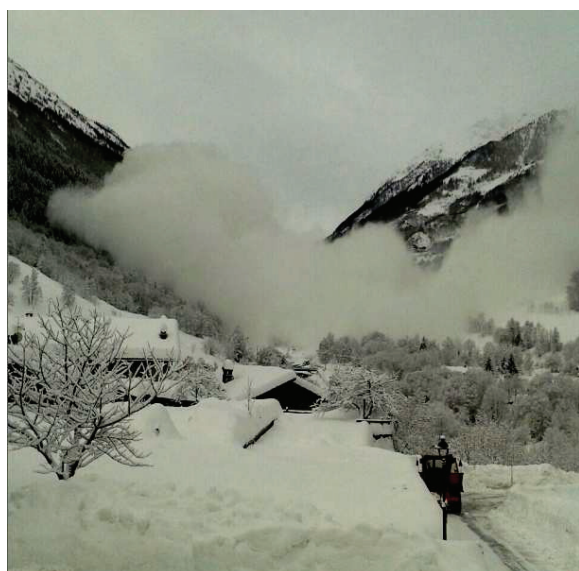
A strong storm brought one meter of fresh snow on the whole Region on the 10<sup>th</sup> of December. Then other snowfalls occurred in December led to high spontaneous avalanche activity that in several cases reached the valley floor and the roads network forcing, in some cases, the Local Avalanche Commissions to close it for some days (fig.2).

Figure 2. A powder avalanche near Rhêmes Saint George on the 14<sup>th</sup> of December.

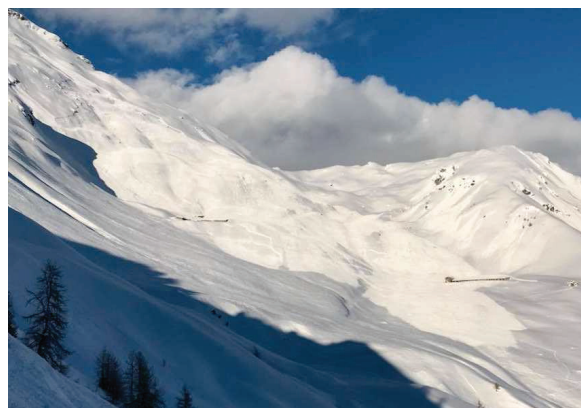
During the morning of January 4<sup>th</sup>, after the snowfalls intensity peak many avalanches, some big, reached the valley floor and in some cases affected roads and infrastructures (fig.3), either the powder cloud and the dense flow.

Figure 3. The Ayas valley on the 4<sup>th</sup> of January: the slab avalanche that damaged the Vascoccia cowshed (Photo: Jean Nicco).

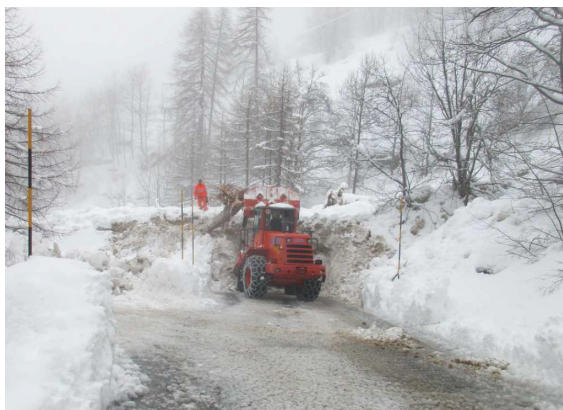
Figure 4. The avalanche that reached the regional road before the village of Dejoz in Valsavarenche on January 9th.

It is very likely that the avalanche that damaged the northern side of the Frassati mountain hut (2556 m a.s.l. - Saint-Rhemy-en-Bosses, G.S.Bernardo Pass) occurred those days. But the avalanche that really got an exceptional magnitude released from the wide south-eastern slopes of Crête-de-l'Aouille (3100 m - Valsavaranche). The avalanche destroyed two high voltage pylons and damaged others (fig.4 e 5).

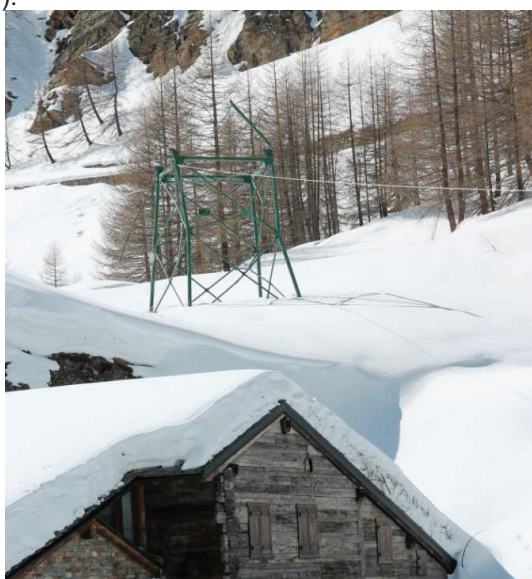
Figure 5. Exceptional avalanche that reached the regional road before the village of Pont in the upper Valsavarenche on January 8<sup>th</sup>. Great damages to high voltage power line and to the woods

The area affected by the powder cloud was 350 m long and 500 m wide.

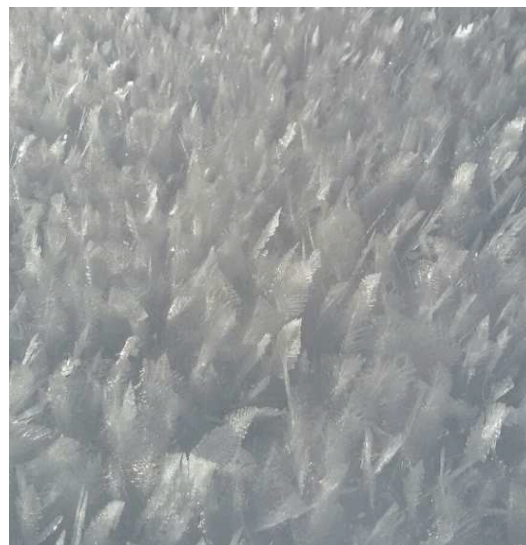
The new snow consolidated pretty fast but the good weather and high percentage of humidity helped the formation of surface hoar (fig.6) in all the Region. Only over 2800 m a.s.l. it was swept away from the wind.

A very beautiful top layer to ski but very dangerous as the new widespread instability for the incoming snowfalls.

Figure 6. Very thick surface hoar.

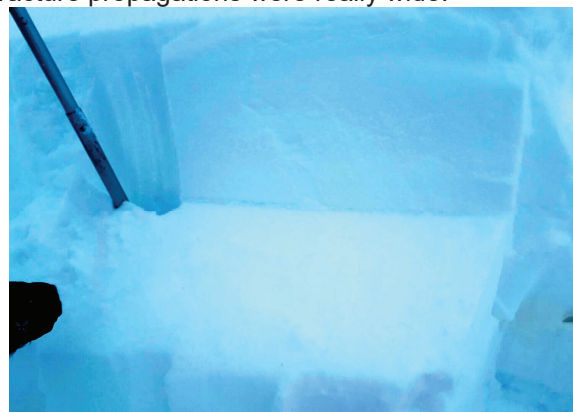
The peaks of snowfall were reported along the border with France and Switzerland. The new snow, reworked from the wind, settled on the very thick buried surface hoar (fig.7) which brought to a great instability. The avalanche danger degree rose to 4-high for avalanche triggering and reported 'persistent weak layer' as typical avalanche situation.

Figure 7. The buried surface hoar.

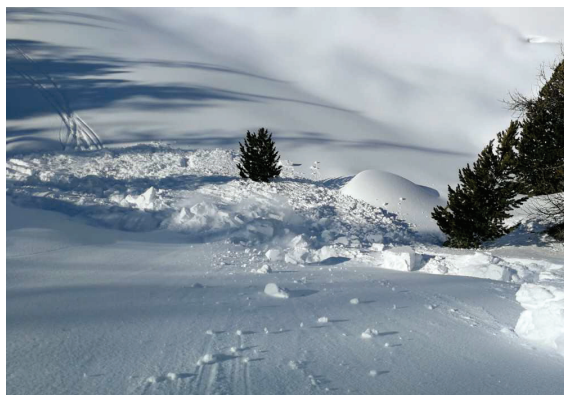
Many triggered slabs (fig.8) reported in the "comfort zones", considered safe by off-piste skiers, such as lee slopes, the forest clearings and slopes not so steep: the ones where the surface hoar were not swept away from the wind. The instability was so high and the weak layer so thick and prone to triggering that the fracture propagations were really wide.

Figure 8. Triggered slab. The slab releases on the buried surface hoar hidden by new wind drifted snow.

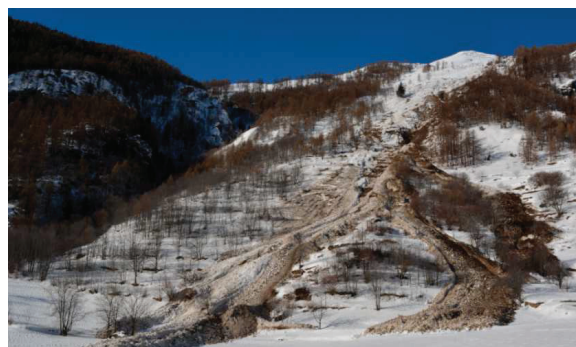
Figure 10. The big and dirty avalanche deposit of Mont Riond (Ollomont).

Fortunately only the forest was involved in this avalanche.

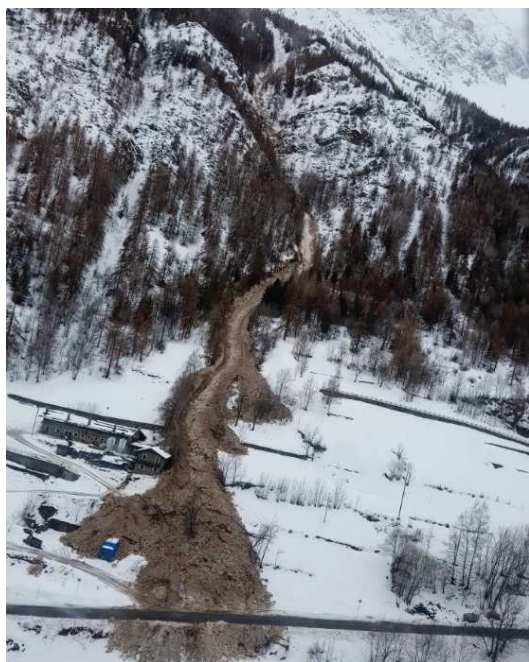
Other big avalanches occurred in Valpelline (fig.12) in those days, with magnitude never seen in the last decades. Many of them overflowed on the regional road. Very big avalanches interested 12 km of the upper Valpelline and neither snow fences could prevent them: 1,5 to 2 m thick slabs released among snow fences.

Figure 12. The avalanche deposit is very close to the house. Oyace, Valpelline.

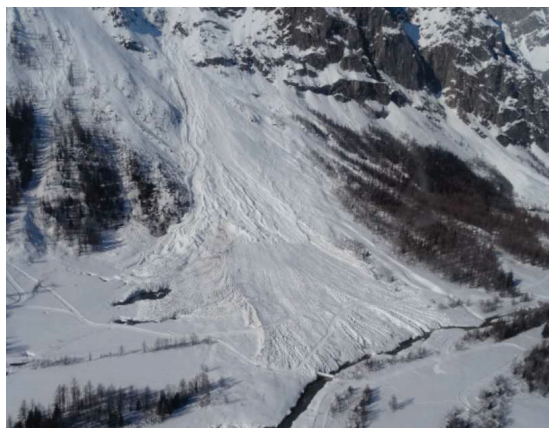
The avalanches that released above 3200 m a.s.l. were really impressive: the "Tronchey" (fig.13) and the "Torrent de Frebougé" avalanches descended on 22<sup>nd</sup> of January and left snow deposits so huge that are still not completely melted.

Figure 13. The Tronchey large avalanche in Val Ferret (Courmayeur).
