SLUSH FLOWS ON HIGHWAY RV80 TO THE CITY OF BODOE, NORTHERN NORWAY

ABSTRACT: RV80 is the main road to Bodoe, the largest city in Nordland County in Northern Norway. The road is one of only two roads to the Bodoe peninsula, and every day more than 3 000 cars travel on the road. About 30 minutes outside the city is Ytre Kistrand, an area with several slush flow paths known to close the road almost every year. Usually the slush flows, a mixture of snow and water, have been small and only causing trouble for traffic without being a great danger to vehicles. In February 2021 everything changed when a contractor on duty for the Norwegian Public Road Administration was killed when a slush flow hit his car and threw it upside down on the railway 10 meters below the road.

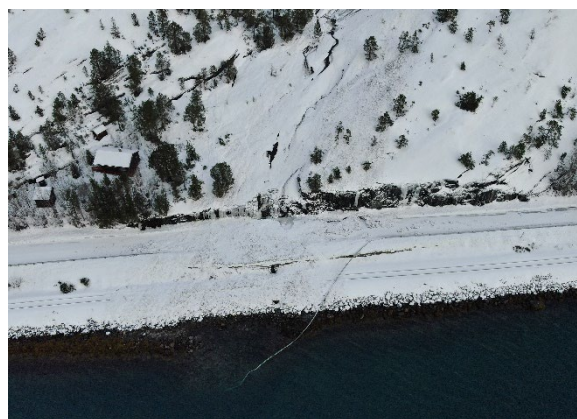
In the early morning on 25 January 2023, almost two years after the tragic accident, new slush flows hit the road. As the last time, the first released in the westernmost path and closed the road. Traffic was trapped in the slush flow-prone area, and a bus was standing in the easternmost path. The snow clearance contractor decided to evacuate the vehicles out of the area and managed to do so just in time for the third slush flow to hit the road.

Figure 2: The slush flow in 2023 was even bigger than in 2021. Photo: Dag Theodor Andreassen

The slush flows were once again triggered by heavy rainfall and a sudden temperature increase after a long cold period, but was even bigger than those in 2021. The quick and determined reaction from the contractor probably prevented another accident by evacuating the vehicles.

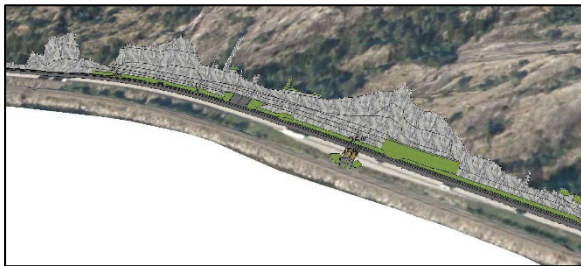
Figure 3: Protective measures will consist of dams blasted into the mountain. Screenshot of 3D-model created by Lars Joergen Sandvik.

The two major events in 2021 and 2023 have pushed the demand for protective measures at Ytre Kistrand. The bare rock slope above and railway and ocean below the road don't leave much room, but the measure consists of blasting into the mountain to create protective dams. The construction starts this fall.
