## AVALANCHE MITIGATION AT LIZARD HEAD PASS

**ABSTRACT:** Lizard Head Pass, a section of State Highway 145 (SH 145) between the towns of Ophir and Rico, located in Southern Colorado, averages 2300 vehicles daily\*. Though this is not a large number as compared to more trafficked highways of Colorado, it is an important thoroughfare for the local population. SH 145 is one of the few routes connecting Interstate 40 and Interstate 70. SH 145 is also the main north/south route for Southwest CO when US 550 over Red Mountain Pass is closed. Many residents of the area work in Telluride and commute over Lizard Head Pass. Throughout the years, there have been various forms of avalanche mitigation techniques including temporary passive avalanche mitigation, helicopter charge deployment, avalauncher, howitzer, hand charges, case charges, and, in 2020, remote avalanche control systems (RACS). This account details the different avalanche mitigation techniques employed and how they have evolved through the decades as well as key avalanche paths on Lizard Head Pass. Historical records of avalanche activity on Lizard Head Pass are taken into account to get a picture of the operation on Lizard Hea

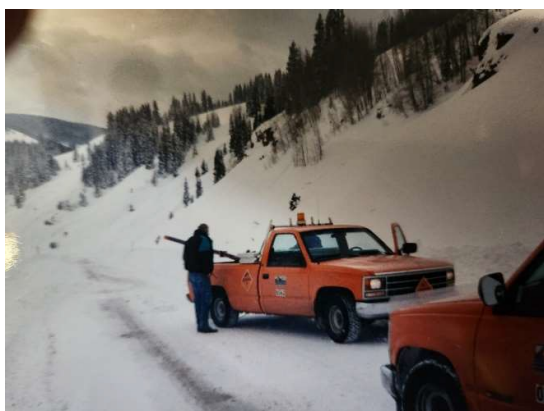
Figure 1: Tray Loaded Avalauncher in use at Lizard Head Pass, 1993, provided by CDOT

In the late 1980s or early 1990s CDOT started to employ the first use of helicopter avalanche control missions in the area. Soon after that the CDOT avalanche mitigation program received a Tray Loaded Avalauncher and then upgraded to a McCracken Avalauncher around 1994 or 1996.

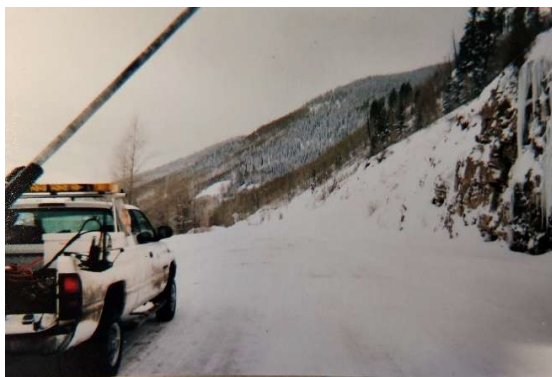
Figure 2: McCracken Avalauncher in use at Lizard Head Pass, 1998, provided by CDOT

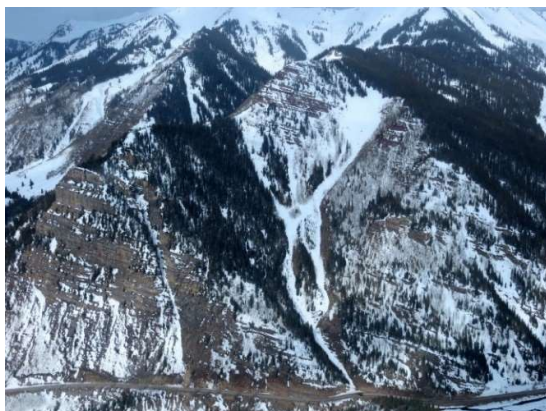
Figure 4: Yellow Springs Wall and Yellow Springs Gully, left side, and Peterson, right side, above SH 145, provided by CDOT

However, the starting zone of the Peterson avalanche path cannot be seen from the road with the exception of the runout zone. Due to the terrain, avalanches get funneled into a tight gully that directly impacts the road. This is the only place for the avalauncher to get a shot at the Peterson start zone. This involved positioning the truck with the avalauncher in this runout zone, shooting the explosive round and then driving the truck out of the way of a potential avalanche. This avalauncher avalanche mitigation technique was in use until 2014.

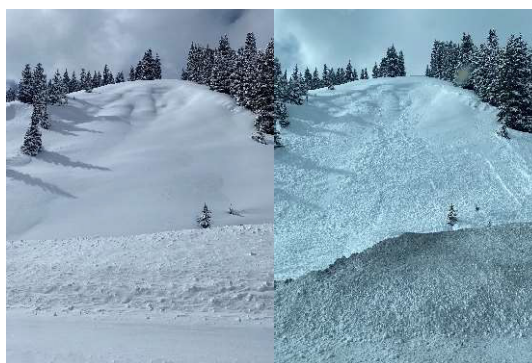
Figure 5: Avalanche Control with Case Charge on Snow Spur Northwest, 2023

Case Charge and hand charges are also used to mitigate avalanches at Lizard Head Pass. There is a record of a hand charge used on 9 February 1993 on the Peterson producing a soft slab avalanche.

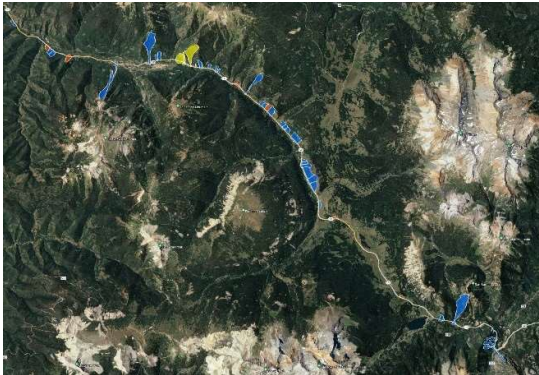
Figure 7: Avalanche paths on Lizard Head Pass, provided by CDOT

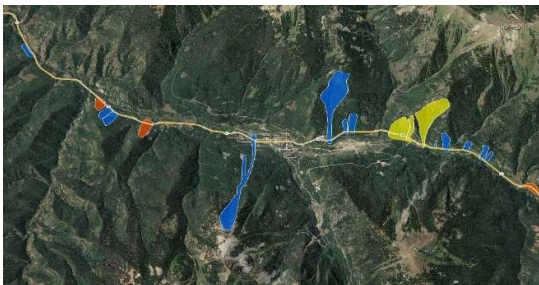
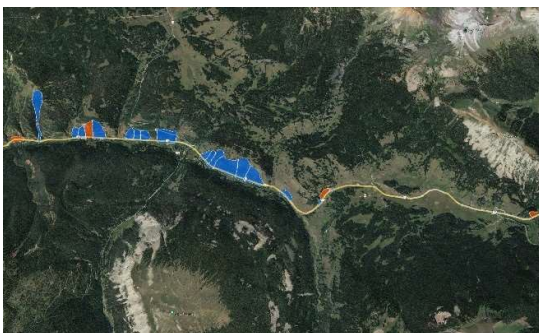
Figure 8: Zoomed in view of avalanche paths on Lizard Head Pass, provided by CDOT

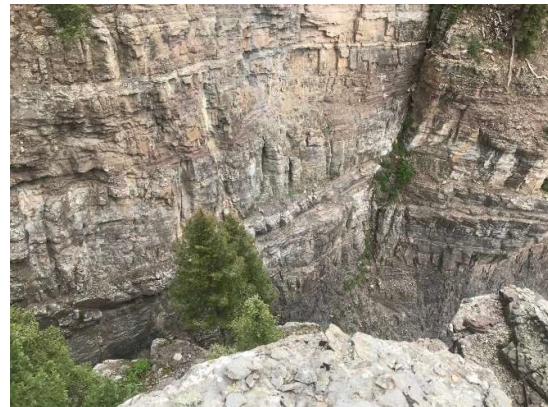
Figure 9: Yellow Springs Gully

Software like Google Earth and QGIS are powerful tools for analyzing terrain, however, setting foot in the starting zone is needed to determine final RACS locations and can expose terrain features unnoticed by digital mapping methods. For example, it was found that Yellow Springs Gully, which looked like an insignificant feature from photos and Google Earth was a significant gully with walls around 300 feet tall.

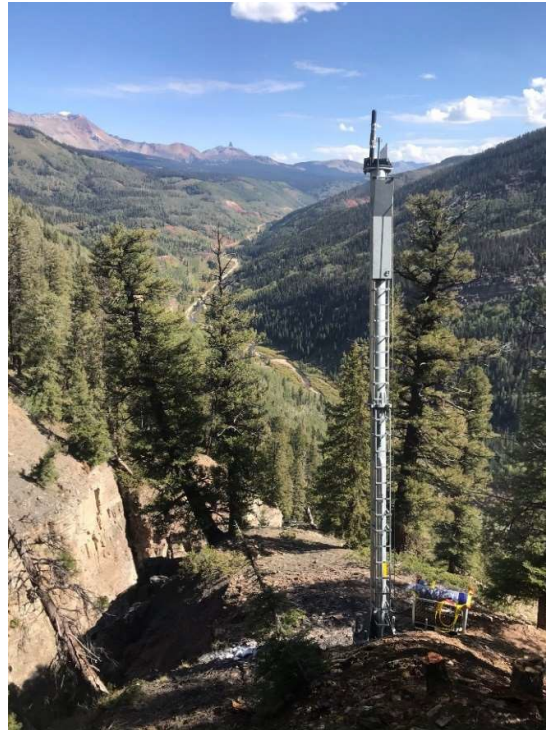
Figure 12: Yellow Springs Gully tower after construction was complete

Construction of the tower foundations began in August of 2020 and was completed in mid-September 2020. The final step was charge assembly and loading and then flying the deployment

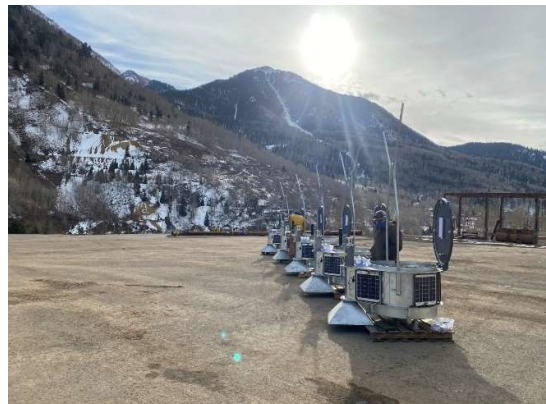
Figure 13: Wyssen Avalanche Tower Deployment Boxes being loaded for the winter season

boxes to the towers. This occurred mid-November 2020 and the Wyssen Avalanche Towers were ready for the winter season. This was the first installation of Wyssen Avalanche Towers in the state of Colorado.

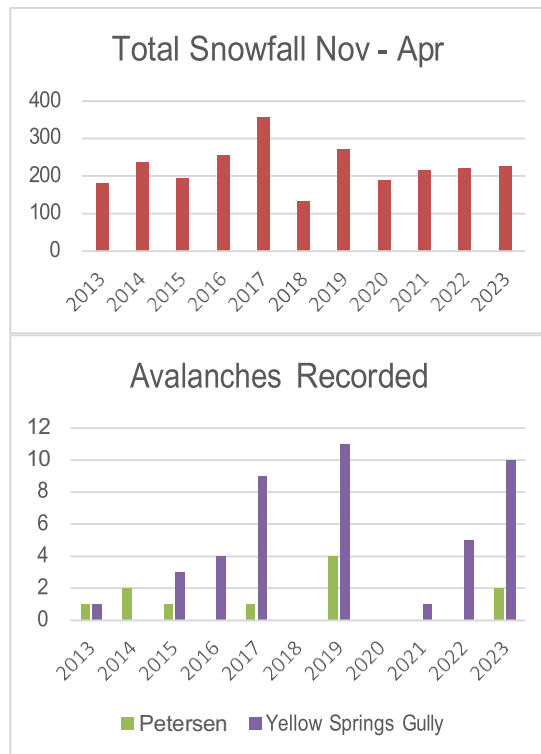
Figure 16: Total Snow Depth Recorded on Lizard Head Pass as compared to avalanches recorded for the Peterson and Yellow Springs Gully

Comparing the snowfall totals throughout recent years as compared to avalanches per season, the snowfall totals roughly relate to the number of avalanches recorded. But there are many other factors that influence avalanche occurrence in a year besides only the total snowfall. A lack of data prevents further research for this account. See Figure 16 for a comparison of total snowfall per avalanche year and avalanches recorded.
