CULTURAL HERITAGE IN A SITE IMPACTED BY AN EXCEPTIONAL SNOW-AVALANCHE A FEW DECADES AGO: WHAT TO DO? A TENTATIVE EXAMPLE IN SVANETI, GEORGIA

ABSTRACT: In 1987, Upper Svaneti in the Georgian Caucasus faced an exceptional meteorological phenomenon, which was a mix of snow and rain and caused catastrophic avalanches. Several villages were impacted with many houses made uninhabitable, dozens of victims and ultimately these villages and hamlets abandoned. Unfortunately, a fairly classic scenario for avalanche disasters. Except that Upper Svaneti also represents a major cultural and historical heritage, recognized internationally by UNESCO thanks to its famous Svan Towers, and is particularly important for the state of Georgia.

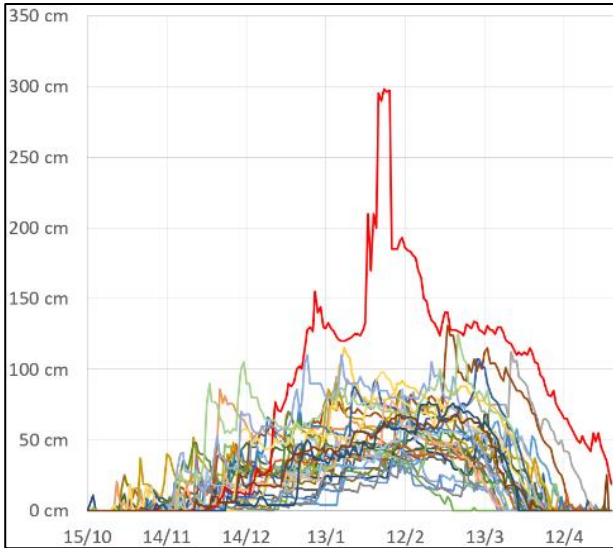
Figure 3 : Seasonal snowpack height at 1448 m asl showing the exceptional situation of winter 1986-87 (in red) – other curves cover the 1960-1992 period – source: Georgian National Environmental Agency

Though this hamlet was already impacted in 1976 within “normal” snow conditions, 1987 sequence was totally exceptional in term of snow and weather conditions (Figure 3). According to official statements, conditions at that time started with an unusually powerful persistent anticyclone above the European part of USSR, which caused strong/rapid re-cooling of air and blocked the common way of Atlantic cyclones to the Caucasus. Relatively warm and over-moistening air masses rushed to Georgia from south-west. South slopes of Great Caucasus became the barriers for them to induce cool and warm air masses collision and so heavy snowfalls, typical of the “pole of precipitation and snowiness” (Troshkina et al., 2001).

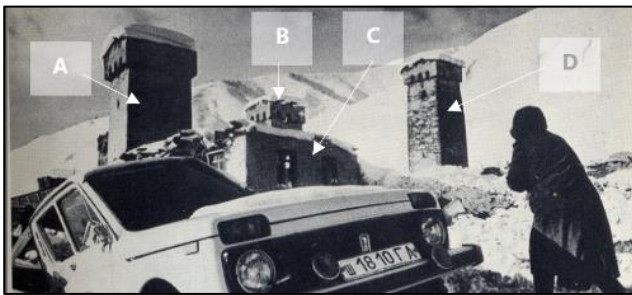
Figure 4 : Historical picture of 1987 main avalanche from south-facing slopes (top) and identification of visible elements on a recent picture (bottom) (red circle: tower top damaged after 1987 avalanche impact, still standing in 2018 but now collapsed)

(Few) pictures at that time and TV report footages (Figure 4 & Figure 5) allowed to draw this 1987 main avalanche outline (Figure 6) inside the village. This limit is uncertain due to the fact that the avalanche flow interacted with more or less resistant buildings which partly stopped the still moving flow and that some building outside of the main urban area were reached but not fully destroyed (like J on Figure 5). A back-analysis on the damages showed that the event was mainly a cold dry flowing avalanche, surely including a suspension layer. The main cause of destruction was related to the core layer.

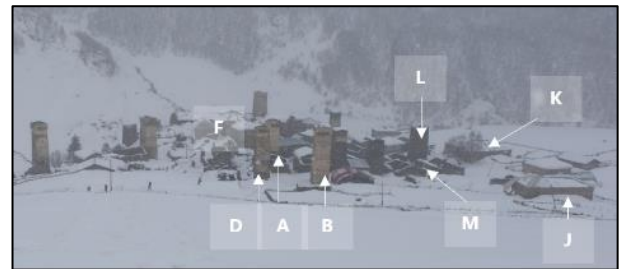
Figure 5 : TV footage of 1987 avalanche rescue (top) and identification of visible elements on recent pictures (right) [2]

What is noticeable is that most uphill buildings which resisted in 1987 (or seemed to, J and uphill to B on Figure 5) are situated exactly between these flow path in low intensity zones: they were undamaged not because of their resistance but more obviously thanks to their "lucky" location as naturally outside the main flows.

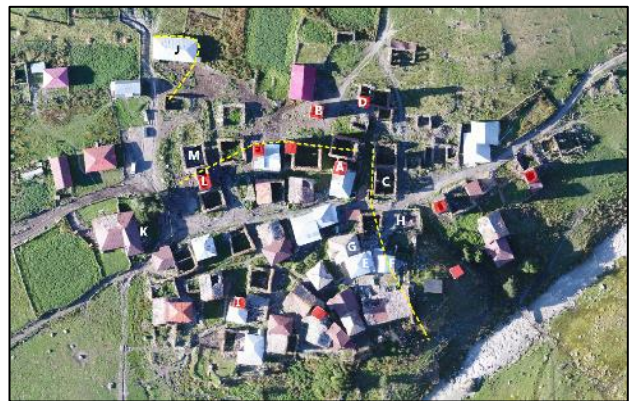
Figure 6 : Location of 1987 main destruction limits inside the village (yellow dashes) from south-facing slopes avalanche – current towers appear in red.

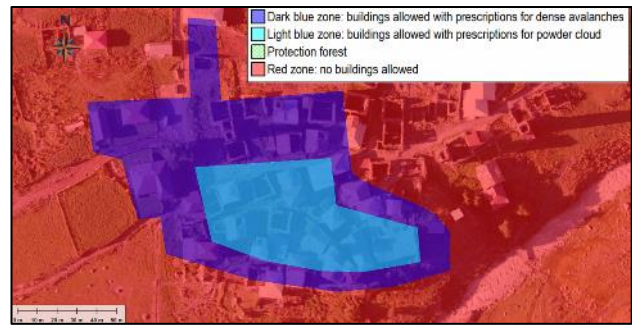
Figure 8 : Hazard zoning of Murkmeli in the current situation (no protection) by reference to 1987 event where relevant

Based on previous analyses, next figure shows the hazard zoning corresponding to the current situation regarding a reference scenario like 1987 avalanche and based on a simple approach: the red zone indicates the area where a building gets completely destroyed in case of such event whereas the blue zone indicates the area where a building gets “only” damaged. Here, the red zone covers most of the ruins but also many towers and some inhabited houses. Several inhabited houses are located within the blue zone (Dark/purple for dense flows, light for powder cloud) but are surely not reinforced consistently.

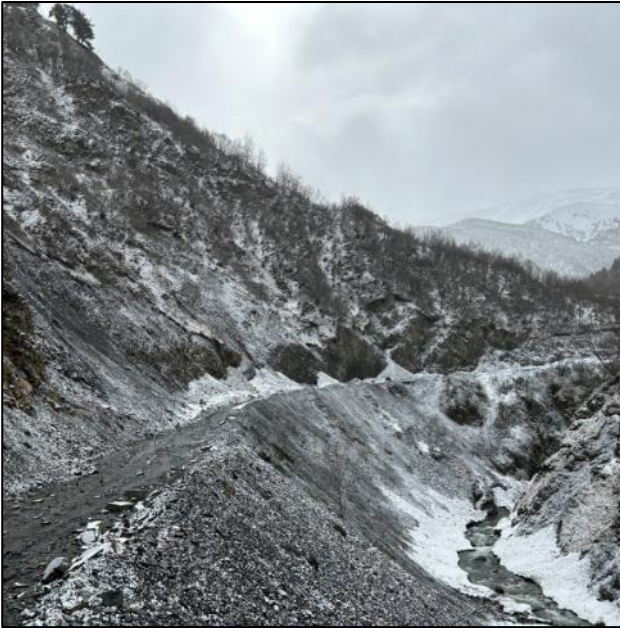
Figure 14 : Typical section of the only road access to Ushguli Upper Svaneti valley.

- Because all these efforts would be nothing without a reliable (and so sufficiently safe) access, previous goals are possible only if a deep analysis is also initiated regarding the road general improvement and/or alternatives: for now, it is sometimes classified among the most threatening road (or track) in the World (Figure 14). This shall be fully consistent with the high-level quality of Ushguli cultural heritage.

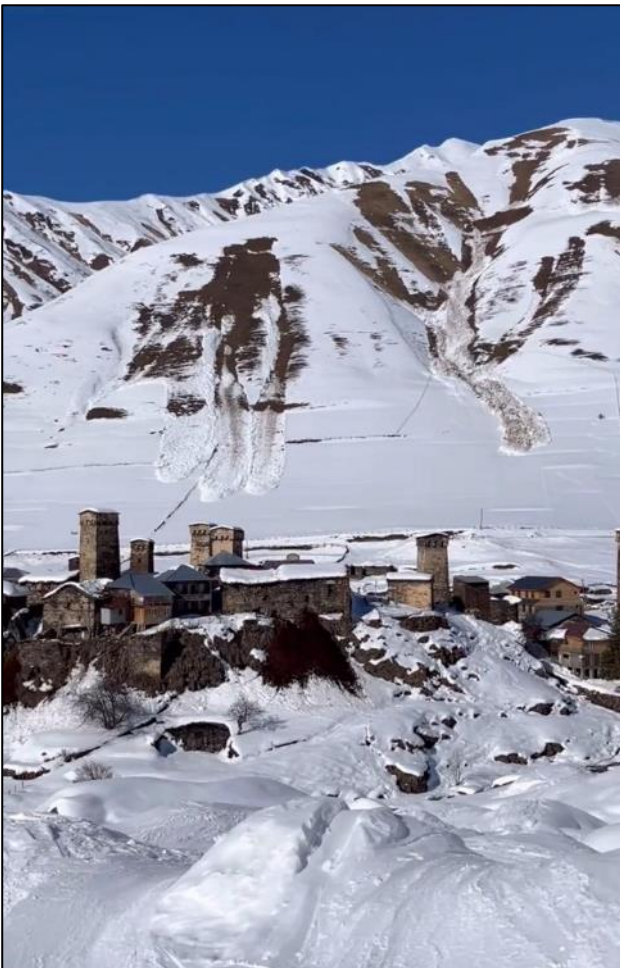
Figure 15 : One of the last remarkable avalanches in the north slopes above Murkmeli in February 2024.

At this stage, it is also important to underline that all three avalanche paths (south and north-western lateral valleys and north slopes) present like a “threshold behavior”: they normally stop far from the village but in extreme snow conditions, they can generate huge events: it is not a progressive process and the protection strategy has also to take this into account. For instance, designing protections regarding short return period avalanches would make mainly no sense as corresponding avalanches would even not reach them. About that, it has also to be kept in mind that no dangerous avalanches have occurred since 1987.
