LESSONS FROM SEVERAL AVALANCHES IMPACTING AVALANCHE PROTECTIVE STRUCTURES IN ICELAND IN JANUARY 2020 AND MARCH 2023

ABSTRACT: Seven snow avalanches from two recent avalanche cycles in Iceland, that interacted with snow supporting structures, braking mounds, deflecting dams and catching dams, provide empirical data about the effectiveness of avalanche protective structures. Observations of the avalanches also provide important indications about rest risk in protected settlements. One of the cycles occurred at Flateyri, NW-Iceland, in January 2020. The settlement at Flateyri is protected with two 14–20-m-high deflecting dams with an upstream slope of 40°, and a 10-m-high catching dam, built from un-reinforced loose materials. Field observations at Flateyri indicate that the dense core of the avalanches was preceded by a rapidly-moving fluidized front, which overflowed the dams, damaged cars and buildings, and buried a person in snow in her bedroom. The dense core of both avalanches was deflected away from the settlement. The dams channelled the dense core into thick, powerful streams along the dams, and this part of one of the avalanches caused great destruction in the harbour of th

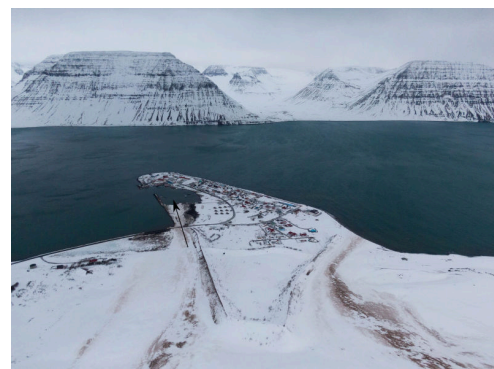
Figure 3: The run-out areas of the snow avalanches from Innra-Bæjargil (right) and Skollahvilft (left) gullies at Flateyri on 14 January 2020. Photo: Haukur Sigurðsson, 19 January 2020.

Field observations indicated a distinct difference in the avalanche deposits above and below the deflecting dams. The snow in the deposits on the upstream side was more coarse-grained and dirtier than the snow on the downstream side, which appeared cleaner and with smaller grains and was less dense than the snow on the upstream side (the average density of the deposits on the upstream side was 495 kg/m^3 whereas the average density on the downstream side was 415 kg/m^3 , see Fig. 2). The snow on the downstream side contained some twigs and branches broken from trees and shrubs over-run by the avalanches whereas the snow on the upstream side contained a substantial amount of debris that created a distinct colouring with an indication of streaklines in the flow of the dense core along

the upstream side of the dams, which was entirely absent in the avalanche deposit on the downstream side, see Fig. 3.

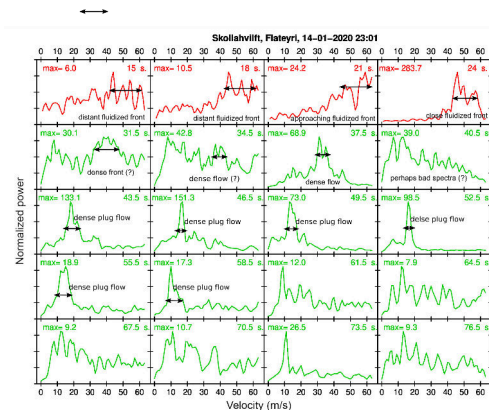
Figure 4: FMCW radar spectra from the snow avalanche from Skollahvilft at Flateyri on 14 January 2020. Red curves are measurements from the upper antenna, green curves are measurements from the lower antenna. Arrows and labels indicate an interpretation of the radar time series in terms of the fluidized front and the dense core of the avalanche.

An FMCW radar with two antennae from the Swiss company AlpuG was operating on the Skollahvilft dam when the avalanches occurred, see map on Fig. 2. The spectra measured by the radar are shown in Fig. 4. The upper radar (red curves) only recorded a few measurements before the fluidized front hit the dam and broke the upper radar mast. The distinct fluctuations in the upper radar reflective power with velocity as the avalanche approaches the radar, as evidenced by the increasing maximum power from frame to frame, may perhaps be interpreted as resulting from mesoscale coherent structures within the fluidized front (Sovilla et al.,

2018). This measurement indicates flow velocity of the fluidized front preceding the dense core in the range 45–60 m/s. The lower radar (green curves) appears to measure the slower dense core travelling towards the dam at 35–45 m/s, arriving perhaps 6–10 s. later within the ca. 500 m detecting range of the lower radar than the fluidized front at the upper radar, which indicates that the fluidized front preceded the dense core by several hundred metres. Subsequently, the dense core flowed more-or-less as plug flow with gradually decreasing velocity along the dam for >15 s.

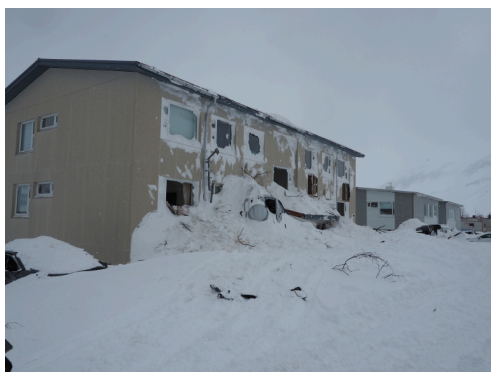
Figure 6: Apartment building below the Nesgöl avalanche path in Neskaupstaður hit by a snow avalanche on 27 March 2023. Photo: Ragnar H. Prastarson, 28 March 2023.

Nesgil and Bakkagil: The avalanche from Nesgil reached into the settlement and caused severe damage, while the slightly shorter avalanche from Bakkagil stopped just above the settlement. Windows and doors were broken in an apartment building and some snow flowed into the building (Figure 6). The residents had to be rescued out of the building, and some suffered minor injuries due to broken glass from windows. Cars were thrown around and roofs and walls of some single-family houses were damaged. Field observations indicate that it was the fluidized front of the avalanche that reached the settlement, and that the dense core stopped about 100 m above the uppermost buildings, although a distinction between deposit types was not as obvious as in the Flateyri 2020 avalanches. The Nesgil avalanche broke and uprooted many trees in a reforestation area between Drangagil and Nesgil and uprooted large boulders from the ground, some of which were carried hundreds of metres with the flow. The crown of the avalanches was at ca. 700 m a.s.l., near the top of the mountain.

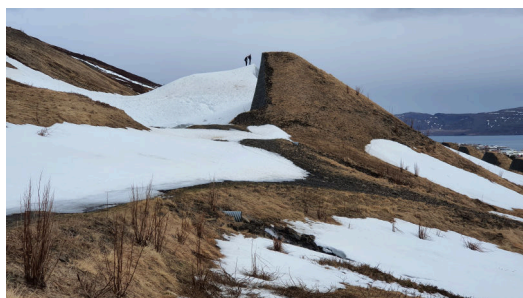
Figure 7: Snow deposit by a braking mound below the Innra-Tröllagil avalanche path in Neskaupstaður from an avalanche on 30 March 2023. Photo: Sveinn Brynjólfsson, 12 April 2023.

Innra-Tröllagil: An avalanche from Innra-Tröllagil on 30 March impacted the upper row of braking mounds below the gully and deposited thick snow by two mounds, see Figs. 5 and 7.
