ALPS2.0: INTERACTION OF FLEXIBLE ROCKFALL BARRIERS WITH STATIC AND DYNAMIC SNOW PRESSURE

ABSTRACT: Due to the demand for protection systems with a design on the combined load case rockfall and snow pressure, a research project is enrolled for the better understanding of the load distribution in rockfall barriers which are exposed to snow load. Static snowpack forces and dynamic snow slide pressures act over a much larger area and over longer time periods, compared to dynamic rockfall events. Since rockfall barriers are not primarily designed for the former load case, they often must be adapted if a certain snow load is expected. To obtain a first semi-quantitative understanding of the interaction and performance of rockfall barriers with snow pressure and snow slides, a case study has been performed from 2003-2006 in Fieberbrunn, Austria. This resulted in a first design concept, which is still widely used today (Margreth & Roth, 2008). The aim of the measurement campaign in the winter 2023/24 is to verify the findings of the first project, to apply those for different types of rockfall barriers and to determine a fully quantitative load distribution for a given snow load. Four bar

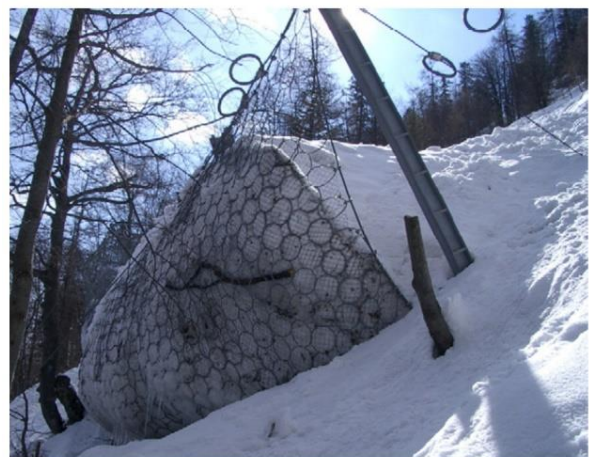
Figure 1: Rockfall barrier in Fieberbrunn, Austria, on April 15, 2004 (Margreth & Roth, 2008)

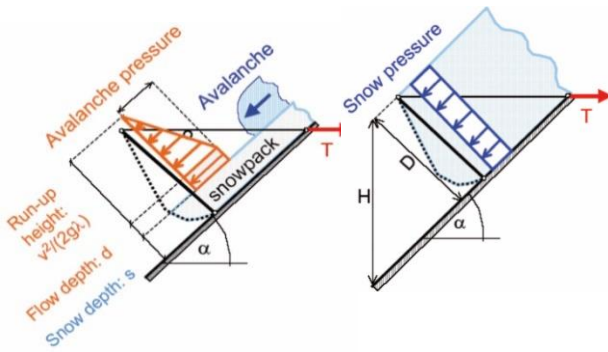
Fig. 2: Design concept of rockfall barrier with load distribution of avalanche impact (left) and snow pressure (right). The tension force T in the retaining rope is calculated by taking the moment at the hinge of the post. (Margreth & Roth, 2008)

In 2003-2006, a semi-quantitative study was carried out to determine the snow loads and to optimize the systems so that they can absorb static snow pressure loads without damage. The tests have confirmed that rockfall barriers are generally capable of stopping snow slides. The reaction of the barriers to the local snow loads in terms of net deflection and damage was investigated at several locations, such as Fieberbrunn, Austria, see Fig. 1. This resulted in a first design concept, which is still widely used today. The scheme is shown in Fig. 2. However, the loads were not

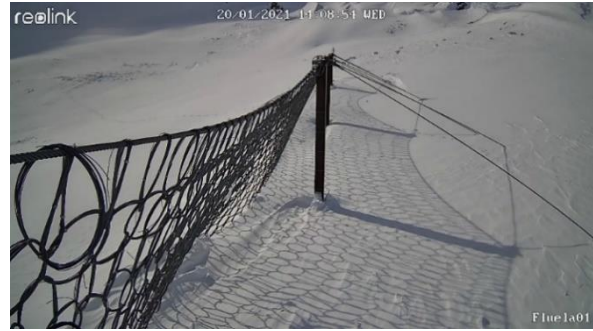
Fig. 3: Snow filled rockfall barrier at Chant Sura in January 2021.

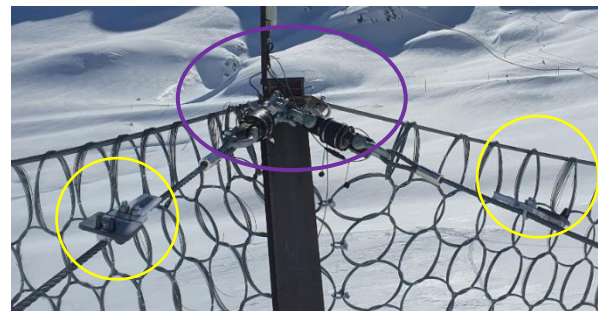
Fig. 8: Rockfall barrier at Chant Sura. Retaining ropes equipped with GUARDs (yellow) and "MicroStrains" (purple).

The weather conditions in high alpine locations over the winter can be very challenging for the force measuring instruments. To validate the measured tension forces, the results of the GUARDs are confirmed in Chant Sura by mounting load cells ("MicroStrains") combined with a 3-channel wireless sensor to the same ropes during the same period, see Figure 8. The rope forces are measured three times per day and the results are transmitted online. Besides to the rope forces, side bracing forces and post forces at post 5 and 7 are measured.

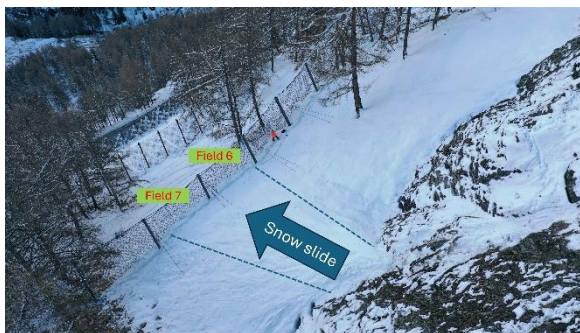
Fig. 9: Rockfall barrier at Arolla on March 7, 2024 with recorded snow slide in field 6 and 7.

The snow conditions varied greatly depending on the location. In Felbertauern, a below-average amount of snow was recorded, while in Arolla a snow depth of just over 1m was measured in March 2024, which corresponds to the long-term average in the region (SLF, 2024a). Minimum one snow slide with a thickness of almost 2 m and a width of 8 m was recorded in fields 6 and 7, as

shown in Fig. 9. The mean snow density over the snow profile in field 6 was 320 kg/m^3 .

No snow slides were detected at the Felbertauern site in winter 2023/2024 due to the poor local snow conditions. In Arolla, smaller accelerations of the suspension cables of up to 10g were detected, but they could not be unequivocally attributed to snow slides. The inspection on March 7 revealed a landslide wedge between fields 6 and 7 with a catchment area in the rock face above the barrier, see Figure 9.

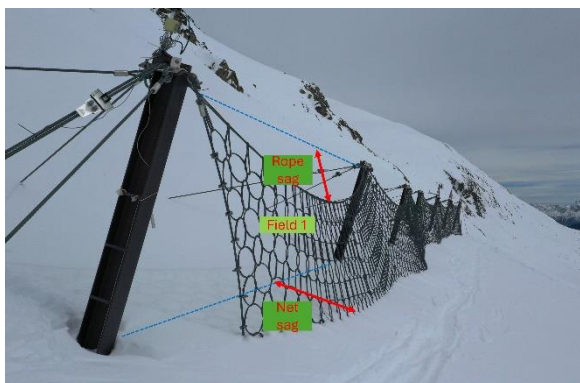
Fig. 10: Rockfall barrier at Chant Sura on April 4, 2024 with recorded rope and net sag in field 1.

During the winter of 2023/2024, above-average snow depths were recorded in the region of Chant Sura (SLF, 2024b) and Rosalba (SLF, 2024c). In the beginning of April, the snow height in Chant Sura was approximately 2.50 m, leading to a half-filling of the barrier (see Fig. 10). The flexible interaction between load bearing and reaction in the form of net and rope sag is clearly visible. The mean snow density over the snow profile in field 1 was 370 kg/m^3 .

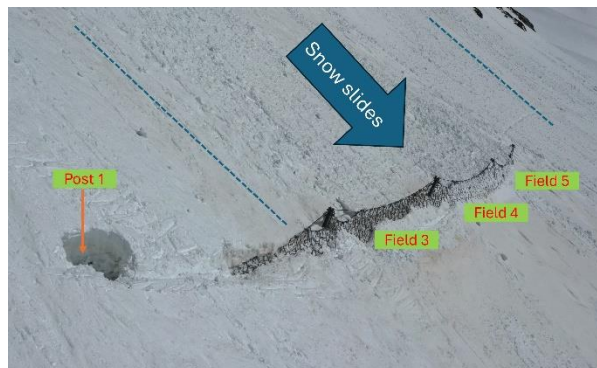
Fig. 11: Rockfall barrier at Rosalba on April 11, 2024 with overtopped post 1 and recorded snow slides in fields 3 to 5.

In Rosalba, the barrier was completely filled by snow in April 2024, as shown in Fig. 11. The snow cover even overtopped post 1 by 1.60 m. This corresponds to a punctual perpendicular snow depth of almost 6 m. Furthermore, this location is highly exposed to snow slides; several snow slides were recorded by the GUARD sensors (see Chapter 6 *Results*). The mean snow density over the snow profile in field 1 was 410 kg/m^3 .

The events after the field inspection in April 2024 were proven beyond doubt to be snow slides. During the field inspection itself, 5 major snow slides were documented, which overflowed the barrier, as the snow depth had already reached the barrier height (see Figure 11). On May 1, a rope acceleration of approximately 26g was measured at the upslope anchor rope on field 2,

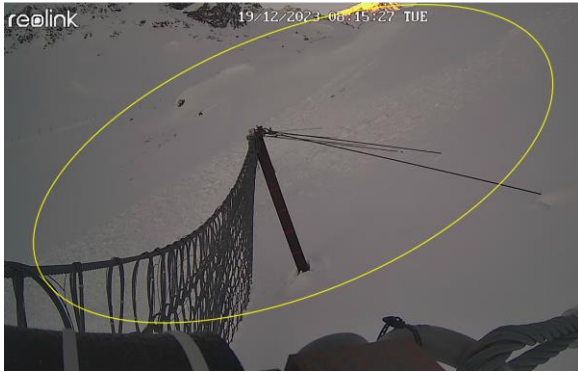
Fig. 12: Recorded snow slide on field 1 on December 19, 2023, at Chant Sura by the real-time monitoring camera "Reolink".

These could be clearly classified as snow slides as they were recorded on the camera, see Figure 12 and 13. No further events could clearly be linked to snow slides at the barrier after the end of January 2024.

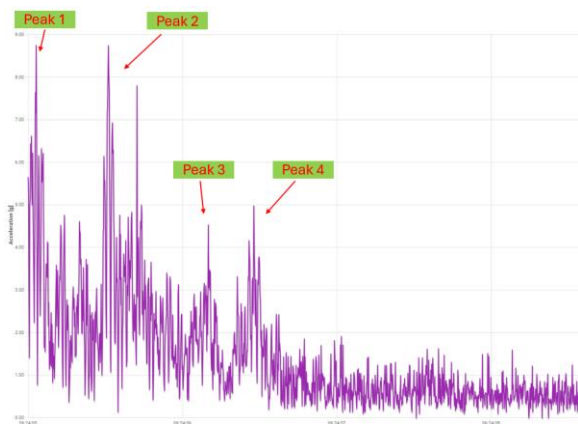
Fig. 13: Corresponding response spectrum of the GUARD's accelerometer at the top support rope to the snow slide on December 19, 2023, in Chant Sura with two main peaks with 9g at the beginning with the main slide, followed by two smaller snow slides around 5g (peaks 3 and 4).

see Figure 14. By restraining the rope in the high snow cover, the oscillation of the rope is immediately prevented, in comparison to Figure 13, with the rope half-restrained.

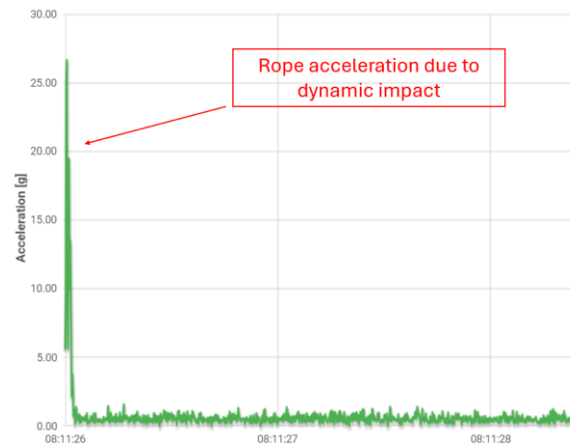
Fig. 14: Response spectrum of the GUARD's accelerometer to the snow slide on May 1, 2024, in Rosalba. The short oscillation time can be explained by the extreme snow height provoking a dampening.

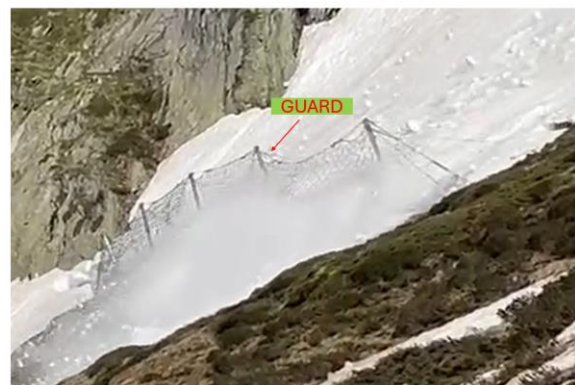
Fig. 15: Documented avalanche impact on the rockfall barrier on June 11, 2024, in Rosalba with highlighted GUARD mounted on the upslope anchor rope.

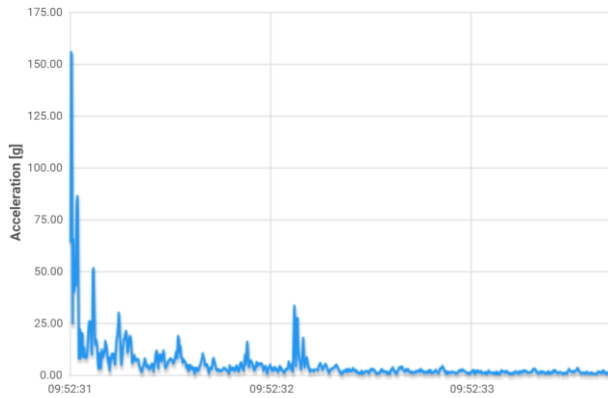
Fig. 16: Corresponding response spectrum of the GUARD's accelerometer to the avalanche impact on June 11, 2024, in Rosalba.

In addition, controlled blasting was triggered by the cantonal road authority above the barrier on June 11 to be able to open the pass road a few days later. A total of four blasts were carried out. All the avalanches triggered by the blasting triggered an acceleration in the ropes of the rockfall barrier and thus a GUARD notification. The explosions were documented on video by the cantonal road authority of Ticino, see Figure 15. A resulting maximum acceleration of 155 g was measured on the upslope anchor rope on field 4 during the resulting avalanche impact, see Figure 16.

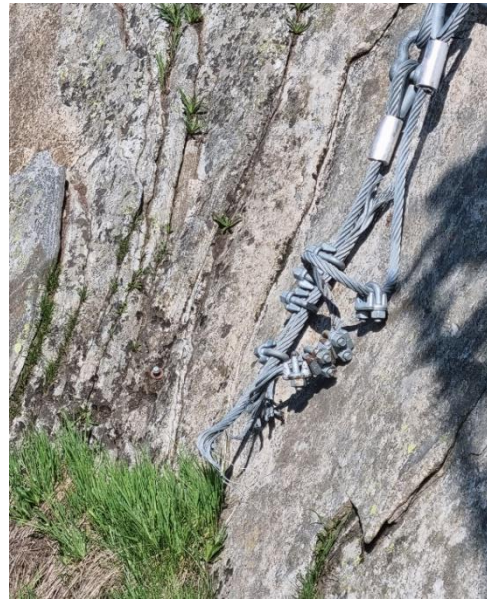
Fig. 17: Broken top support rope at rock connection on July 15, 2024, in Rosalba.

It was found that the rope forces in the upper suspension rope are in some cases significantly greater than in the bottom suspension rope. This can also be seen qualitatively in the torn upper suspension rope in Rosalba. First results from Chant Sura confirm these findings. The decisive load on the upper suspension rope is derived from the net sag due to snow filling. In addition, the forces in the bottom suspension rope are reduced by soil friction. At Chant Sura, the retention ropes show similar tension forces as the bottom suspension rope. These findings need to be validated in further investigations and research.

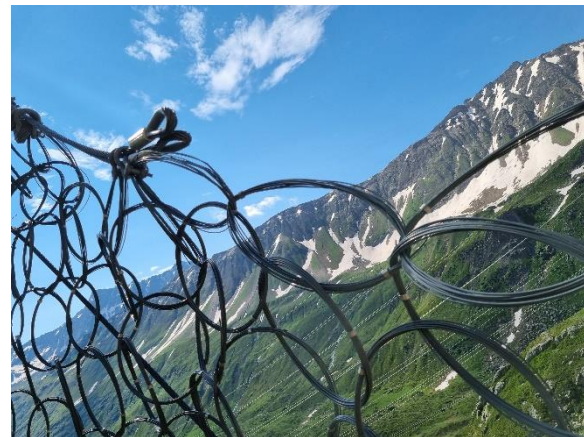
Fig. 18: Plastically deformed ring net close to top support rope on July 15, 2024, in Rosalba.

No summer inspection was carried out in Felbertauern as no significant load case was documented over the winter 2023/24. No major damage was found at Arolla and Chant Sura after the winter of 2023/24. At most, the retaining ropes would have to be tightened here. The barrier in Rosalba was exposed to an overload case and was therefore examined in detail in July 2024. It was found that the upper suspension rope at the rock connection had broken, see Figure 17. The ropes were also partially running, probably due to insufficiently tightened wire rope clips. In addition, the anchor head of the upper suspension rope was bent. The spiral rope anchors of the retaining ropes were exposed by 10-70 cm depending on their position due to the high snow pressure load. In addition, most of the anchored logs above the barrier failed due to the high snow load; one anchored log failed completely and was transported into the barrier. It can be assumed that the snow pressure load on the barrier has also increased due to the failed anchored logs. It is interesting to note that the rings close to the upper suspension ropes remained in the plastic range, contrarily to those close to the lower suspension rope, as shown in Figure 18. Together with the damage pattern of the upper suspension ropes, this suggests that the snow forces were maximum at the height of the upper suspension rope and lower down into the elastic range. For the next winter, it is recommended to replace the damaged ropes and brakes at the rock connection, to re-tension the suspension ropes, to reposition the running cables and to reinforce the uphill anchorages with concrete foundations, see Figure 19. All in all, it appears that the barrier overcame the winter quite well despite the overload case and is fully operational again after the refurbishment.

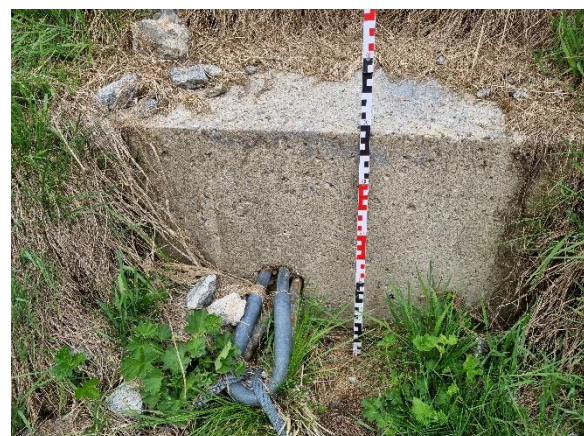
Fig. 19: Proposed uphill concrete anchorage solution for Rosalba.
