AVALANCHE HAZARD MANAGEMENT AT THE EAST TOBA RIVER AND MONTROSE CREEK
HYDROELECTRIC PROJECT, SOUTH COAST RANGE, BRITISH COLUMBIA

Alan Jones*, Chris Stethem, Kevin Fogolin
Chris Stethem & Associates Ltd., Revelstoke, British Columbia

KEYWORDS: Hydroelectric, avalanche hazard, mitigation, deflection berm.

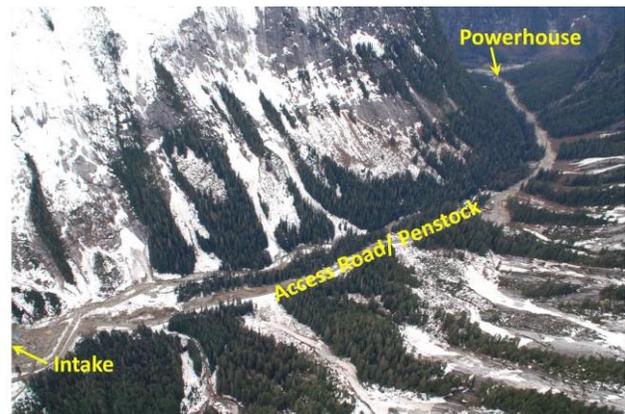
Fig. 3. Looking west down the Montrose Creek Valley towards Filer Creek and Powerhouse. Intake site is off left-hand side of photo.

The Montrose Intake is located at 520 m elevation in the Montrose valley, 4.4 km northeast of the powerhouse which is at 49 m elevation (Fig. 3). The Montrose Intake is affected by two large avalanche paths: MS-6 and MS-5 (Fig. 4). Path MS-6 is the largest path in the valley and, based on observations during 2006-2010, reaches the valley bottom at least once to several times

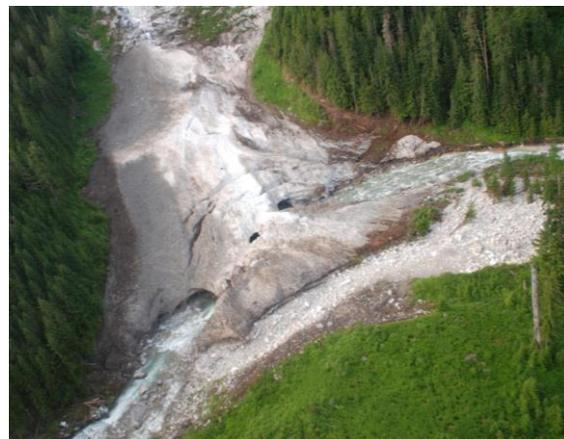
Fig. 5. Montrose Intake and Path MS-6, May 2008 avalanche event (Jun. 26, 2008 Photo). Deposit blocked Montrose Creek with a thickness up to 20 m which persisted well through the summer.

Of the four observed natural Size 3.5 to 4 avalanches from MS-6, the 2008 event was most destructive (Fig. 5). Even though the 2008 event had a smaller volume estimate than the 2007 and 2009 avalanches, the avalanche had a higher destructive potential due to a break-out flood which followed. The interpreted return period for this event was estimated around 30 years. This is evidenced by the resulting tree damage and scouring of material at the distal edge of the avalanche deposit.

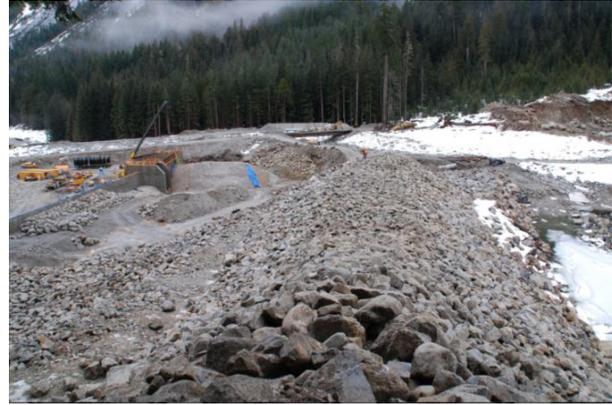
Fig. 7. Deflection berm at Montrose Intake. Photo taken looking north down the length of the berm, intake shown at left near the crane.

Initial impact pressure estimates at the intake were deemed sufficiently high to require modification of the intake design to reduce the impact pressures. The structure was moved both in location (i.e. downstream) and orientation (i.e. reduced angle of incidence) to the main avalanche flow from MS-6. A 15 m high by 120 m long earth fill and rock armoured deflection berm was constructed at the toe of MS-6 (Figs. 7, 8). These revisions greatly reduced the forces at the intake.

The berm was designed so that avalanches with return periods of 30 years or more could overtop the berm and continue onto the intake structure. The intent was to keep the more frequent (i.e. 1-10 year) avalanche deposits clear of the head-pond while allowing less frequent 30-100 year events to impact the intake which was designed to withstand the potential impact pressures and considered an acceptable risk.

Consideration was also given to the potential for avalanches to wrap around the end of the berm and reach the intake, again with consideration of the 30-year or greater avalanche.

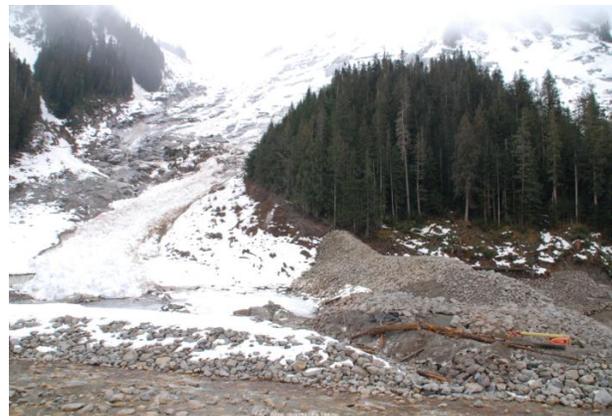
Fig. 8. Nearly completed deflection berm shown at right, Size 3 deposit shown in path at left for scale.

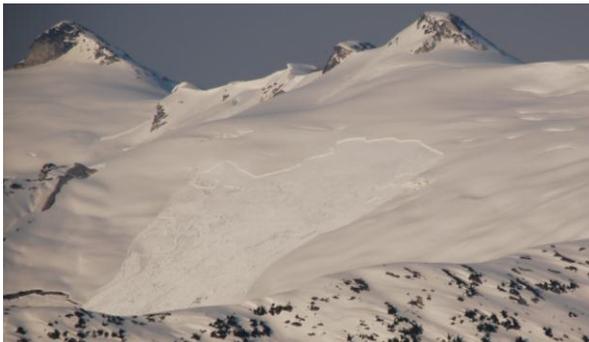
Fig. 10. The season ending slab avalanche on June 2, 2009 which opened the Montrose Intake site for construction. Slab is 2.5-3 m thick.

A Size 4 avalanche was triggered June 2, 2009 during explosive avalanche control. The avalanche had a crown depth averaging 2.5-3 m and temporarily blocked flow in Montrose Creek.

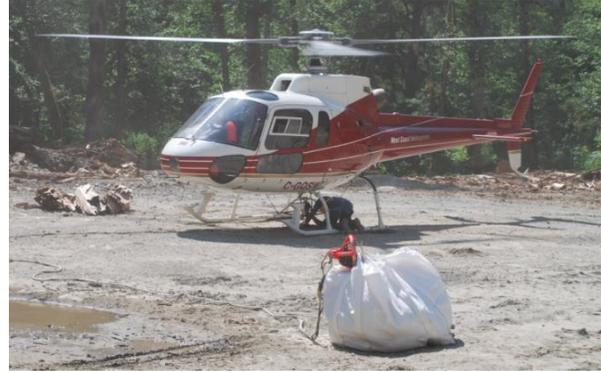
Fig. 11. 16 unprimed 25 kg ANFO bags ready for sling loading into the bomb crater.

Montrose Access Road for the summer. A monitoring and control program was conducted during April-June 2009 to reduce the hazard. Extensive avalanche control on the bedrock slab starting zones above the access road allowed the road to be opened for construction in May. However, the intake site which was below the largest path (MS-6) was closed until June 2 due to the presence of deep slabs with a persistent weak layer from December buried 2.5-3 m deep. This layer was difficult to trigger and large charges were required to trigger the large, season ending avalanche in the MS-6 path (Fig. 10). The effective multi-bag method included detonation of a 25 kg crater with an initial charge, then slinging in a bag with up to 16 x 25 kg unprimed ANFO bags (Fig. 11), and finally detonation of a final primed 25 kg charge on top of the sling load.

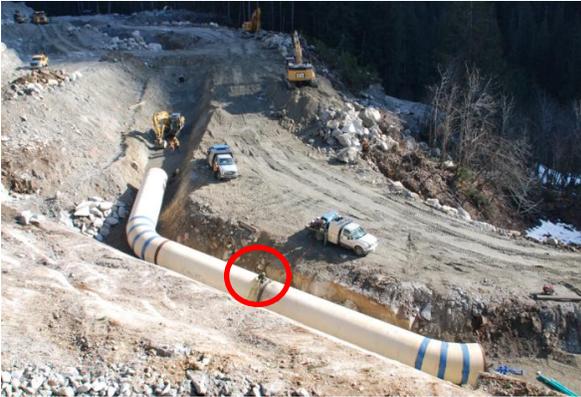
Fig. 12. Installing penstock along the Montrose Intake access road. Note welder on pipe in centre of photo (red circle), directly in an avalanche path.

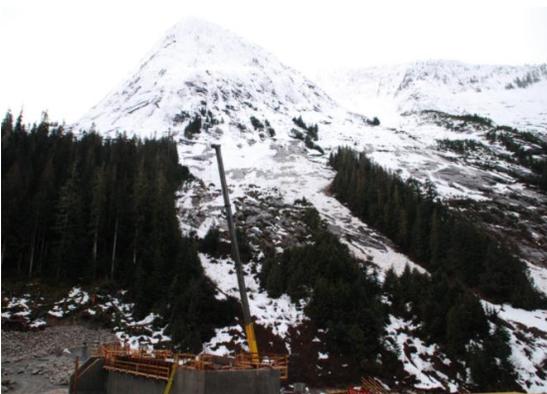
Fig. 13. Glide slabs located directly upslope of Montrose Intake worksite in Path MS-5.

Glide slabs required monitoring and control on the bedrock slabs above the Montrose Access Road and on the slabs located directly above the Montrose Intake worksite (Fig. 13). Long sections of cornice were also removed, primarily in the MS-6 path directly above the Montrose Intake worksite.
