The results from two years of testing The Wyssen Avalanche Tower in Norway

Njål Farestveit* Norwegian Public Roads Administration and Sara Skutlaberg
SWEKO Norge AS, Norway

ABSTRACT: The Wyssen Avalanche Tower LS12-5 has been tested for the first time in Scandinavia by The Norwegian Public Roads Administration (NPRA) in cooperation with Wyssen avalanche control AG and SWEKO Norway AS. Between January and May in 2011 and 2012 there has been detonated 24 charges.

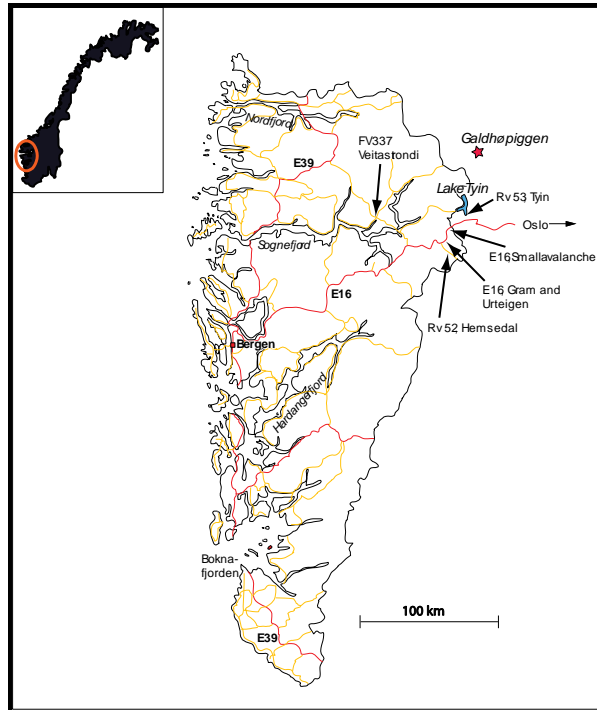
Figure 1: The western region of Norway, according to the organization of NPRA. The arrows indicate some of the avalanches cutting the connection between east and west during a storm in 2008.

The highest mountains are located to south central Norway with the highest peak, Galdhøpiggen, reaching 2469 m a.s.l. (Figure 1). The mountains are incised by steep fjords. Southern Norway has the 2nd and 3rd longest fjords in the world, respectively the Sognefjorden (203 km) and the Hardangerfjorden (179 km).

There are 5 million inhabitants and the country has an extensive public road network, totally 55.000 km of national highways and county roads in addition to 38.000 km of municipal roads. Figure 1 shows some of the most important roads in the Norwegian Public Roads Administrations (NPRA) western region and the locations of some of the avalanches cutting the connection between the capital, Oslo, in the east and the second larg-

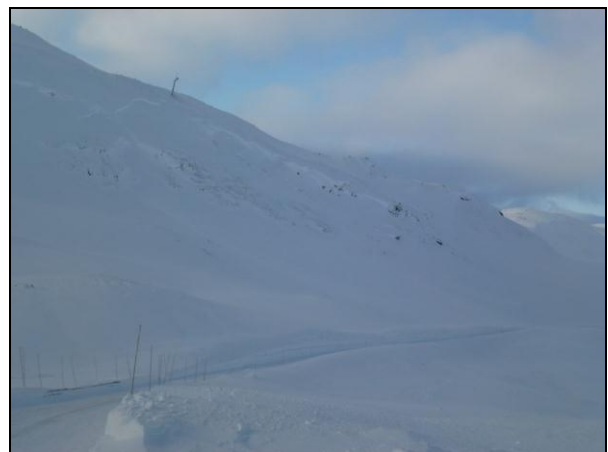
Figure 2: The location of the tower and the road shown after an artificial release the 21st of February 2012. The avalanche was about 30 meters wide on the road, and reached the Lake Tyin, that can be seen in the lower right corner. (Photo: Njål Farestveit, NPRA)

The test site is located along Road 53, on the western shore of Lake Tyin (1084 m a.s.l.), (Farestveit 2010). The tower is located at ca 1210 m a.s.l. and the road is at ca 1090 m a.s.l. This gives a vertical distance from the tower to the road at about 120 meters (Figure 2).

of February closed the road in 30 metres length (Figure 2).

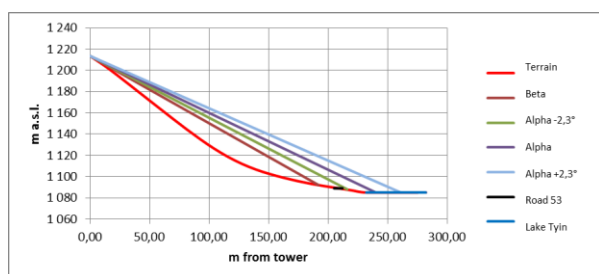
Figure 3: Alpha/ Beta profiles from the test site. Notice that the road is placed within the limit of the line: $\alpha=0,96\beta-1,4^\circ$, $SD=-2,3^\circ$, (Modified from Langeland and Sund, 2012).

The particular avalanche is situated so close to the road that the entire avalanche area can be seen from it. This was demanded by the authorities, for guaranteeing no recreation skiers would be involved. This avalanche overruns the road annually and there is little space for avalanche measures, like i.e. an effective dam (Figure 3).

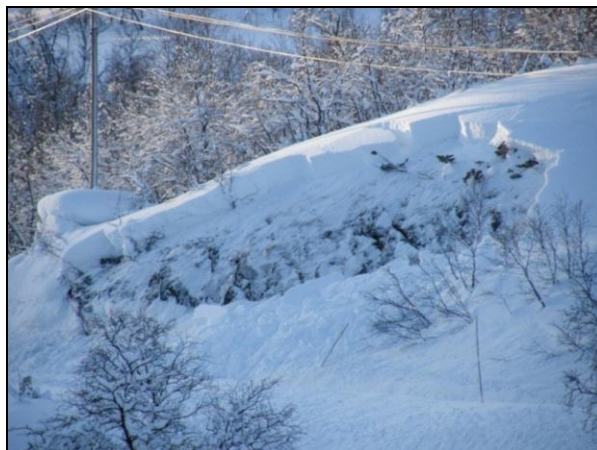
Figure 4: Small slab avalanche at Tyin released on depth hoar by ploughing truck 12th of January 2011. (Photo: Njål Farestveit, NPRA)

The early season of 2010/2011 was characterized by low temperatures combined with a very thin snow cover in southern Norway. This led to an extensive growth of depth hoar in general, in southern Norway (Figure 4).

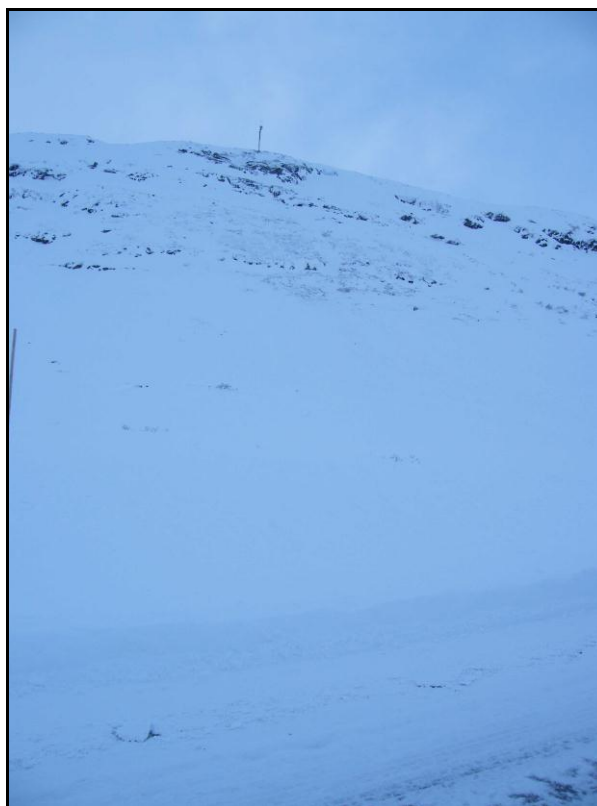
Figure 5: The avalanche path after the release 13th of January 2011. Notice that there are uninfluenced areas both to the left and the right of the tower. (Photo: Njål Farestveit, NPRA)

Our first release 13th of January removed the depth hoar in a limited area of the releasing zone (Figure 5 and 6).

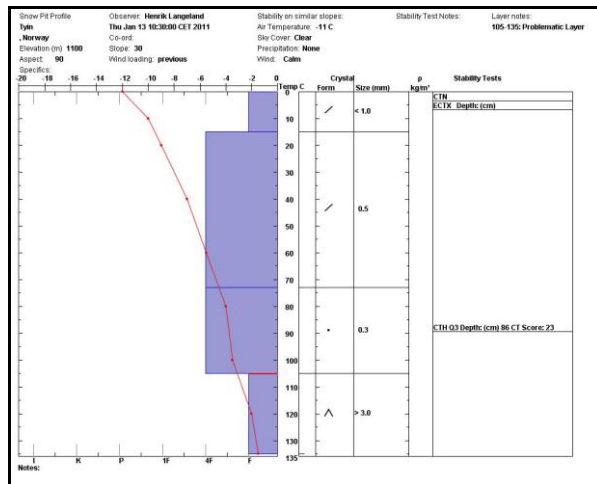
Figure 6: Snow pilot profile from 13th of January 2011. The slab is only 4 fingers hard. We think this is why we did not manage to release more of the release area.

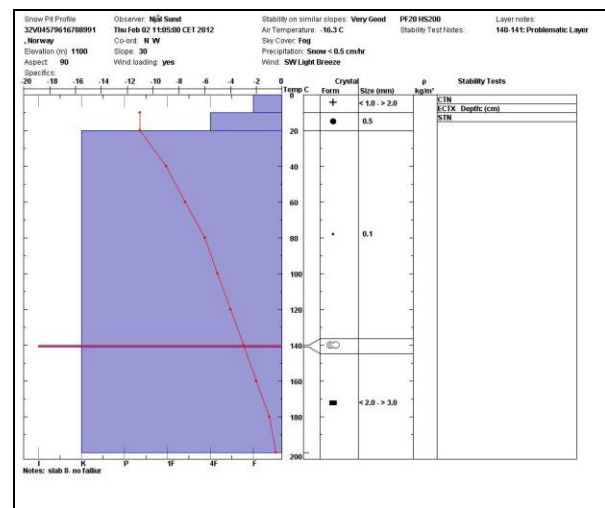
Figure 7: Snow pilot profile from the 2th of February 2012 shows no formation of depth hoar.

The hurricane did not damage the tower, and we had no dots! According to depth hoar formation this season was opposite to the last one. Due to the hurricane we had an "ice sandwich", as the lower most layers until February - March (Figure 7).
