RAPID ASSESSMENT OF A LARGE-MAGNITUDE SNOW AVALANCHE EVENT IN COLORADO

ABSTRACT: The winter of 2010-2011 set records for snowfall and snowpack depth for many mountain areas in Colorado. Large, destructive avalanches were reported from locations across the state. On April 29, 2011, an impressive slide damaged high voltage power lines along Peru Creek, near Montezuma, CO. The avalanche destroyed a power line tower that had been in place since the 1970s, and deposited massive piles of snow, rocks, and woody debris in the runout zone. The slide created fresh trimlines, widening the existing avalanche path by uprooting, stripping, and breaking trees. The disturbance event left behind many mature downed trees and extensive areas of vegetation damage, providing a unique opportunity to improve our knowledge of local avalanche frequency and magnitude. Initially, we gathered historical records of avalanche incidents and observations, and used repeat photography to track changes in the avalanche path vegetation over time. Next, we used field measurements to survey the vegetation damage, assess relative tree ages, and estimate maximum runout distances. We collected discs and cores from downed

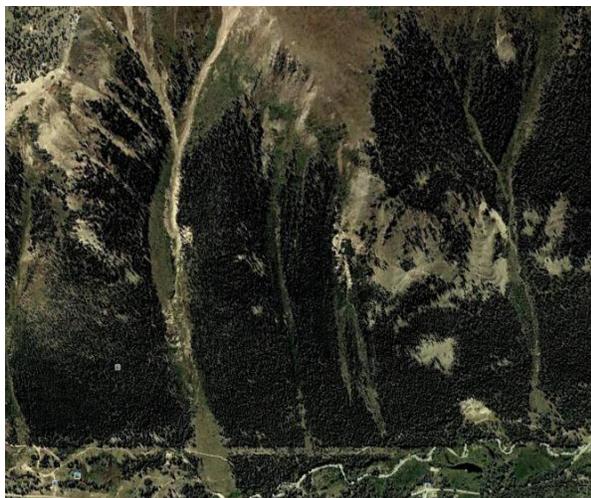
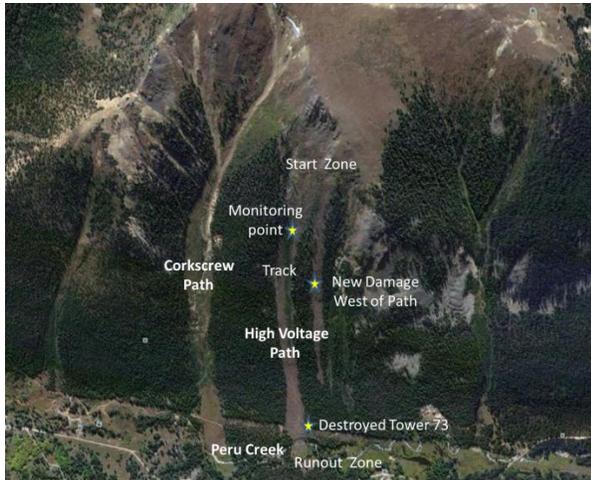
Figure 1: Before and after images of the High Voltage path: Before the 2011 event, the lower track and runout had grown in with trees, and the area of new damage to the west of the path was densely forested. The High Voltage path now clearly intersects the power line and Peru Creek in the runout zone, and the track is almost as wide as the adjacent Corkscrew path. Images were collected June 30, 2008 (above), and Sept 23, 2011 (below), Google Earth 2012.

On April 29, 2011, an impressive slide damaged high voltage power lines along Peru Creek, near Montezuma, CO (path location 39°35'57.49"N, 105°50'55.15"W, see Figure 1). The avalanche occurred in an area that we will refer to here as the "High Voltage" path, on a forested north-facing slope of Tip-top peak, west of a larger path known as "Corkscrew." The High Voltage avalanche destroyed a power line tower that had been in place since the 1970s, along an historic transmission line that was originally constructed in 1906-1909. We do not know of any witnesses to the slide that occurred on the morning of April 29, 2011. At 5:58 A.M., a power outage was reported on the transmission line, and workers found that a large slide had destroyed "Tower 73" and deposited massive piles of snow, trees, rocks, and debris in the runout zone.

In recent years, backcountry recreationalists have increasingly explored the area during winter, and they have started to report some impressive avalanches. For example, the 2010-2011 avalanche season started in the Peru Creek drainage on November 15, 2010, when an avalanche was reported from the Corkscrew path (a large path just east of High Voltage) that caught a skier and a dog. The Corkscrew path is easily recognized as an area of avalanche hazard, with a complex starting zone and a potential vertical fall approaching 610 meters (see Figure 1).

Immediately after the damaging High Voltage event, people started to ask whether the path might be new (see Figure 1). On first glance, the path was somewhat difficult to detect on images available from Google Earth (Google.com/earth; Composite Satellite Imagery collected from 1999-2008). However, the High Voltage path was much more evident in historic photos. We compared aerial photographs taken in 1938, 1974, and 1994; courtesy of the Dillon Ranger District, US Forest Service. The main track of High Voltage can be distinguished in most of the available photos as a linear, relatively open channel of approximately 50-100m wide. Over the past 20-25 years, the lower track of the path had gradually grown in with dense trees.

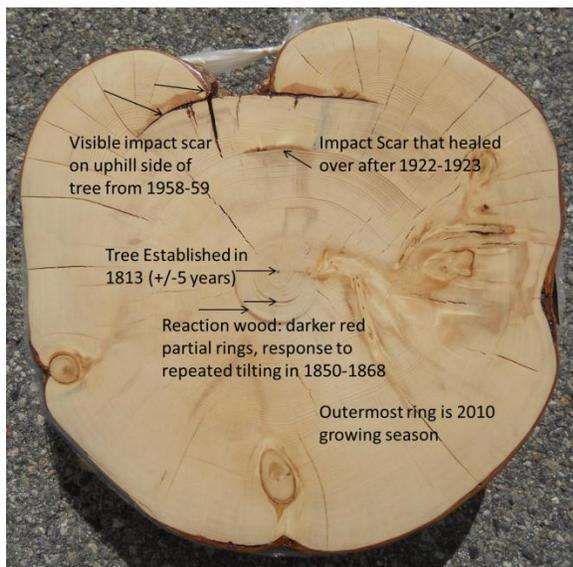
Figure 2: Example of a tree disc collected from a downed tree in a fresh trimline on the High Voltage path, showing multiple signals of past avalanche impacts recorded in the growth rings.

We collected cross-section discs of uprooted and downed trees along the elevation gradient of the High Voltage path (see Figure 2). We targeted trees with visible scars in the outer bark and vegetation breakage suggestive of avalanches. We sampled an initial set of representative trees that grew *in situ* on the High Voltage slope, rather than from logs in the jumble of debris in the runout zone.

Initial cross section samples and cores from the downed trees ranged from 116 to 335 (± 5) years in age, with diameters of up to 60cm. Avalanche signals recorded in the woody plant tissue included direct impact scars and development of reaction wood in response to repeated tilting. Several of the tree disc samples contained multiple clear signals of avalanche disturbance and related growth response as it is recorded in the rings (Pederson et al., 2006; Reardon et al., 2008).

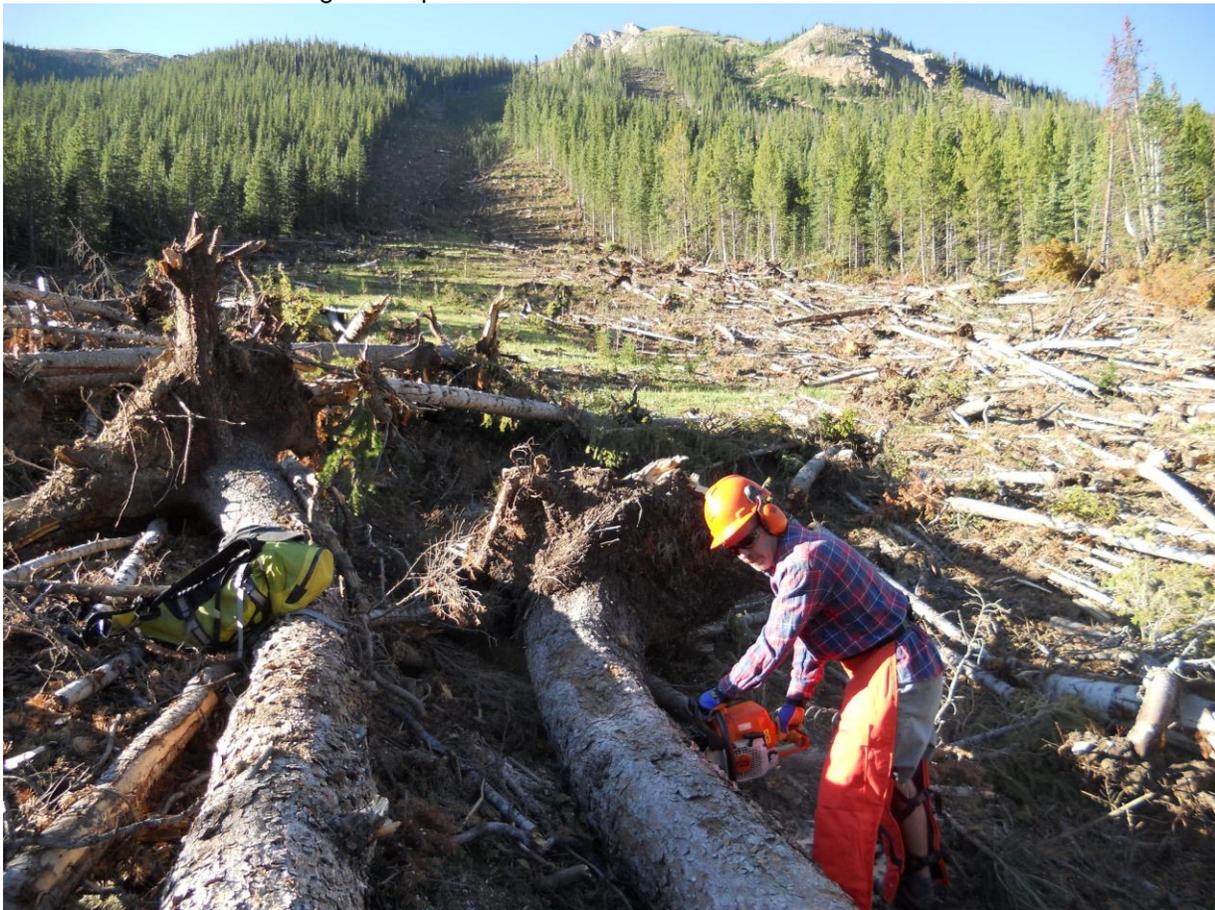
Photo: Scott Toepfer, Forecaster at the Colorado Avalanche Information Center, collects a disc from an uprooted tree in the High Voltage path, August 9, 2011.
