GONE LIKE A GHOST: THE GHOST GLACIER FAILURE AND SUBSEQUENT OUTBURST FLOOD,  
MT. EDITH CAVELL, JASPER NATIONAL PARK

**ABSTRACT:** During the evening of August 9th or early morning of the 10th 2012 the Ghost Glacier fell from the North Face of Mount Edith Cavell in Jasper National Park. Approximately 125,000 cubic meters of ice fell close to a vertical kilometer onto a lower glacier and then a tarn which was full to overflowing with recent precipitation and the winter's snowmelt runoff. The resulting wind blast and water displacement caused extensive damage to the park's infrastructure within an area that receives high numbers of park visitors. After an extensive search and rescue response it was determined that, due to the timing of the event, nobody was missing or injured. The glacial lake outburst flood is representative of the hazards within a rapidly changing post glacial environment and presents challenging questions to risk managers in high visitor use areas such as the Canadian National Parks.

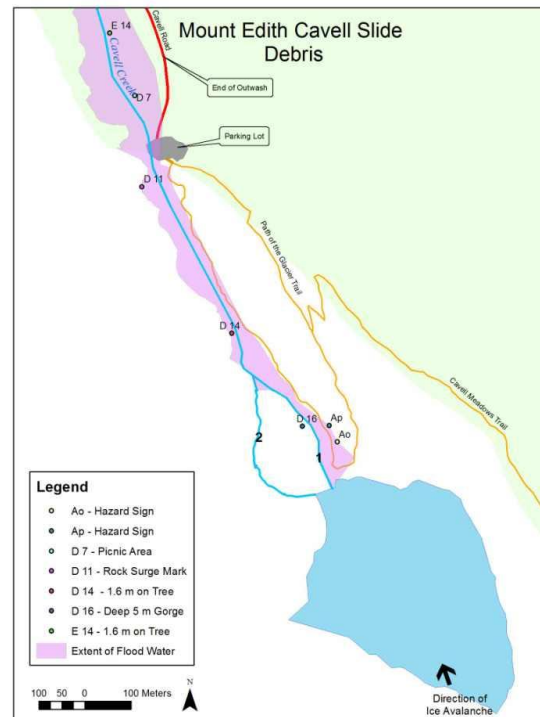
With public safety concerns under control, and access to the area restricted, the site was visited on August 11th and 12th to measure and record the character and destructive nature of the event. The field work focused from the tarn and downvalley for 1.2 km (Fig. 10).

Fig. 10: The survey area composite map.
