## LOADING ON STRUCTURES FROM FLUIDIZED AVALANCHE FRONTS OVERFLOWING DEFLECTING DAMS AT FLATEYRI, ICELAND, JANUARY 2020

Kristín Martha Hákonardóttir<sup>1,2\*</sup>, Ragnar Lárusson<sup>2</sup>, Árni Kristjánsson<sup>2</sup>, Gunnlaugur Pétursson<sup>2</sup>

<sup>2</sup> Verkís Consulting Engineers, Reykjavík, Iceland

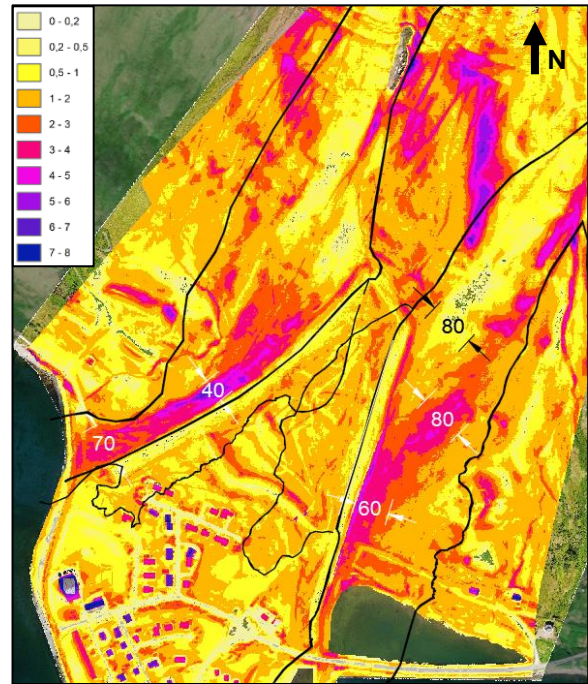
damage to one house that was partly filled with snow and where a person was buried, but saved unharmed. Additionally, three vehicles were damaged, a steel mast was broken, a timber shed was destroyed, and shrubs and trees were broken or uprooted. Type 2 debris was found on the lee side of the dams. It was about 0.75 m thick on top of approximately 0.35 m thick layers of older dense snow (see Figure 2 and Figure 3). The deposit was fine-grained and mixed with tree branches, with an average density of 415 kg/m<sup>3</sup>. Upstream of the dams, the debris was primarily Type 1 with traces of Type 2 deposit. The debris was blocky and mixed with soil and branches. Next to the dams, it was up to 7 m thick and 10–70 m wide, with an average density of 495 kg/m<sup>3</sup>.

Figure 2: Snow depth on the ground calculated from a LiDAR scan on January 16, 2020. The snow depth includes avalanche debris on top of older snow.
