REAL-TIME RADAR AVALANCHE DETECTION OF A LARGE DETECTION ZONE FOR ROAD SAFETY IN NORWAY

ABSTRACT: The project involves testing a long-range and wide-angle Doppler radar for detection of avalanches, as a part of an early warning system planned for County Road 293 at Holmbuktura, Troms, Northern Norway. The avalanche-prone road through Holmbuktura is the only access road to an area inhabited by approx. 100 permanent and 100 weekend inhabitants. The average traffic through Holmbuktura is around 200 vehicles per day. Possible mitigation measures include an 800-1'000 m long tunnel or an avalanche protection gallery of similar length, both involving costs between 30 and 35 Mio Euro. The Norwegian Public Roads Administration (NPRA) is therefore evaluating cheaper solutions with a better cost-benefit ratio, among them long-range and wide-angle Doppler radars with automatic road closure to protect vehicles from being caught by avalanches. During the two test winters, Long-range, wide-angle Doppler radar has proven to detect avalanches with sufficient warning time for road closure

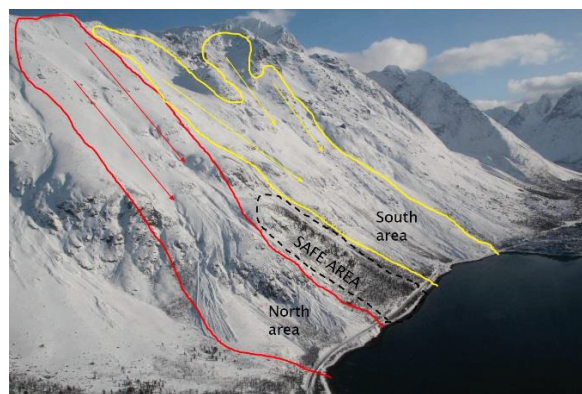
Figure 1: The avalanche area consists of two main avalanche gullies: the north gully and the south gully. Between them is a safe spot with no avalanche activity registered. Photo: Ole-André Helgaas.

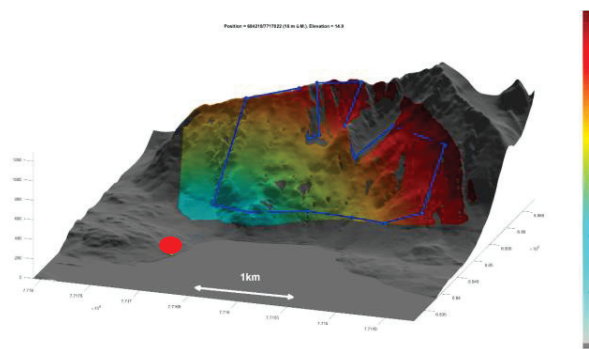
Figure 2: The simulated radar coverage is shown. Coloured areas are monitored by the radar. Colour indicates distance in meters. The red dot is the position of the radar. Figure is taken from Geopraevent project report (Meier 2018).

The radar has a range of approx. 4 km and a field-of-view of 90 degrees horizontally and 15 degrees vertically (Meier 2018), which covers most of the avalanche area in Holmbuktura. The radar should detect any avalanches of size 2 or larger (EAWS classification) according to detection criteria given in the project. The position of the radar was determined based on both visibility of the release zones and access to permanent power supply (figure 2).

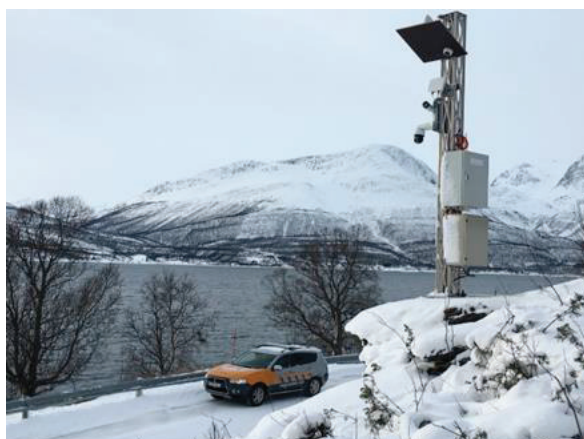
Figure 3: Radar installation (February 2017). To verify detections, a remotely controllable PTZ camera and a thermal camera were installed additionally. Photo: Andreas Persson

The radar was installed in February 2017. To verify detections, we also installed a remotely controllable PTZ camera and a thermal camera. The radar system sent SMS messages immediately after it detected an avalanche. A few minutes after the avalanche, the radar sent another SMS with an estimate if the avalanche reached the road or not. The goal of this service was to provide road personnel with an early warning, but also to evaluate the implementation of traffic lights with automatic road closure and reopening, which is planned for 2019.

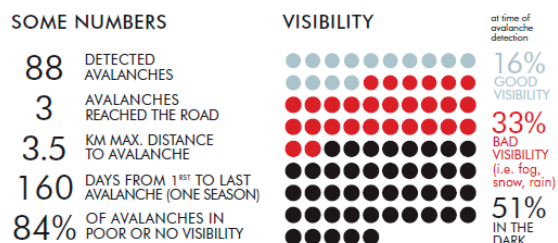
AVALANCHE RADAR HOLMBUKTURA: FEBRUARY 2017-MAY 2018

Figure 3: Some numbers from the project report provided (Meier 2018).

The radar system successfully detected 88 small to large avalanches during the two test winters (Meier, 2018). Of these avalanches, three hit the road. 16 % of all avalanches were detected in good visibility, 33 % in poor visibility due to bad weather conditions, and 51 % of the detections were made in dark conditions (Meier, 2018).

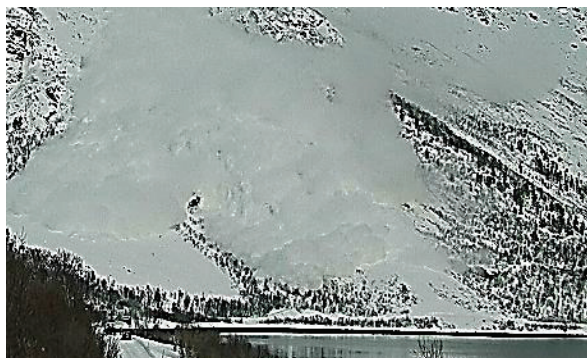
Figure 5: Example of a live photo documentation of an avalanche just before hitting the road in the northern avalanche gully on the 29th of March 2018. The PTZ camera connected to the radar documents the event.
