SNOW DRIFT CHALLENGES AT KLETTSHÁLS MOUNTAIN ROAD PASS IN ICELAND

ABSTRACT: Snow fences are usually used to control snowdrift problems on a relatively flat and open terrain. Snowdrift problems on mountain roads and passes are normally more challenging. The terrain is often more complex, winds can be stronger and other problems related to road construction have to be solved in joint action with snowdrift problems.

In 2004 a road section across Klettsháls in southern part of Westfjords Iceland was reopened after major reconstruction. Before the road was only open and passable in periods of good weather during winter-time. The road section is known for the heavy snowdrift problem and some previous attempts to solve the problem did not proof successful. The challenge was that one side of the road has a steep slope downhill and the opposite side is an excavated rock wall 4 to 5 m high. In 2007, an alternative method of solving the snowdrift problem was tested along a short section of the road. The result was acceptable and the year after a new permanent and robust snow fence was built. The structure functions not only as a snow fence but also as a guardrail for the road. The road is n

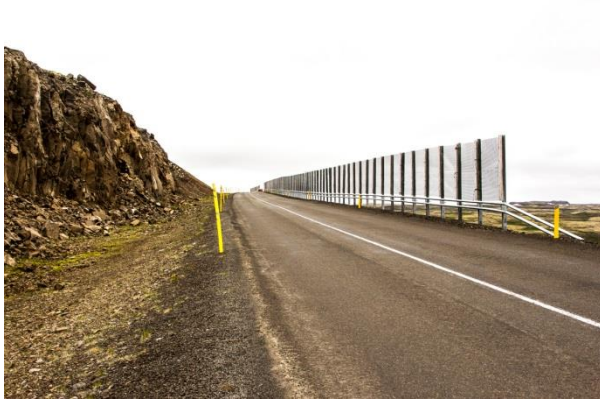
Fig. 7 The photo shows two sections of snow fences at the road side in summer time.

In 2009 an approx. 180 m long section was built at the top most part of the site (Fig. 7-9). Experience during the two first winters was very promising so a second section of similar length was built in 2011. A third section is now planned.

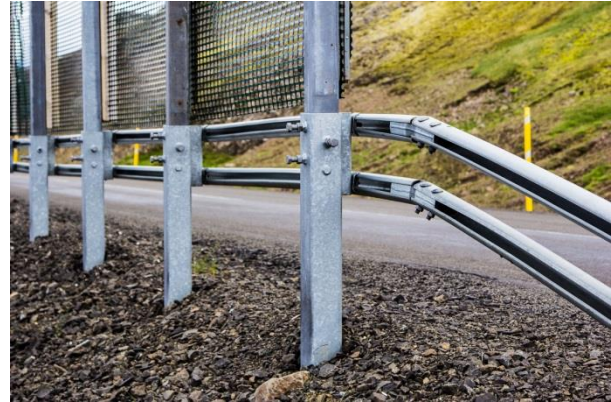
Fig. 9 A close up of one of the end posts. The guardrail end is bent down from the post into the ground.
