Monitoring of snow and ground temperature in the glide avalanche area at Trefall, Eksingadalen in Western Norway

Julie Engelién Bjørlien^{1*} and Njål Farestveit¹

¹The Norwegian Public Roads Administration, Norway

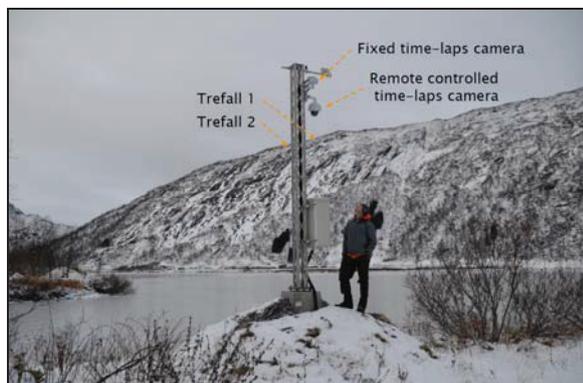
Figure 1: The fixed time-lapse camera is an Axis P1357, and the remotely controlled camera is an Axis Q6045-E MkII. Data is transferred via the local mobile phone network.

Two webcams are monitoring the site (Figure 1). One camera is a fixed time-lapse camera, and the other camera is a remotely controlled camera with zoom capability (Bjørlien et al. 2016).

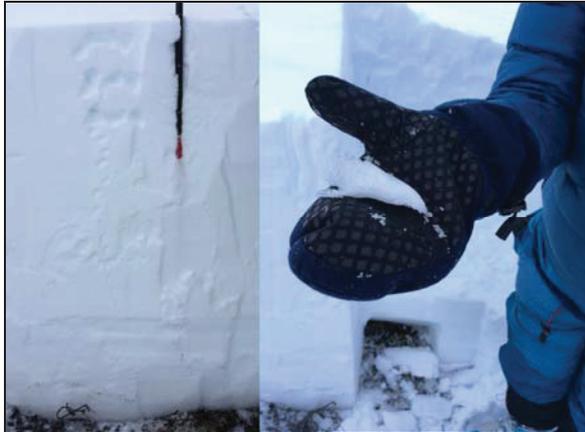
Figure 5: Snow pit dug close to the sensor strings, 1st of December, 2017.

uminium mast and the darker colour of the mast, snow had melted around the sensor string (Figure 4). A snow pit close to the sensors had 105 cm of snow. In the pit the ground surface – snow bottom interface was wet (Figure 5 and 6).

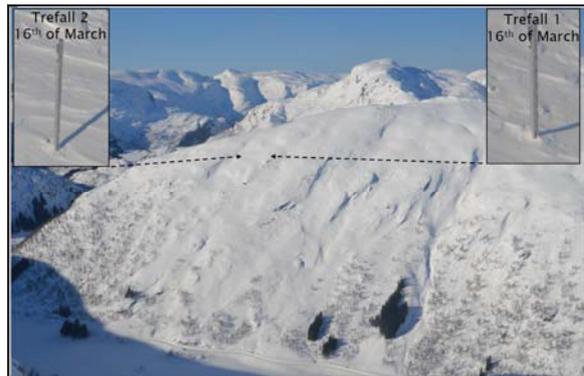
Figure 8: Overview of the study area 16th of March, 2018. Glide cracks are not observed.

The third inspection took place 16th of March, 2018. This inspection was done by helicopter without landing. Accurate snow depth measurements from this inspection is therefore lacking. Estimated snow depth from picture analyses at Trefall 1 is ca 50 cm snow depth, and at Trefall 2 the snow depth is estimated to ca 30 cm. These are very rough estimates. It is possible to see from pictures that the snow had not melted around the sensors at this time, and no open glide cracks were observed (Figure 8).

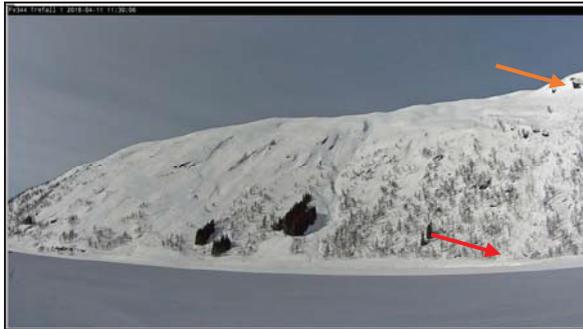
Figure 9: The area shown 11th of April some days after glide cracks started to appear. A wet loose snow avalanche size 2 ran this day (orange arrow marks the starting point, and red arrow marks the end point for end of the run out zone).

a few shorter periods with higher temperatures. Avalanche activity as wet loose snow avalanches up to size 2, started in the area around the 9th of April (Figure 9). From the 9th of April and into the 17th of April the area went through massive cracking, changing the characteristic of the area from having a smooth snow surface, into glide cracks over all (Figure 10).

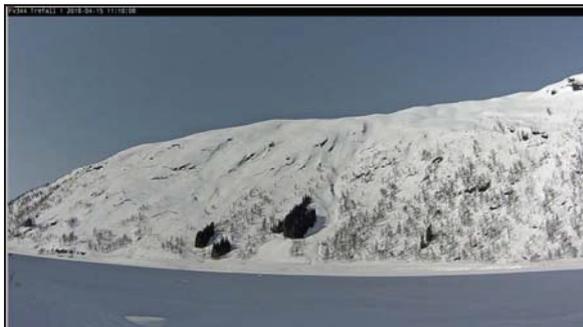
Figure 10: The area shown 15th of April. Glide cracks have expanded much compared to the picture in Figure 9.

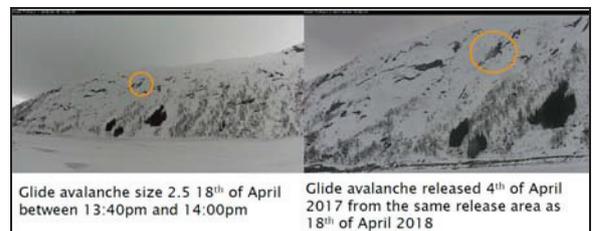
Figure 13: The same release are seen in 2017 and in 2018.

By looking at pictures taken the winter of 2016/2017, we found that the release area that produced the avalanche that overran the road in 2018, also released in 2017. Monitoring of this smaller release area, in combination with looking at the developing of glide cracks, could act as an indicator for when avalanche danger is high in the area (Figure 13).
