## THE CHALLENGES OF MITIGATION MEASURES IN LONGYEARBYEN SVALBARD

**KEYWORDS:** Svalbard, Longyearbyen, Sukkertoppen, Mitigation measures.

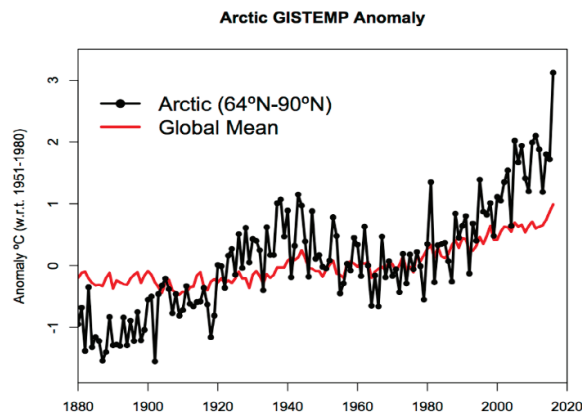
Figure 3. Arctic Anomaly. 2016 is the warmest on record in the Arctic. Source: K. Isaksen.

Longyearbyen is in one of the driest areas in Svalbard. The observed annual precipitation in the period from 1961-1990 was just about 300 mm, but in recent years the temperature has been increasing and less sea ice is observed which is thought to increase the moisture and precipitation. The monthly mean temperature on Svalbard has been over the normal from November 2010 to present (summer 2018). Figure 2 shows the annual mean temperature at Svalbard airport for the last hundred years and Figure 3 shows the Arctic anomaly compared to global anomaly.

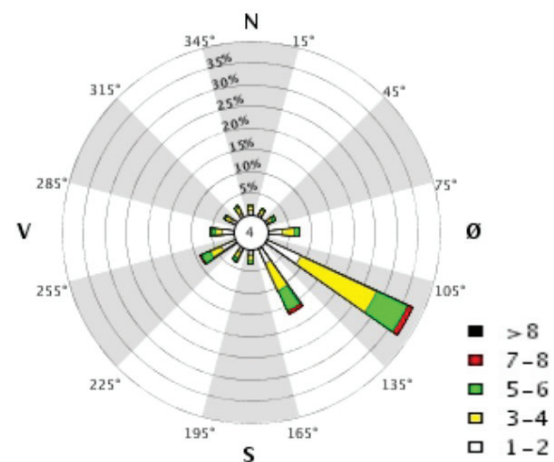
Figure 4. Wind frequency distribution at Svalbard airport during Nov.-April in the period 1975-2016. Wind force is shown on Beaufort scale. Source: (Isaksen et al., 2017).

Sukkertoppen mountain is a known avalanche site in Longyearbyen but in recent years avalanches have not, except for 2015 and 2017, hit the buildings located at the foot of the mountain. Accumulation of snow into release areas is primarily from South-East-winds out Adventdalen (valley), as shown in Figure 4.
