## UTILIZING ACCELEROMETERS FOR AVALANCHE DEBRIS DETECTION ON THE BNSF RAIL GRADE

**ABSTRACT:** Since 2005 BNSF Railway (BNSF) has operated an avalanche safety program (Program) in John F. Stevens Canyon (JFS) of northwestern Montana, USA. The Program is comprised of BNSF personnel and avalanche safety specialists employed by David Hamre & Associates LLC. A key attribute utilized for avalanche forecasting are “slide fences.” Slide fences are binary detection hardware comprised of horizontal wiring strung between posts installed on the uphill side of the rail grade in geohazard areas. If one or more of the slide fence wires is broken, an indication alerts BNSF crews that hazardous debris may be present at that location. In February 2017 a widespread avalanche cycle occurred in JFS Canyon. During this cycle, a natural, Destructive Size 3, dry slab avalanche buried the rail at a location now called *Path 1183*. When this avalanche occurred, Path 1183 was not included in the Program forecast area nor did it have slide fencing installed. BNSF Signal Department (Signal), a department committed to development and maintenance of rail detection systems, including slide fence, was tasked wi

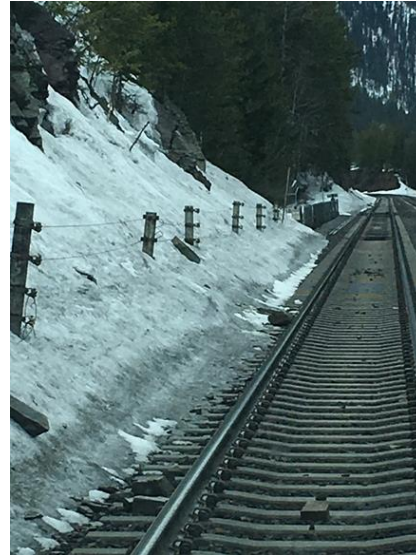
*Photo 1: Slide Fencing*

Fencing is binary in design and consists of multiple voltage-charged strands of parallel wire strung between posts (Photo 1). If one or more wires in a particular fence are broken, an indication is provided to BNSF dispatchers and crews that a fence has been compromised within a particular section of rail grade (known as a block) and hazardous debris may be present and/or have damaged the rail grade. A block varies in lineal

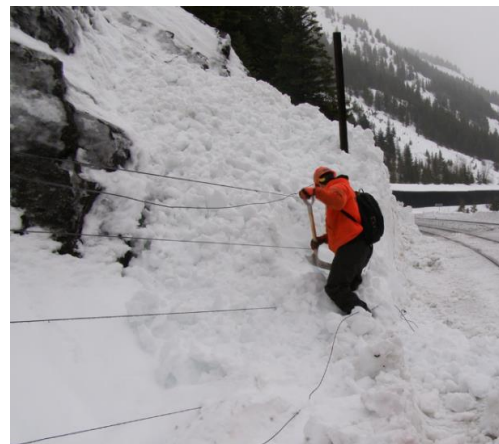
*Photo 2: Clearing avalanche debris on a slide fence.*

In all instances regarding fence maintainance and repair, crews are working diectly beneath identified natural hazard areas (Photo 2).

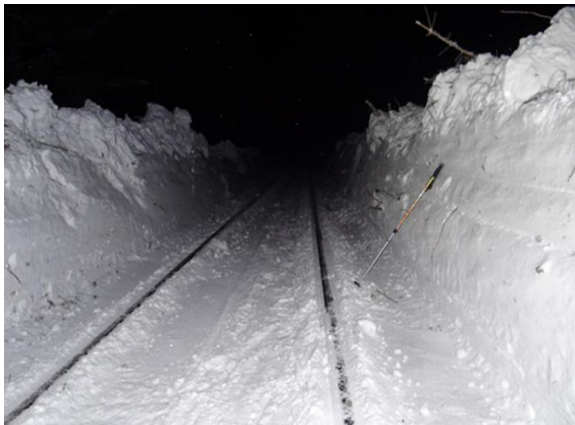
*Photo 3: Path 1183 avalanche debris terminus on the rail grade.*

This avalanche terminated on the low side of the rail grade and deposited 1.2m to 1.8m of debris on rail grade (Photo 3), Steiner and Clark (2017).

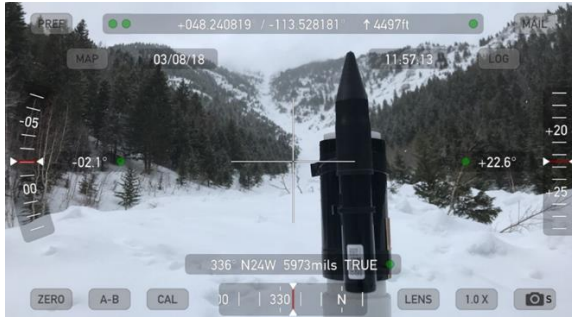
Photo 4: Path 1163 upper elevation test-site sensor.

For this test, Signal had Program forecasters temporarily install five (5) sensors in the 1163 avalanche path with the upper two sensors positioned approximately 300m lineal distance above the rail grade and the lower three sensors 150m lineal distance above the grade.

The lower sensors were mounted on PVC piping secured to trees and the upper elevation sensors were mounted on PVC pipes driven into the existing snowpack (Photo 4).

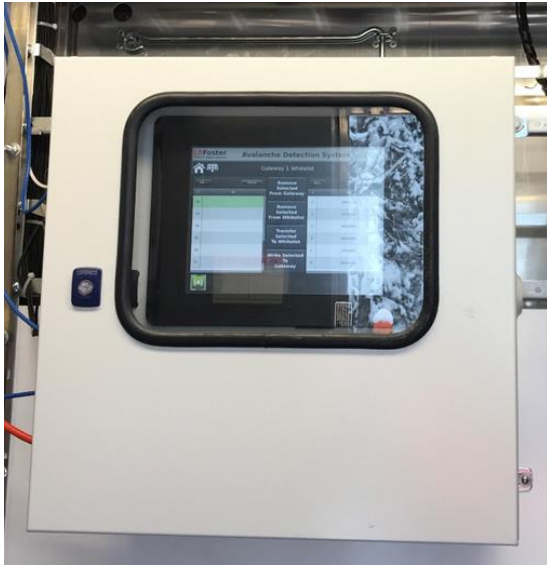
*Photo 6: An LB Foster HMI onsite monitor.*

Status is displayed in real-time and electronically accessible remotely (Photo 5) or from a field-based monitor onsite (Photo 6). The onsite HMI monitor is stationed in a heated bungalow and outside avalanche prone terrain.

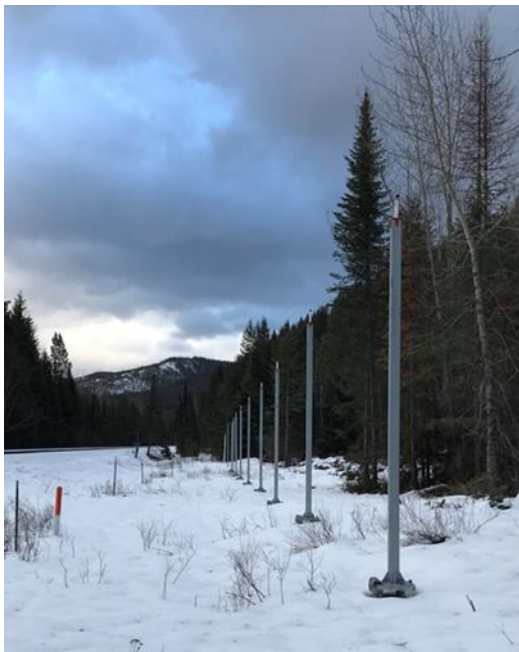
*Photo 7: 1183 tower and sensor array*

With the completion of monitoring hardware and software, Signal focused on a permanent install of the 1183 sensor array (Photo 7) and creating instructional policy for BNSF Dispatch, the Signal Operations Center (SOC), and Maintainers.

- 12 rugged tip-over towers with sensors.
- Concrete tower foundations with modular tower connection points.
- New mounting hardware for sensors.
