SITE-SPECIFIC SLUSH FLOW WARNING ON HIGHWAY RV80, NORTHERN NORWAY

¹ Norwegian Public Roads Administration (NPRA), Bodø/Tromsø, Norway

ABSTRACT: RV80 is the main road to Bodø, the largest city in Nordland County in Northern Norway. About 30 minutes outside the city is Ytre Kistrand, an area with several slush flow paths known to close the road almost every year. In February 2021 a contractor on duty for the Norwegian Public Road Administration (NPRA) died from his injuries after a slush flow hit his car and threw it upside down on the railway 10 meters below the road.

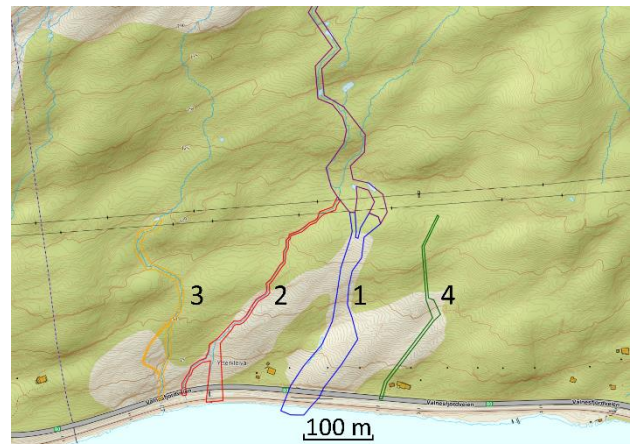
There are 4 known slush flow paths at Ytre Kistrand (Figure 1). They all mainly follow water streams in the terrain.

Figure 1: The slush flow paths at Ytre Kistrand.

The release area is not known for all the slush flow events, but it was assumed to be in a flat area underneath the powerlines at around 100 m.a.s.l. Slush flows are most common in the paths 1 to 3, and the latest events show that they also can be released higher up in the terrain.

To open the road, the contractor would have to send a crew to clear the debris. It was still raining and the water content in the snow cover in the release area was high. Due to the risk of a slush flow in the primary path 1 (*Figure 1*) during clearing of the area, the high hazard level persisted. On Wednesday, the rain subsided, and the water content in the snow cover decreased. It was considered safe to begin work on opening the road and construction site.

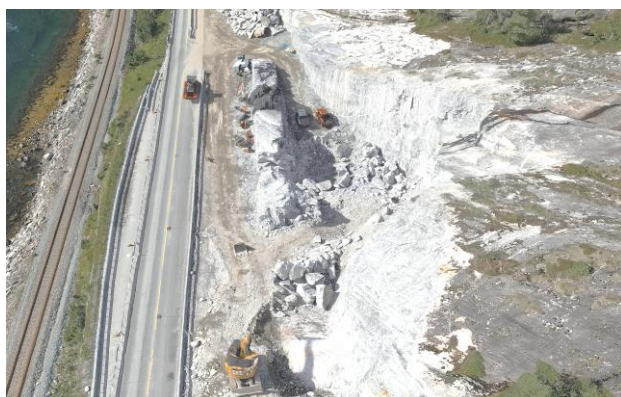
The mitigating measures will consist of catchment dams constructed with drilling and blasting the rock on the upper side of the road (Figure 2). The construction will be completed by the end of 2024.

Figure 2: Construction of catchment dams in progress by drilling and blasting. Screenshot from a photogrammetry 3D model.

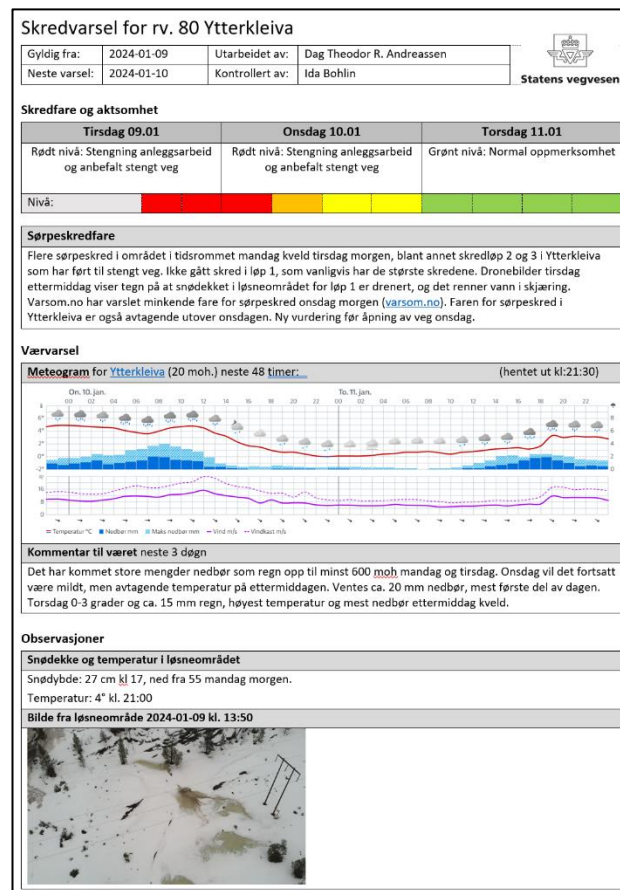
The slush flow bulletin has two pages. The first page contains the assessed hazard level and information to support it, such as weather and snow conditions (Figure 3). The second page contains an explanation of the bulletin and measures associated with each hazard level. This page also defines risk owners according to recommendations approved by the European Avalanche Warning Services (EAWS) general assembly in Davos in 2022 (EAWS, 2022).

Figure 3: An example on the layout of the first page of the slush flow bulletin.

The bulletin contains assessments for three or four days, including the rest of the day of publishing (day zero). Each day is divided into four periods: night, morning, afternoon and evening. To support the assessment the bulletin includes a graphical view of the weather forecast, a short summary of the weather forecast, observations of snow depth and temperature as well as a photo of the release area.

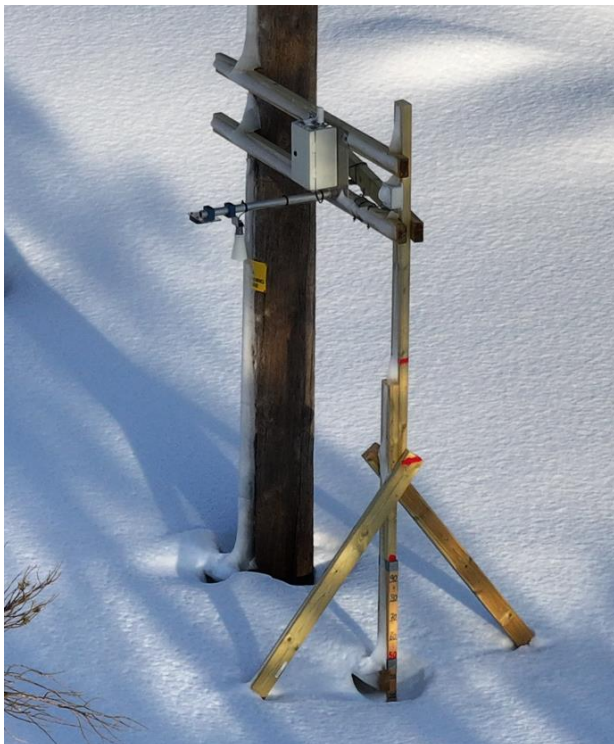
The weather station was attached to a power line mast at the edge of the release area (*Figure 4*), and measured snow depth and temperature every hour. The data was sent 3 times a day to save battery and could be accessed through a web portal.

Figure 4: A weather station was mounted at the edge of the release area.

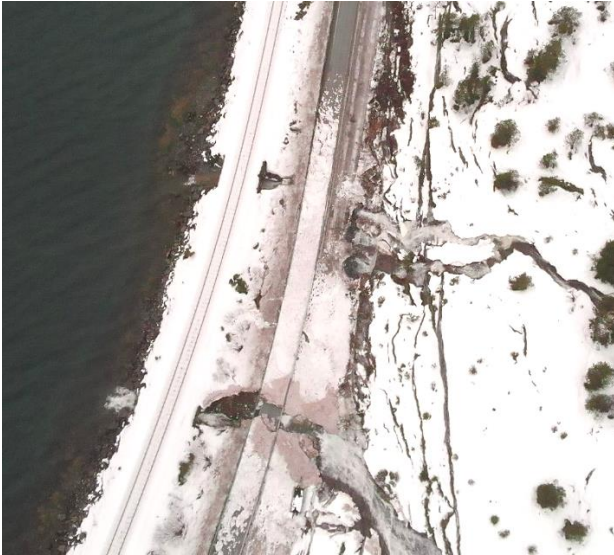
The next morning two slush flows were registered on the road, from slush flow paths 2 and 3. They caused no significant damage, but the construction site and road were filled with debris.

Figure 5: The slush flows registered 2024-01-09.
