CASE MOSJØEN - CHALLENGING RISK MITIGATION IN THE TOWN CENTER DUE TO POWDER CLOUD AND AVALANCHE GENERATED FLOOD WAVES

Priska Helene Hiller^{1*}, Anne Bruland Høyen¹

¹ Norwegian Water Resources and Energy Directorate, Trondheim, Norway

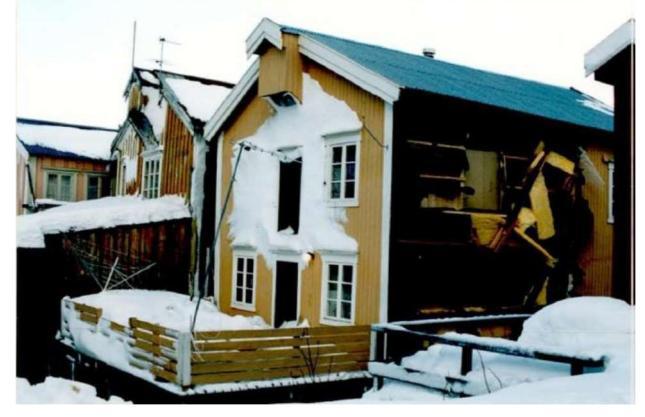
Figure 2: Snow deposits and damages in Mosjøen after the avalanche in 1996. (Foto: NGI, from NGI 2020)

1996: Powder cloud of an avalanche causes several damages in Mosjøen (Figure 2). This is the best documented event. The Norwegian Geotechnical Institute (NGI) analyzed the event and described some mitigation measures for the community (NGI, 1996).

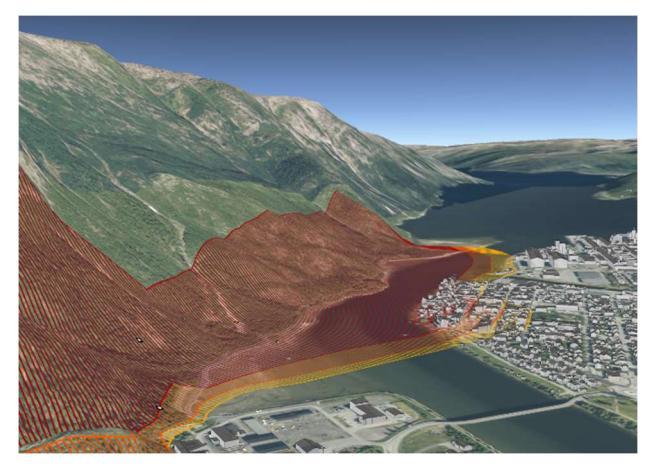
Figure 3: Mosjøen seen from south to north in 3D visualization including the avalanche hazard zones. The red zone implies an annual nominal return interval of 1/100, orange 1/1000 and yellow 1/5000. (Screenshot of NVEs temakart available on https://temakart.nve.no/prosjekt/360d1931-d392-4a74-b6c0d7725798632e)

In the case of Mosjøen there are about 75 buildings in safety class S3 and S2 within the 1/1000 hazard zone, including a hotel, a bank, a shopping center and the town center marked place, see Figure 3. Most of the historic houses along the famous Sjøgata are even within the 1/100 hazard zone. Sjøgata is the first road parallel to the river, ca. 50 m from the shore. Those houses, mainly wharves, are especially vulnerable as they are constructed of wood and some of them founded on poles partly in the river.
