Ronna J. Simon

OBSERVED GEOMORPHIC CHANNEL RESPONSE TO WILDFIRE OF MOOSE CREEK, A SPRING-DOMINATED STREAM

Ronna J. Simon, USDA Forest Service, Targhee National Forest, St. Anthony, ID 83445

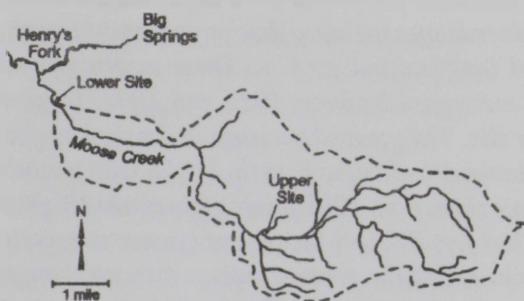
Figure 1. Map of Moose Creek study area and locations of sampling sites.

Channel surveys and discharge measurements were conducted at two sites (Table 1 and Fig. 1). The lower site is about 1.1 km upstream of the confluence with the Henry's Fork and 9.0 km downstream of the upper site, at

The upper site is located about 7.6 km below the beginning of the first defined channels, at an elevation of 1989 m (Fig. 1). The channel has the general characteristics of a C4 channel. Typical C4 channels have entrenchment ratios greater than 2.2, gradients between 0.1 percent and 2 percent, high sinuosity, moderate to high width/depth ratios (>12), and substrates comprised predominantly of gravel. The reach is in a confined valley, which results in lower

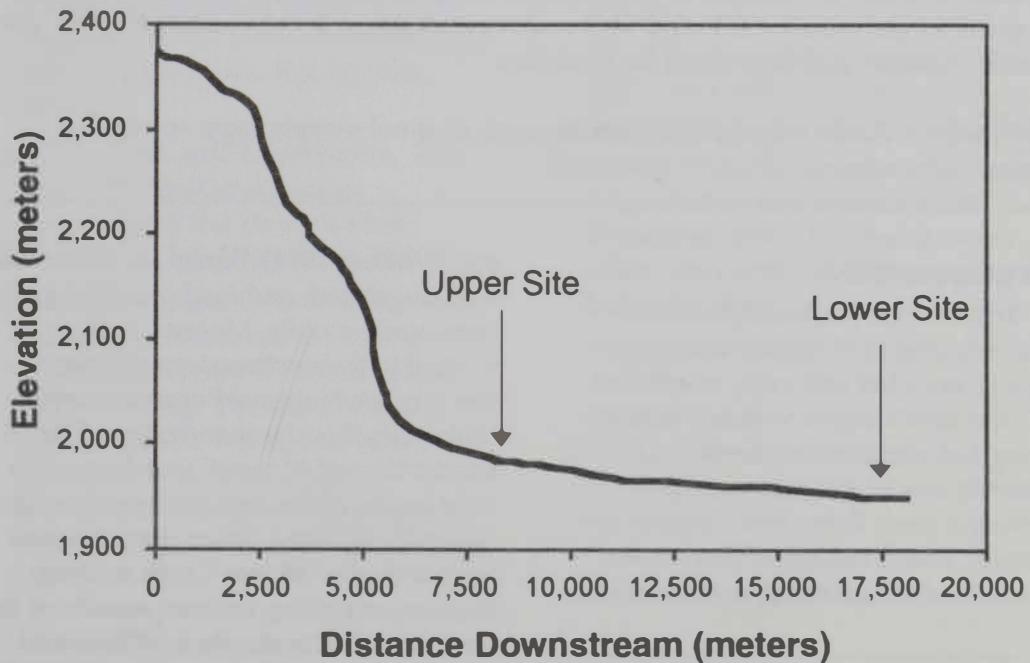
this volume, Fig. 1). Elevations along the stream vary from about 2378 m where defined channels can first be identified to about 1948 m at the confluence with the Henry's Fork (Fig. 2). The apparent drainage area is 41.6 km². Springs, which are the primary source of perennial water for the stream, emanate from steep volcanic headwalls; secondary spring sources further downstream originate at the base of the volcanic flows. The watershed extends above these springs, with the upper reaches characterized by intermittent drainages containing infrequent perennial springs. Surficial geology includes Quaternary rhyolite ash-flow tuffs, with Quaternary alluvium in the lower reaches of the stream. Obsidian sand and gravel are commonly found with the tuff in alluvial deposits. Soils are generally young, developed in volcanic ash and related volcanic materials, and have loess caps in some areas. Textures are mostly silt loams and gravelly sands, and soils are well-drained and acidic (pH about 4.5-5.0).

Figure 2. Longitudinal valley profile with site locations.

The stream's steepest reach is in the upper 5.6 km of the drainage (Fig. 2). This reach has an average gradient of 6.3 percent, punctuated by locally steeper segments where the stream cuts through the front lobes of volcanic deposits. In the lower 12.6 km, the profile flattens and is smooth, with an average gradient of about 0.4 percent.

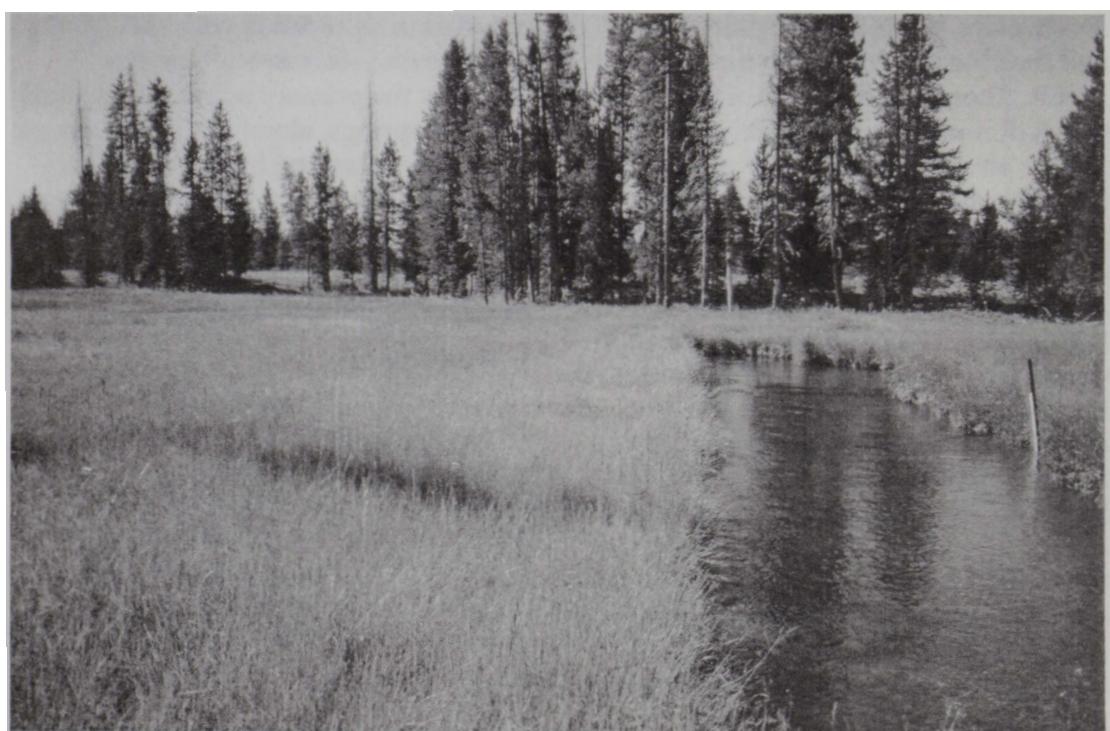
an elevation of 1949 m. About 55 percent of the watershed above this site burned in 1988. The stream at this location is characterized as an E4 type channel (Rosgen 1996, Fig. 3). The channel has low gradient (0.1 percent), high sinuosity, and low width/depth ratio (8.0) and flows through extensive meadows, with sedges and grasses providing excellent bank stability. Mobile sand/gravel bars are common. Remnants of log fish-habitat improvement structures are present in the channel. A number of summer homes are located upstream of the site.

Figure 3. Photo of lower study site.

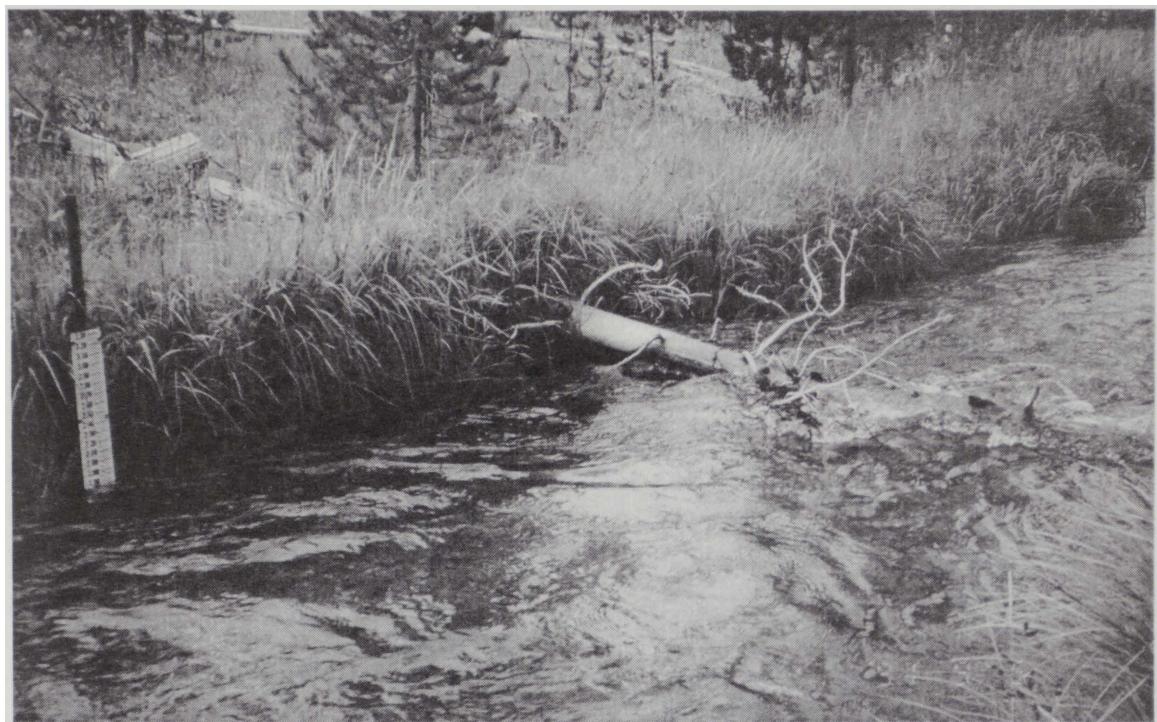
sinuosity and width/depth ratio than would normally be expected for a C channel (Fig. 4). The entrenchment ratio for the site is about 3.7, width/depth ratio is 8.7, and bankfull slope is 0.7

Figure 4. Photo of upper study site.

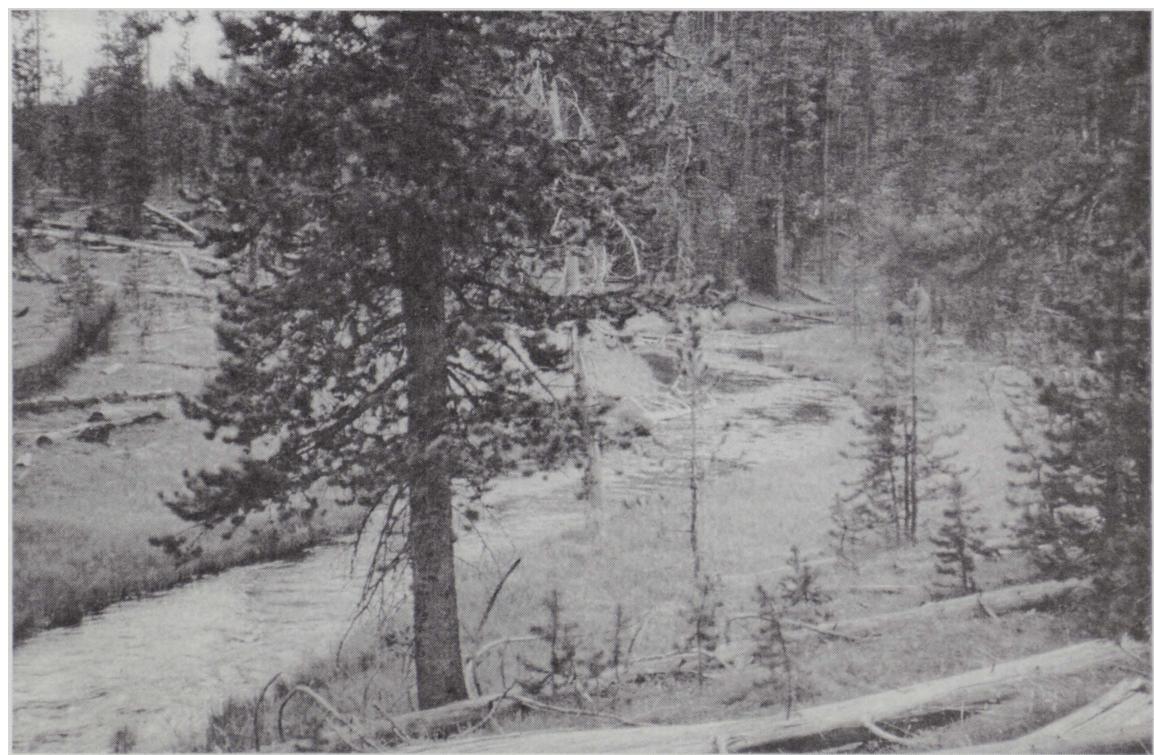
percent. The substrate is mainly comprised of gravel. Adjacent reaches, both above and below, are more typical C channels (Fig. 5). The upper study site also has mobile instream gravel bars.

Figure 5. Photo of reach adjacent to upper study site.

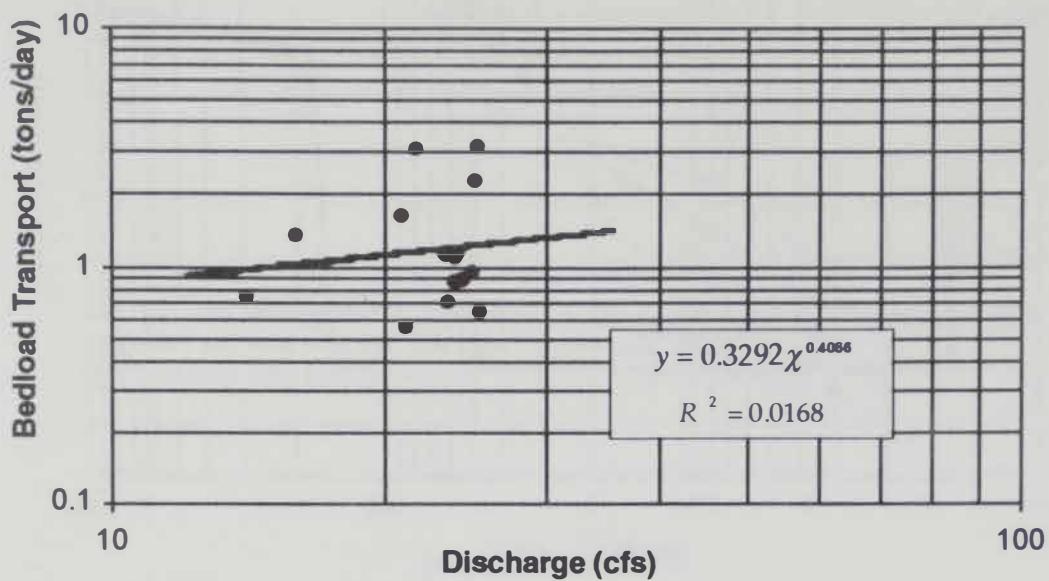
Lower Moose Creek

A scatterplot of bedload transport versus discharge (Fig. 6) may indicate that bedload transport is initiated at a discharge of about $0.40 \text{ m}^3/\text{s}$ (14 cfs) at the lower site. Streamflows less than $0.40 \text{ m}^3/\text{s}$ (14 cfs) were not observed during the summer when bedload sampling was conducted, however, and the correlation between bedload transport and discharge is weak ($r^2 = 0.017$, Fig. 6). The low coefficient of determination may be caused in part by a lack of data collected during storm

Figure 6. Scatterplot of bedload transport (English tons/day) versus discharge, lower Moose Creek site (1 English ton = 0.907 metric tons, 1 cfs = 0.2832 m^3/s).

events, when the relationship between bedload transport and discharge may be stronger. In 1995 and 1996, bedload transport increased on the rising limb of the hydrograph, peaked before streamflow did, and declined quickly as discharge peaked.

A threshold discharge may exist below which bedload is not transported, but this could not be confirmed with the limited amount of data collected. There also is no clear evidence that lower flows from 1991 to 1995 affected the stream's ability to transport sediment. In fact, Moose Creek apparently transports

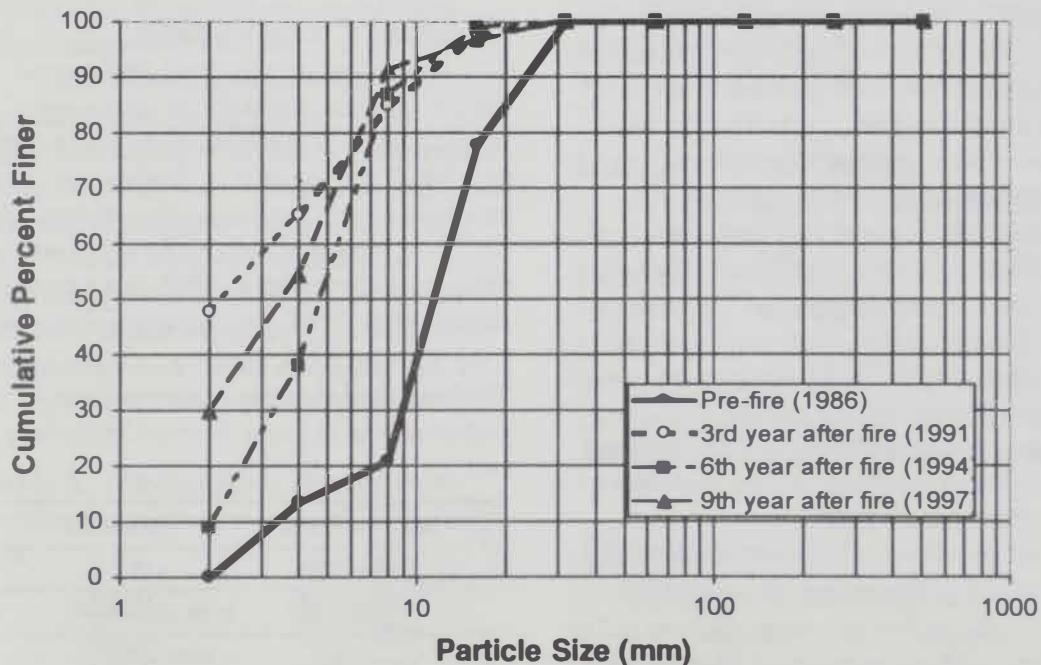
Lower Moose Creek

The pebble count data were collected by different investigators over the years, which may have biased results. Nonetheless, findings reported here are assumed to be a reasonable representation of changes in particle size distributions of bed material at the Moose Creek sites. In general, bed materials were finer at the lower site than at the upper site (Figs. 7 and 8). The median particle size (d_{50}) at the lower site remained relatively constant following the fires, averaging 4 mm and ranging from 2.6 to 4.7 mm (Fig. 7). The

Figure 7. Cumulative particle size distributions, lower Moose Creek site.

pebble count data from the lower Moose Creek site show a statistically significant increase in fine material between 1986 (pre-fire) and 1991 (post-fire) (chi-square, $P < 0.05$). Pre-fire cumulative frequency plots show that none of the sampled bed material was finer than 2 mm (Fig. 7). By contrast, the 1991 (post-fire) plot shows 47.8 percent of the bed material finer than 2 mm (Fig. 7). In all post-fire samples collected, the percentage of fine material was significantly higher than that observed in 1986 (chi-square, $P < 0.05$). Materials finer than 2 mm comprised between 8.0 and 29.8 percent of particles in samples collected after 1991. There was no apparent trend in bed material composition after 1991, and the highest post-1991 percentage of fine material was observed in 1997.

The lower Moose Creek site exhibited an increase in fine materials (<

2 mm) 3 years after the 1988 fires. Measurements made in subsequent years contained smaller percentages of fine material than those made in 1991 but higher percentages than observed in 1986. Levels of fine in 1997 were the highest since 1991. Although there were no pre-fire data at the upper site, levels of fine materials there were higher in 1991 and 1997 than in intervening years, as was the case at the lower site. With a change in transport capacity of the stream ruled out at this time, a change in the amount of fine sediment delivered to the stream is the probable reason for this occurrence. A logical cause for the 1991 increase in fines was the fire, which resulted in loss of vegetation, creation of hydrophobic soil conditions, and accelerated delivery of fine sediment to the stream. The 1997 increase in fines may have been caused by continued sediment production in the burn area, where revegetation was still not complete, and where high amounts of fine sediment were still being delivered downstream. Fresh deposits were evident along the upper reaches of the stream in 1997. Logging units and associated roads in the watershed also were contributing fine materials to the fluvial system and exacerbating effects of the fire. The contribution from these features could not be separated from fire effects using data from this study. Road obliteration, when effective, eventually would reduce sediment delivery to channels, and levels of fines also can be expected to decline if upland revegetation is successful.

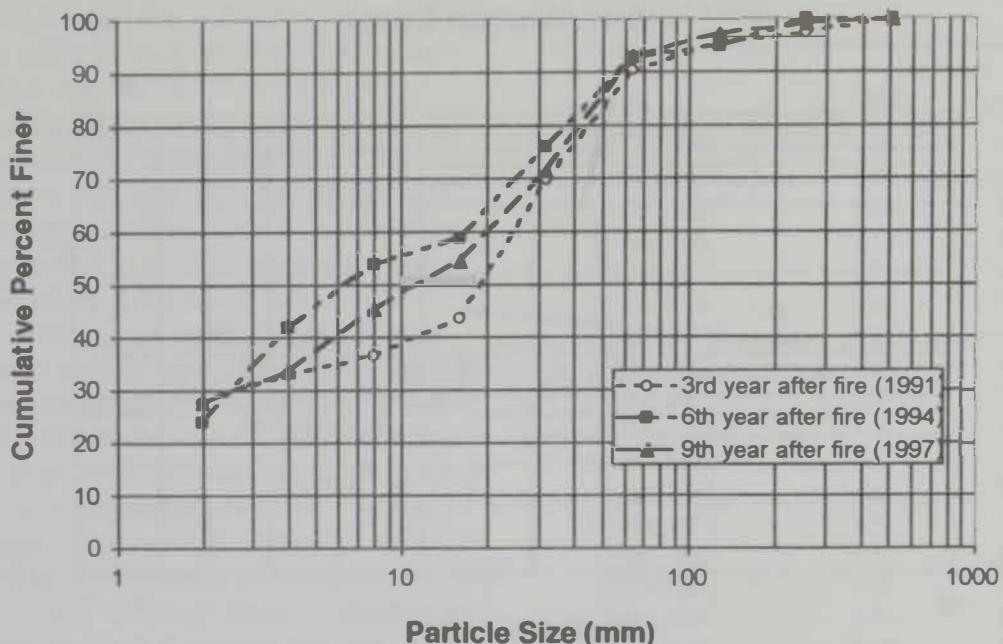
Upper Moose Creek

Figure 8. Cumulative particle size distributions, upper Moose Creek site.

No pre-fire particle size data were available for the upper site. After the fire, the d_{50} at this site ranged from 6.2 to 19 mm, with an average of 14 mm (Fig. 8). The percentage of material smaller than 2 mm observed in 1997 was not

significantly different at $\alpha = 0.05$ than that observed in 1991. Smaller percentages of fine material were observed in intervening years, but there was no apparent trend over time (Fig. 8).

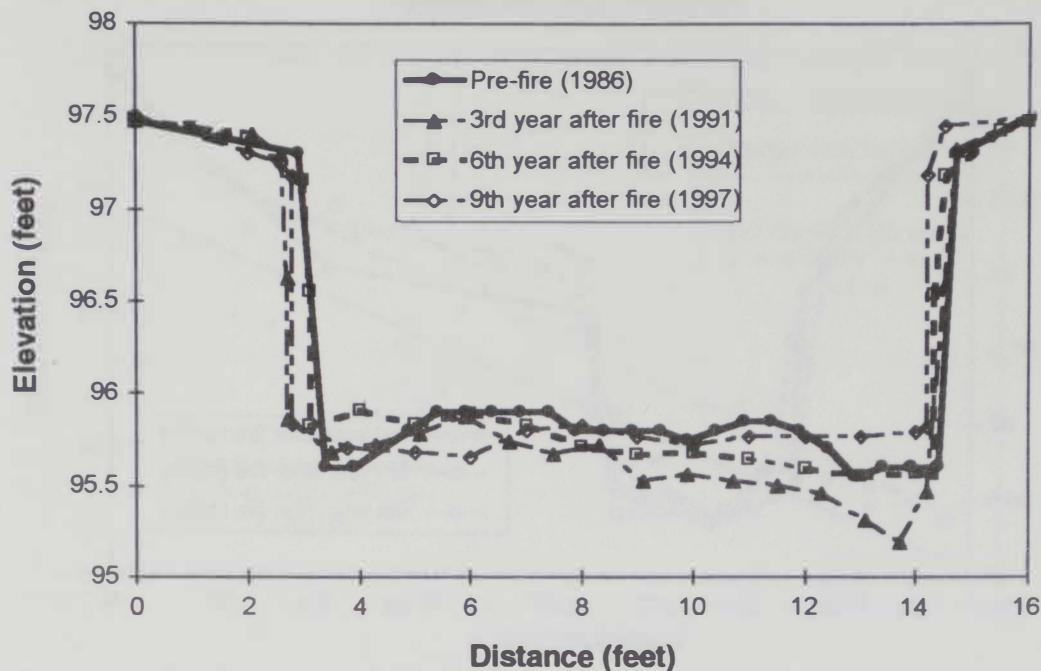
Lower Moose Creek

At the lower site, post-fire cross-sectional area calculations show net degradation at the site when compared to 1986 (Table 4), but no major changes in cross-section are visually evident (Fig. 9). The greatest net change relative to 1986 was observed in 1991 (first post-fire data). After 1991, aggradation occurred,

Figure 9. Channel cross sections, lower Moose Creek site (1 ft = 0.3048 m).

and the greatest net difference (-11.5%) relative to 1991 was observed in 1994 (Table 4). All changes occurred within the bankfull channel. The channel bed appeared to smooth out after 1991, but the cross-section was generally very stable (Fig. 9), with bank vegetation providing excellent lateral stability.

A comparison of pre-and post-fire cross-sections at the lower site indicates net degradation between pre- and post-fire periods, i.e., a net increase in cross-section area. Since 1991, however, net aggradation appears to be taking place at the lower site. No floodplain building is taking place, and although the floodplain is frequently wet, overbank flows have not been observed to access the floodplain, and all changes are restricted to the sides and bottom of the channel. Net changes in cross-sectional area at the upper site since 1991 indicated that although the bed of the stream has not been aggrading, the floodplain on the right side of the stream has been rising in elevation, accounting for the calculated net change in cross-section area. Overbank flows have had extensive access to the floodplain, and increased flows and continued high sediment input in recent years would explain this development. The fresh overbank and lateral accretion deposits seen in other reaches of the stream in 1997 further supported the floodplain development shown in cross-section plots.

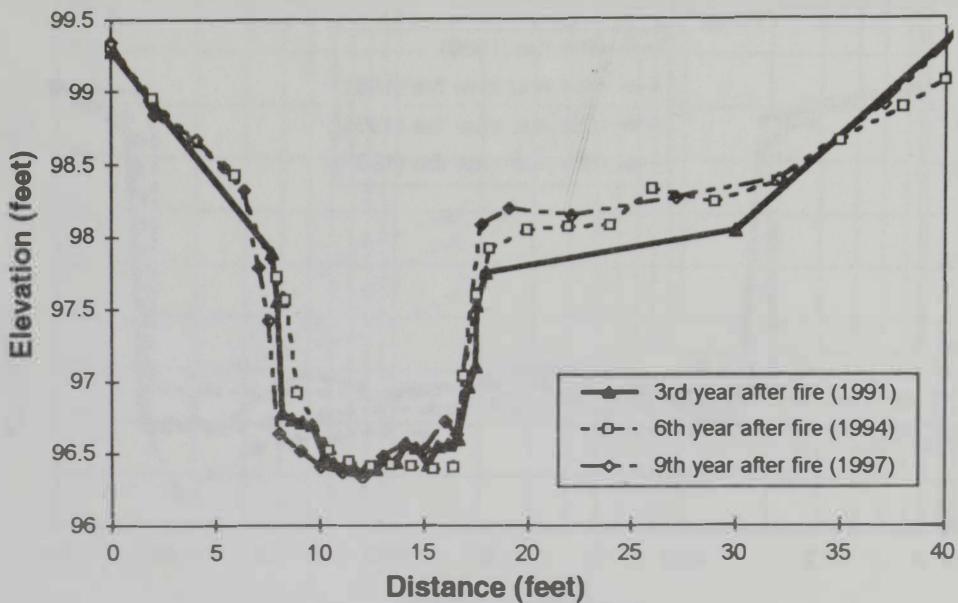
Upper Moose Creek

No cross-section surveys were conducted at the upper site before the fires. Net changes in cross-section area between 1991 and subsequent years had consistent, negative values (between -11.9% and -13.8%), indicating aggradation (Table 5). Because bank position is stabilized by riparian vegetation and valley confinement, all changes in cross-section appeared to be

taking place with respect to channel depth and floodplain elevation, not lateral movement. Visual inspection of cross-section plots shows the most interesting changes occurring not within the bankfull channel, but in the floodplain (Fig. 10). The right bank built steadily after the 1991 survey, indicating vertical floodplain development since the fire.

Figure 10. Channel cross sections, upper Moose Creek site (1 ft = 0.3048 m).

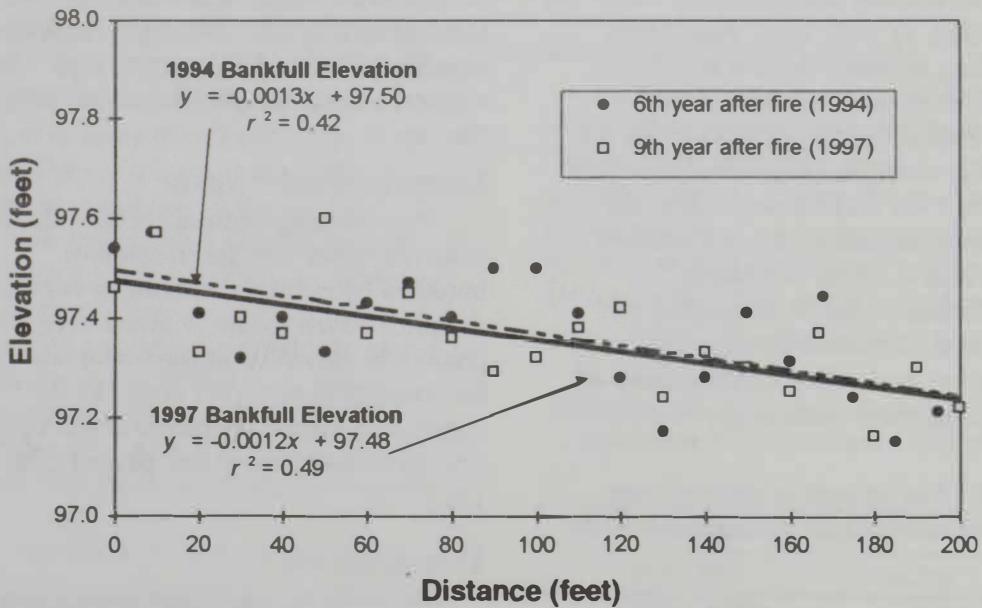
Lower Moose Creek

Pre-fire longitudinal profiles do not exist for either site. Regression of bankfull (floodplain) elevation versus distance downstream showed very little change in elevation at the lower site between 1994 and 1997 (Fig. 11). By contrast, bankfull elevation at the upper site increased during this period (Fig. 12).

Figure 11. Longitudinal profile of bankfull (floodplain) elevation, lower Moose Creek site (1 ft = 0.3048 m).

Changes in floodplain elevations were not evident in longitudinal profiles at the lower site, where lack of overbank flows precludes any major change. This is consistent with the channel trend

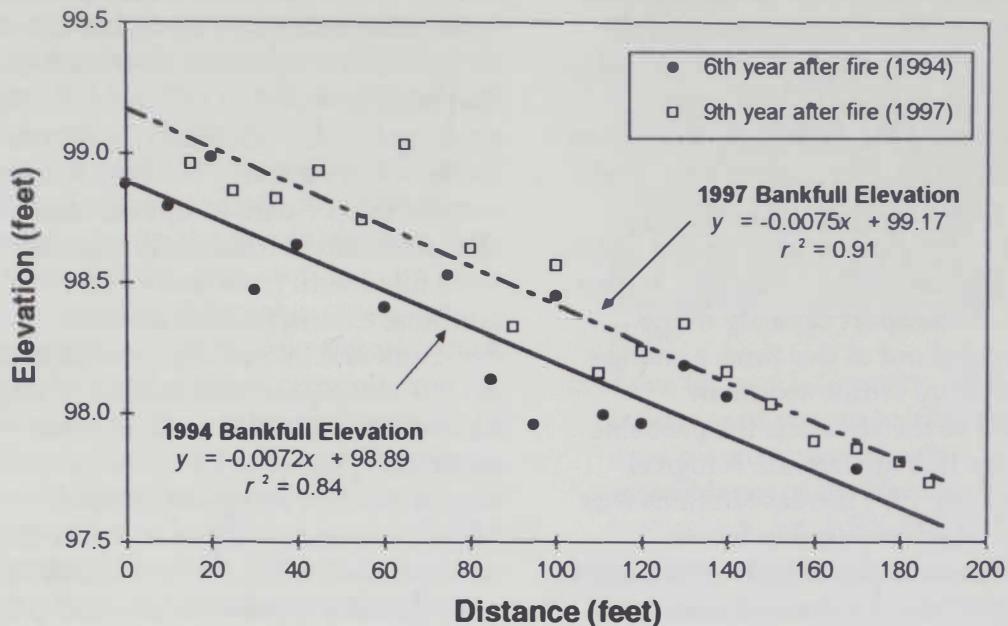
Upper Moose Creek

Figure 12. Longitudinal profile of bankfull (floodplain) elevation, upper Moose Creek site (1 ft = 0.3048 m).

changes observed at the cross-section and the observed lack of overbank flows. Longitudinal profiles of the upper site, however, show a trend of rising bankfull (floodplain) elevations from 1994 to 1997, which confirmed the cross-section evidence that the floodplain is building vertically. The buildup of the bankfull elevation is consistent with the floodplain accretion exhibited at the cross-section.
